Late Circulation
Regulatory Committee Meeting
7 December 2017

Cliff Erosion / Stability Assessment Report for 31 Moody Street, Gore Bay

CLIFF EROSION/STABILITY ASSESSMENT REPORT

31 MOODY STREET
GORE BAY

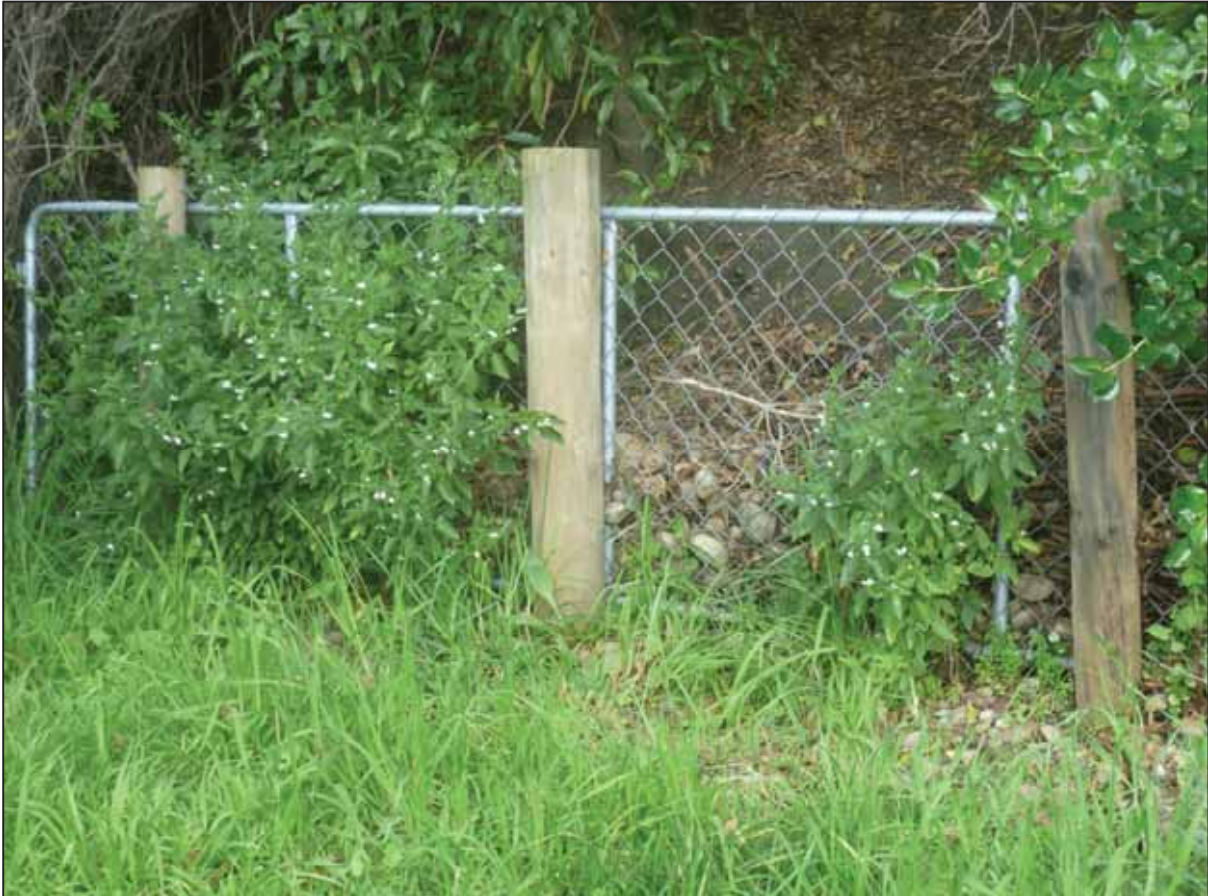
Photo 1: Rockfall protection barrier installed by campsite manager

- There is little evidence of global slope instability although there is the potential for shallow surficial landslips (ie less than 1.0 m in depth) to occur, as evidenced by areas of displaced vegetation and the slip that occurred on the neighbouring site.
- Overland flow into gully's has caused the concentration of water flow and the formation of cavities within the cliff face. The erosion of fines has led to a localised weakening of the soil/rock matrix and the potential for larger gravel, cobbles etc. to become displaced.
- The site manager has installed a wire mesh rockfall barrier at a critical point along the toe of the cliff face. A significant amount of rockfall debris was seen to have accumulated behind the barrier (photo 1).
- The site manager has stopped the use of tent sites that are along the toe of the cliff face due to the risk of falling rock debris.

As evidenced by the above photo, rockfall material of up to cobble size was seen to have collected behind, and in some areas in front of, the existing rockfall barrier. We are unsure if any of the fallen material that is currently located in front of the barrier was displaced prior to its erection, or whether the debris managed to work its way through, under, or around the barrier subsequent to it being built.

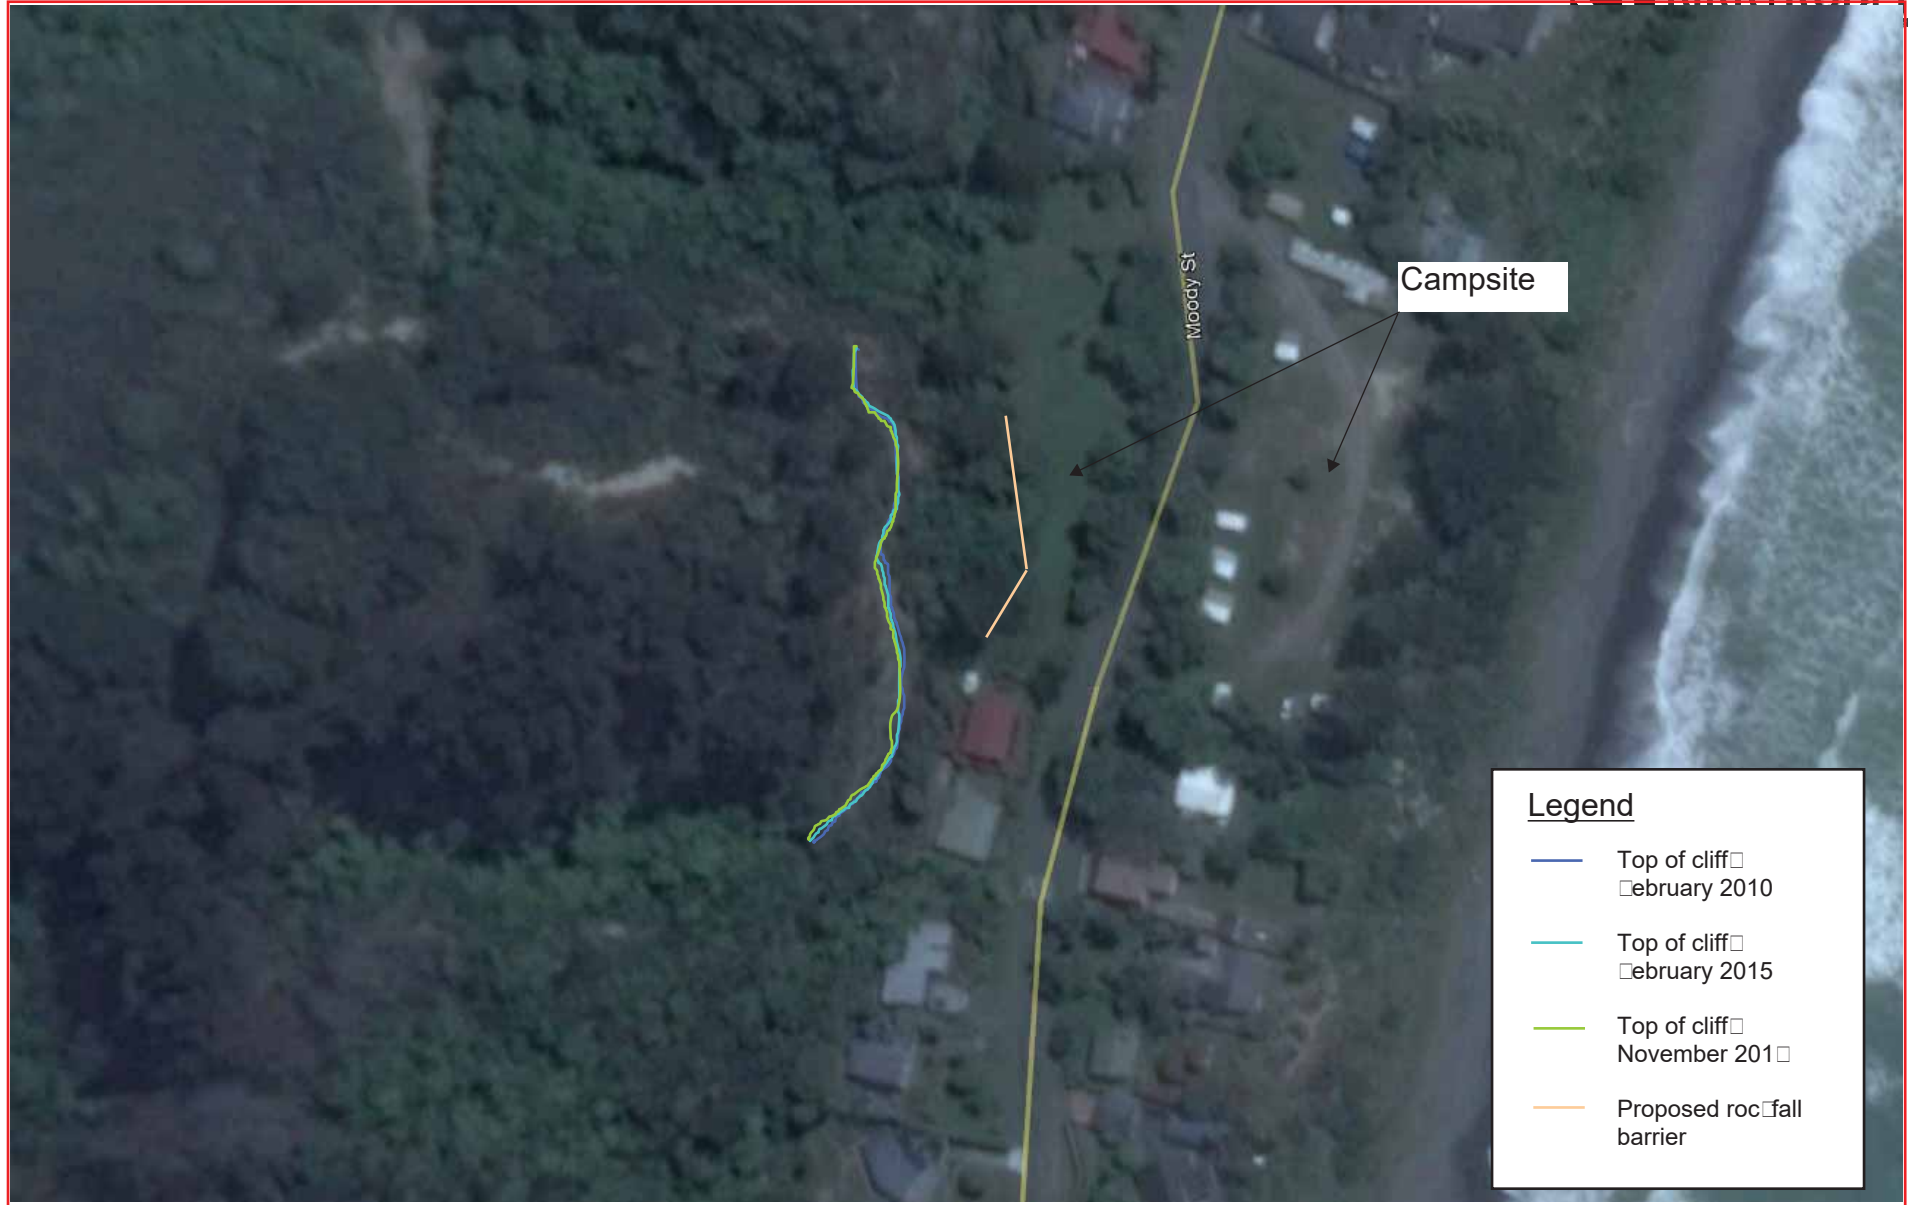
Drawing G1.0 (refer to Appendix A) shows the regression of the cliff top area from 2010 to 2016. We have taken the cliff edge to be where the land starts to noticeably slope downwards, not necessary the edge of a vertical or near vertical face, in order to provide a conservative estimate of cliff regression. We have not used the image from 15th November 2016 due to darkness and lack of clarity. It should also be noted that the ground surface profile across the western half of the subject property includes a series of near vertical faces, as well as moderately to steeply sloping topography. This varied landform, in conjunction with heavy vegetation coverage has meant there is a margin of error (± 5.0 m) in the identification of a suitable reference line across the cliff face.

As can be seen from drawing G1.0, between 2010 and 2016 there is negligible regression of the cliff. In addition, the boundary between the relatively flat camp site and the toe of the steeply sloping cliff appears to remain static, although the sloping cliff face is again heavily vegetated and difficult to accurately define.
