Detailed Seismic Assessment

Hawarden Memorial Hall

Prepared for Huruui District Council

501628

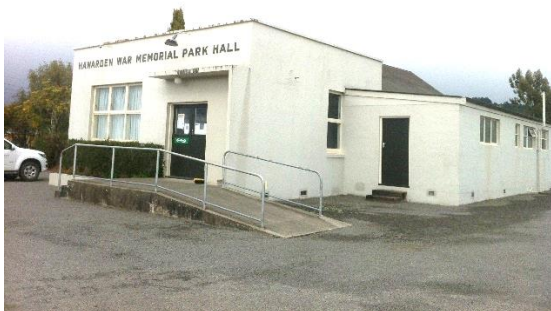
Photo 1 – View of front elevation

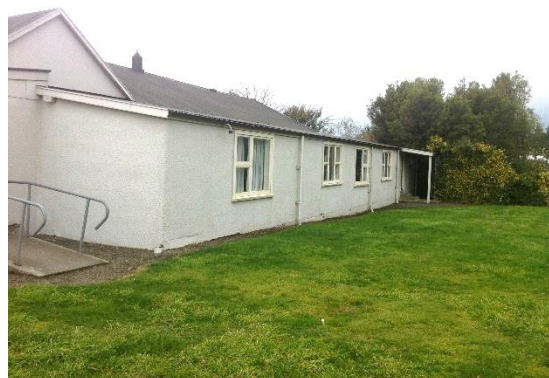
Photo 2 – View of rear elevation

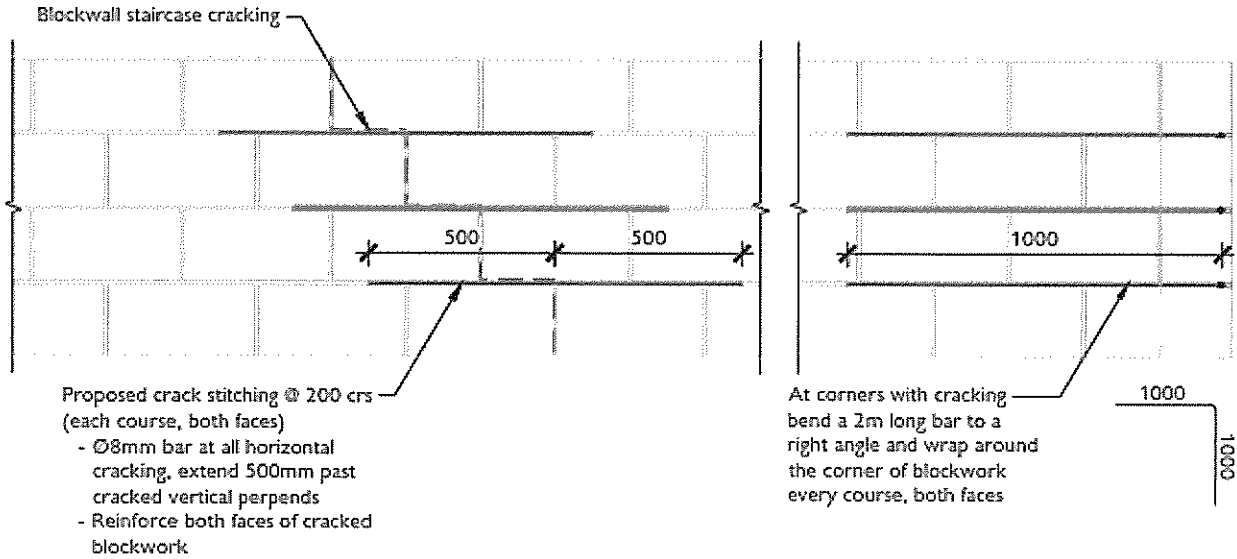
Blockwork Repair Elevation

- d) The seismic rating for the building is governed by the out-of-plane bending strength of the unreinforced blockwork walls to the northern cloakroom extension in their current damaged state.
