Detailed Seismic Assessment

Waikari Memorial Hall

Prepared for Hurunui District Council

501917

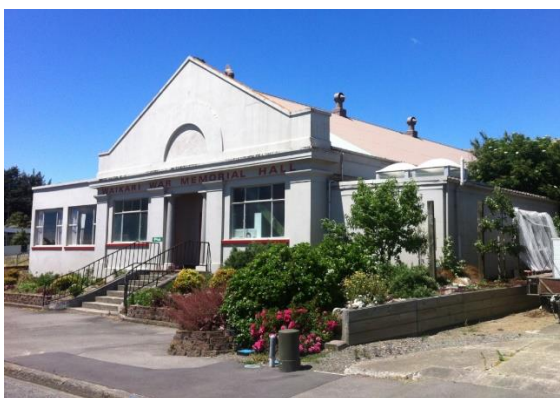
Photo 1 – View of front elevation

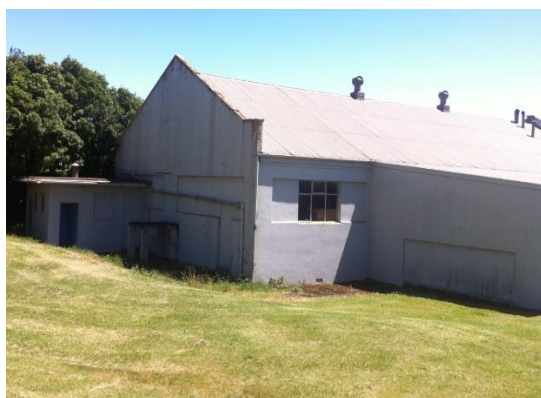
Photo 2 – View of rear elevation

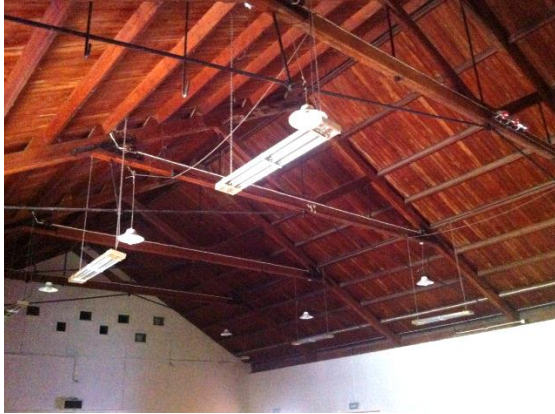
Photo 3 – View to underside of main hall roof.

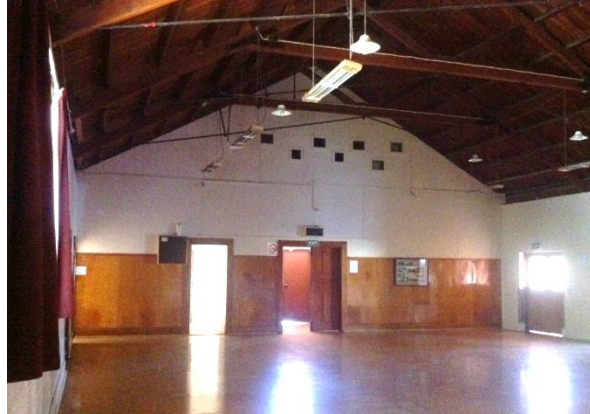
Photo 4 – View to inside of north elevation of main hall (timber internal wall).

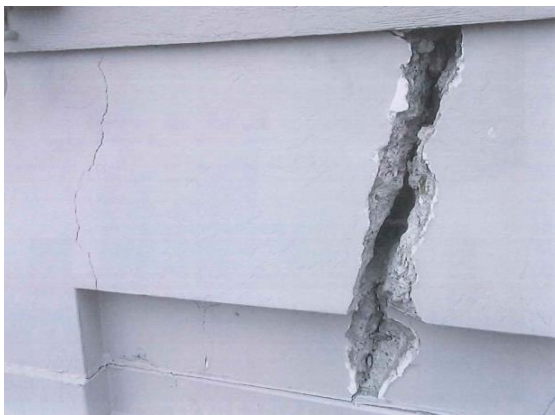
The seismic capacity of the building is limited by the in plane capacity of the roof diaphragm when taking the out of plane wall loading in the 'across' direction. We also note the cracking to the upper level of the western concrete wall as a limiting factor in it's current, damaged state.

Photo 5 – Crack identified to external of West elevation above west blockwork extension.

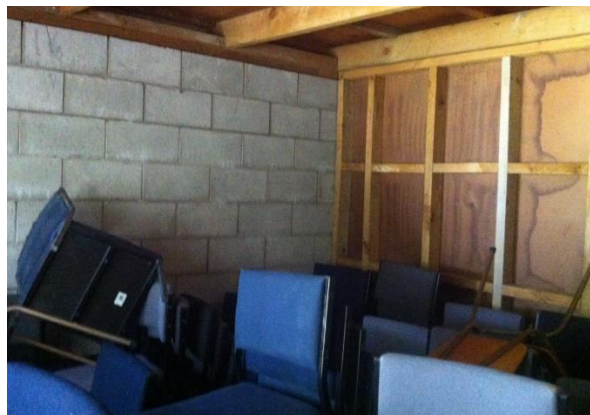
Photo 6 – Internal view of western blockwork extension.

- Unreinforced block walls of western storeroom extension in out-of-plane bending.
