APPENDIX C

Test Pit Logs

PROJECT
 MOUNT LYFORD VILLAGE

Project Name: Mt Lyford Geological Assessment

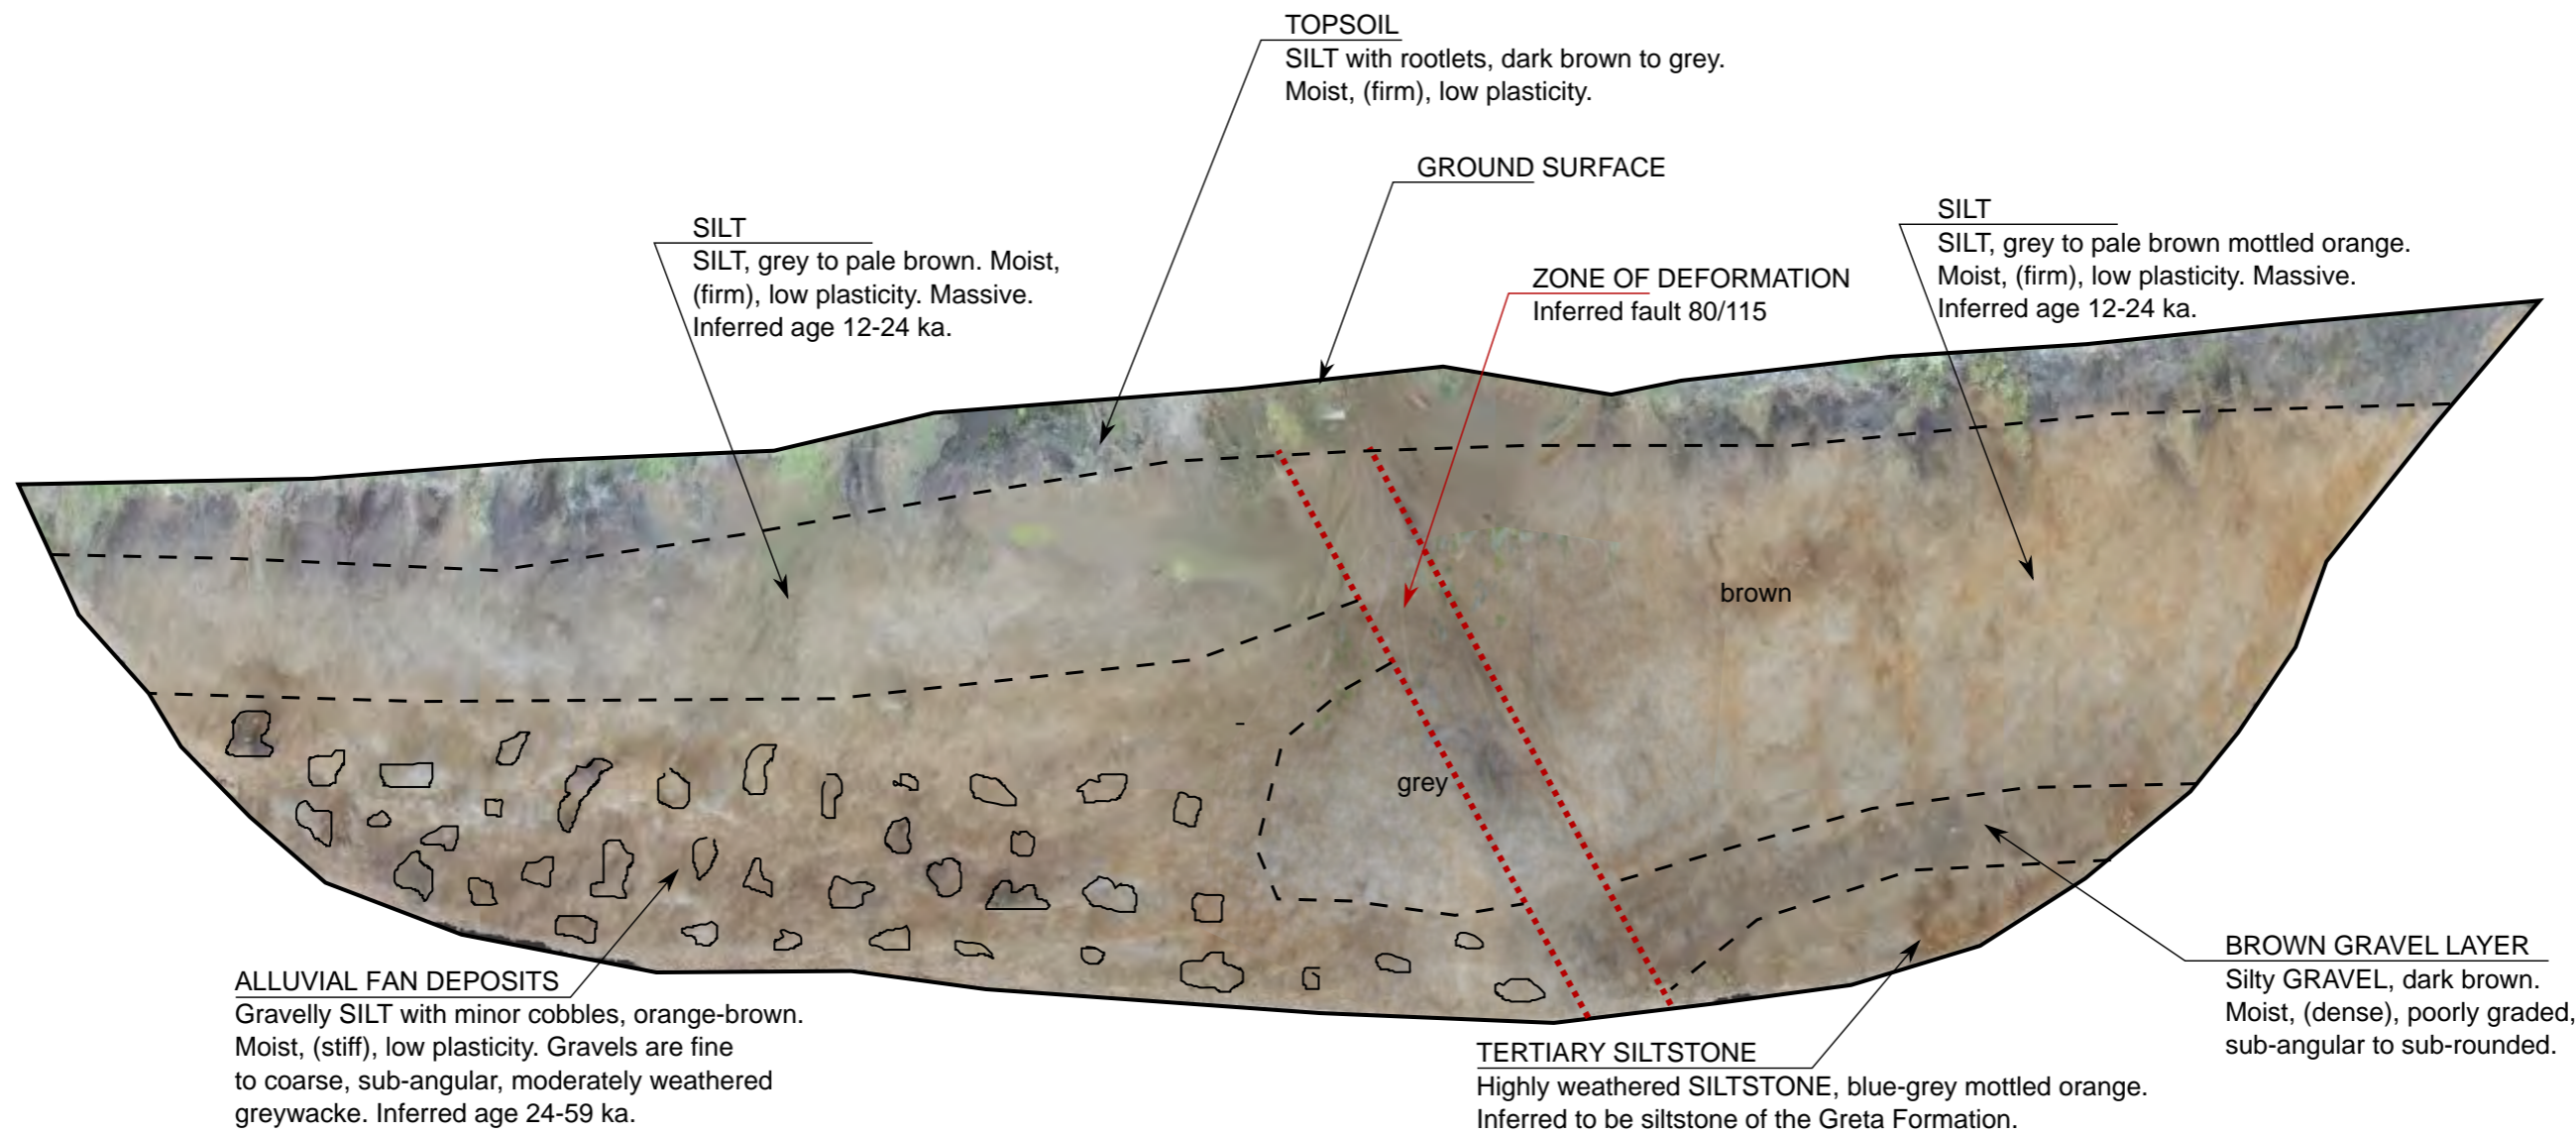
TP01 GEOLOGICAL INTERPRETATION

Note: Trench could not be extended south across the inferred fault scarp due to the presence of mature pine trees.
