Mt Lyford Village

Geological Assessment for Slope Hazards

1895571_7407-003-R-Rev0

December 2018

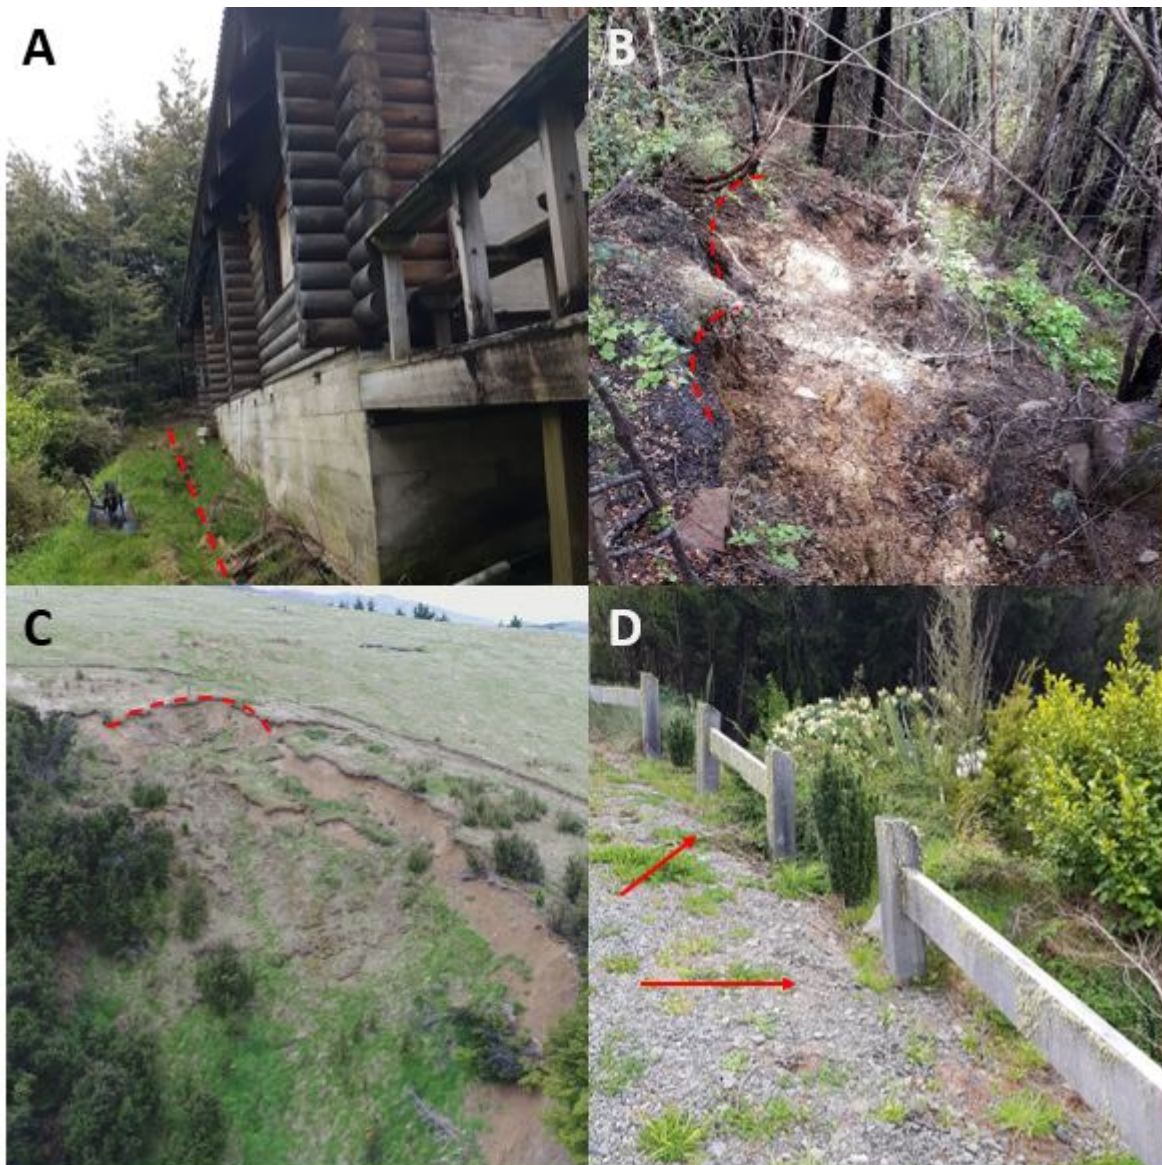
- Multiple tension cracks were observed at 87 Tinline Terrace and neighbouring sites near the crest of the slope. The cracks were observed within the near surface silty soil materials and up to approximately 2 m deep. South of the dwelling at 87 Tinline Terrace, in the wooded area, a 2 m high slip was observed (Figure 1 A). According to the land owner, the cracks occurred during the 2016 Kaikōura earthquake and are widening with exposure to rainfall. One of the tension cracks adjacent to the dwelling was located where stormwater drains down from the roof (Figure 1 B).

- Terraced slumping with multiple scarps and cracks near the slope crest on the north eastern side of Lulu's Creek (Figure 1 C). This is the largest landslide feature currently undergoing active deformation that we observed in proximity to the village.

- Settlement and deformation were observed in areas of fill material at sites along Lulu's Lane and Terako Terrace (Figure 1 D).

Figure 1: A) Dashed line represents ground crack observed at 87 Tinline Terrace where stormwater drained from the roof. B) Scalloped crests approximately 2 m high where landslide occurred south of the dwelling at 87 Tinline Terrace. The homeowner confirmed that the slumping and cracking occurred during the earthquakes but worsened following heavy rainfall. C) Slip with scalloped cracks north east of Lulu's Creek. The dashed line represents approximately 10 m in length. D) Settlement of fence due to movement of the fill material at 42 Terako Terrace. Arrows show approximate direction of the movement.

Figure 1 illustrates the different styles of slope instability observed in our field programme. The results of our investigation suggest that the most common mechanism for slope instability and deformation at Mt Lyford Village is deformation within the silty and gravelly layers overlying the siltstone and within colluvial soils or fill materials on slopes. During the 2016 Kaikōura earthquake, cracking was observed within the silt and gravelly layers. Water ingress into the cracks has been observed to worsen the deformation. The competent siltstone beneath the silty and gravelly layers is relatively impermeable. The interface may form the slip surface for some slope instability and appears to behave as a slip surface for the overlying material. Therefore, the stability seems to be controlled by the thickness of the silty and gravelly layers, the proximity to the slope edge and the orientation of the soil to siltstone contact.

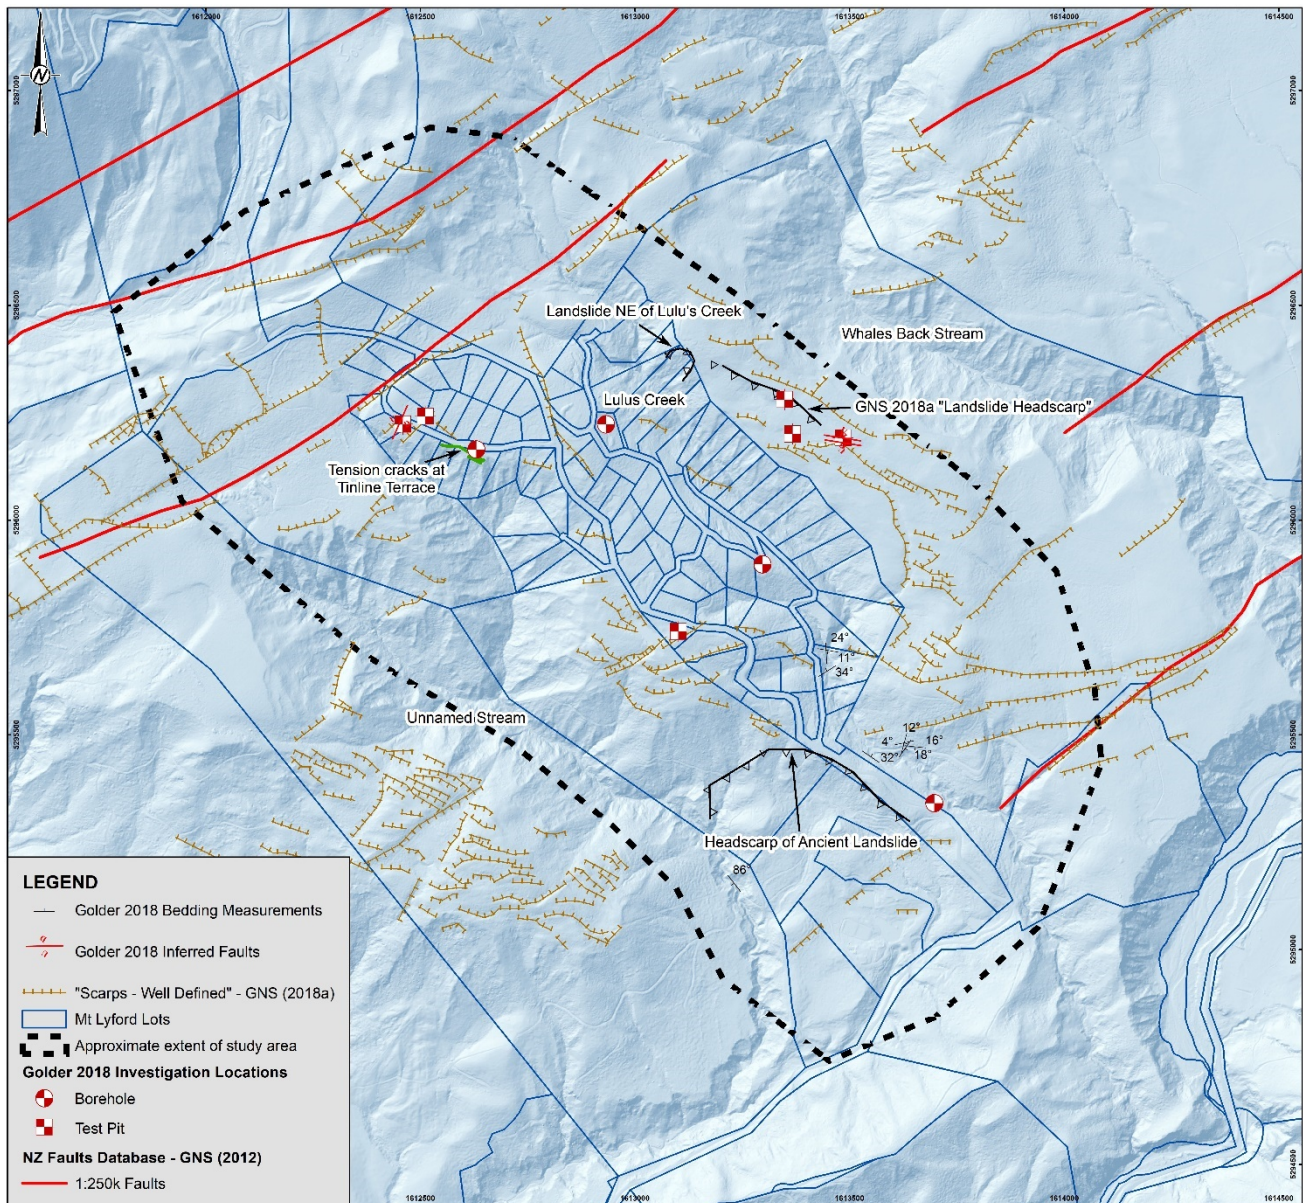
- No evidence of recent movement of cracking was observed in the ancient landslide south of the village (see Figure 3 for location of ancient landslide). This is corroborated by the observations made by GNS (2018a) and from discussions with the landowner.

Figure 3: Geological features of Mt Lyford Village and field observations by Golder.

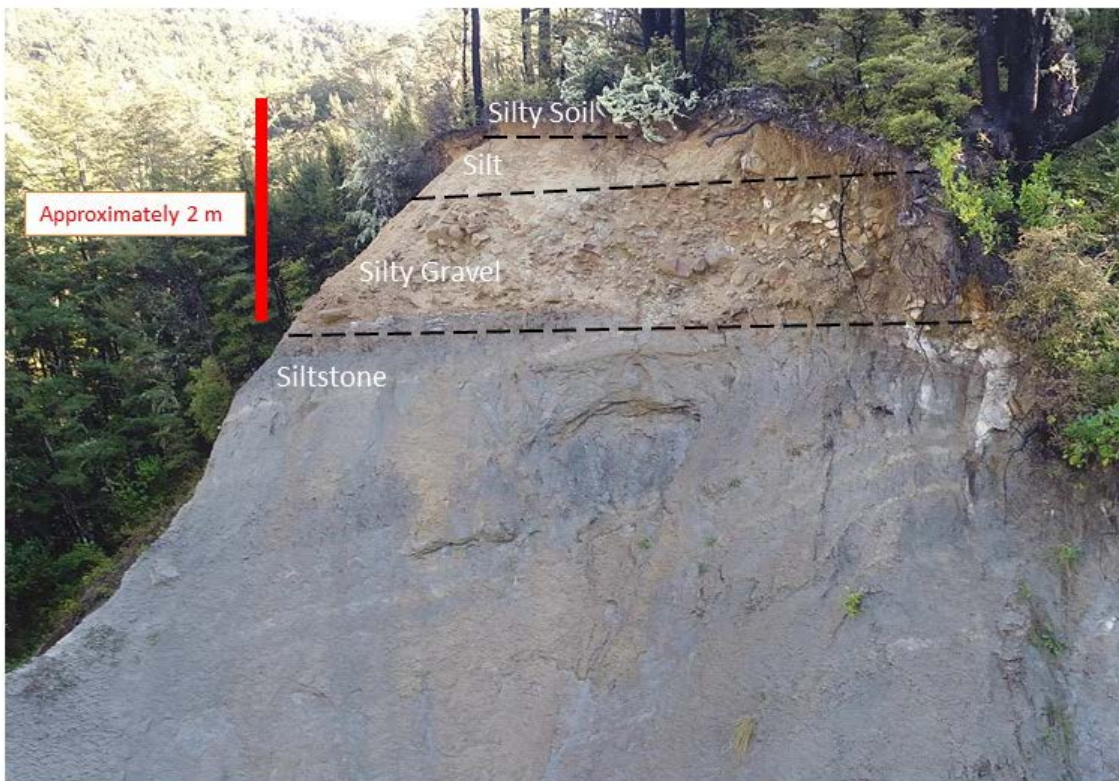
The typical stratigraphy found at Mt Lyford Village is shown in Figure 4. As was confirmed in the drilling, the general stratigraphy of the area comprises silty soils overlying silty gravels (inferred to be alluvial fan materials), which are underlain by Tertiary age siltstone of the Greta Formation. The deposits are folded in what is known as the Wandle Syncline. Our observations of bedding within the siltstone are consistent with the presence of a syncline. However, the bedding orientation did not seem to have an influence on slope instability.

Figure 4: Typical stratigraphy at Mt Lyford Village. Photo taken at the south of Mt Lyford Village near Unnamed Stream.

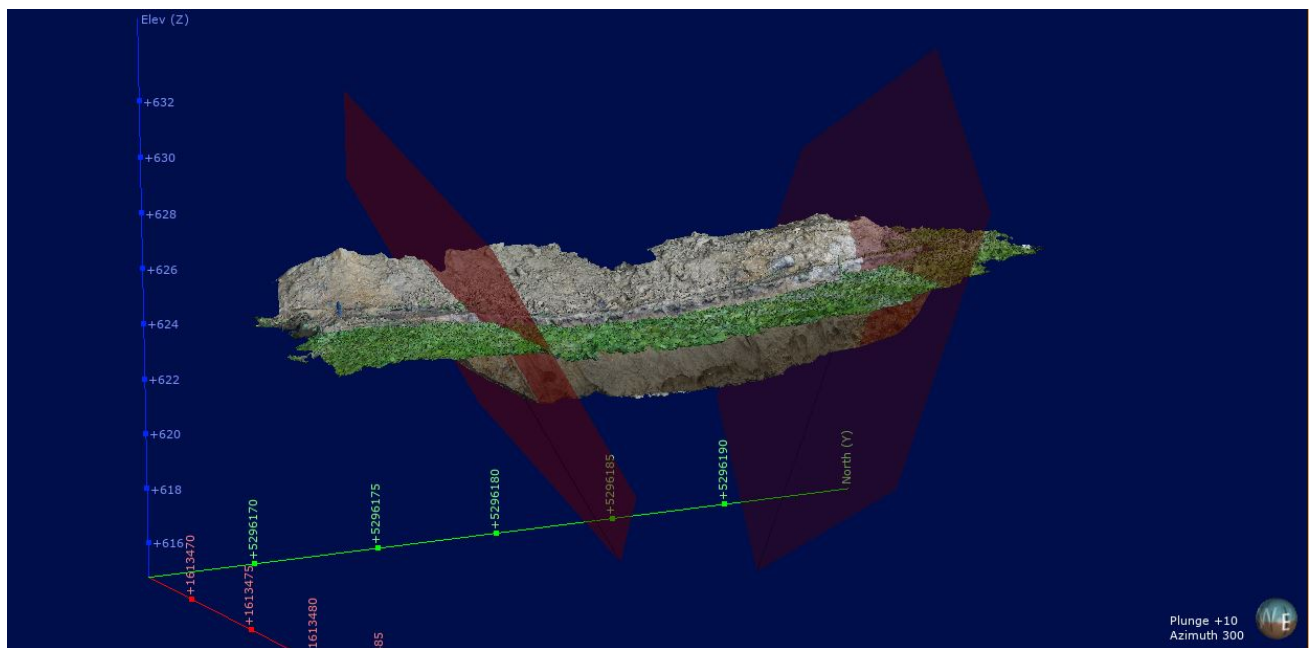
Figure 5: 3D model and cross section of TP_03 showing inferred faults which trend outside of the main trend of the Hope Fault. Looking to 300 and plunging 10°.

The observations made in TP_03 suggest that some ground displacement is possible in the Mt Lyford Village area outside of the known active mapped faults. The observations are in line with the model of the area set out by Eusden et al (2000) shown in Figure 5. This emphasises that the Mt Lyford Village area is a complex fault zone rather than a series of discrete features. Deformation, either from tectonic or slope instability processes, is possible in areas away from the delineated GNS Fault Avoidance Zones. Active faults mapped by GNS are likely to be where the maximum deformation may occur during a Hope Fault earthquake, but it should be considered that deformation may occur away from the mapped faults.

In our geotechnical investigations, specifically TP_03 – TP_05, we identified deformation zones, inferred to be faults or shear zones, which had not been previously investigated and that do not coincide with the trends or locations of previously identified active faults. Similar features had been mapped as “slope rents” and “scarps” in the past (Yetton 2005, GNS 2018a). It is important to consider for future proposed works that movement was identified in these features, which means that movement is possible in areas outside of the currently mapped Fault Avoidance Zones. For the purposes of future development, if an area is away from mapped active Fault Avoidance Zones, no topographical features with significant lineaments, scarps or slopes are identified on site, and there is no evidence of variability in the founding materials, then the risk of future deformation is considered low but not zero. Note that small fault displacements, ground tilting or slope instability related deformation may still occur. We recommend, however, that an assessment be undertaken prior to development to identify if the site is susceptible to future movement. As stated in Section 4.2, active faults mapped by GNS are likely to be where the maximum deformation may occur during a Hope Fault earthquake, but it should be considered that deformation may occur away from the mapped faults. We consider that the extent of deformation away from the active mapped faults is unlikely to cause severe damage to a dwelling, for instance where collapse would occur; and therefore, are within the tolerances of the NZ Building Act for an Ultimate Limit State (ULS) earthquake. For a serviceability limit state (SLS) earthquake, where some deformation is allowable but must be repairable, we consider that the hazard can be mitigated through engineering design as is outlined in the “Construction and Repairability” Section.

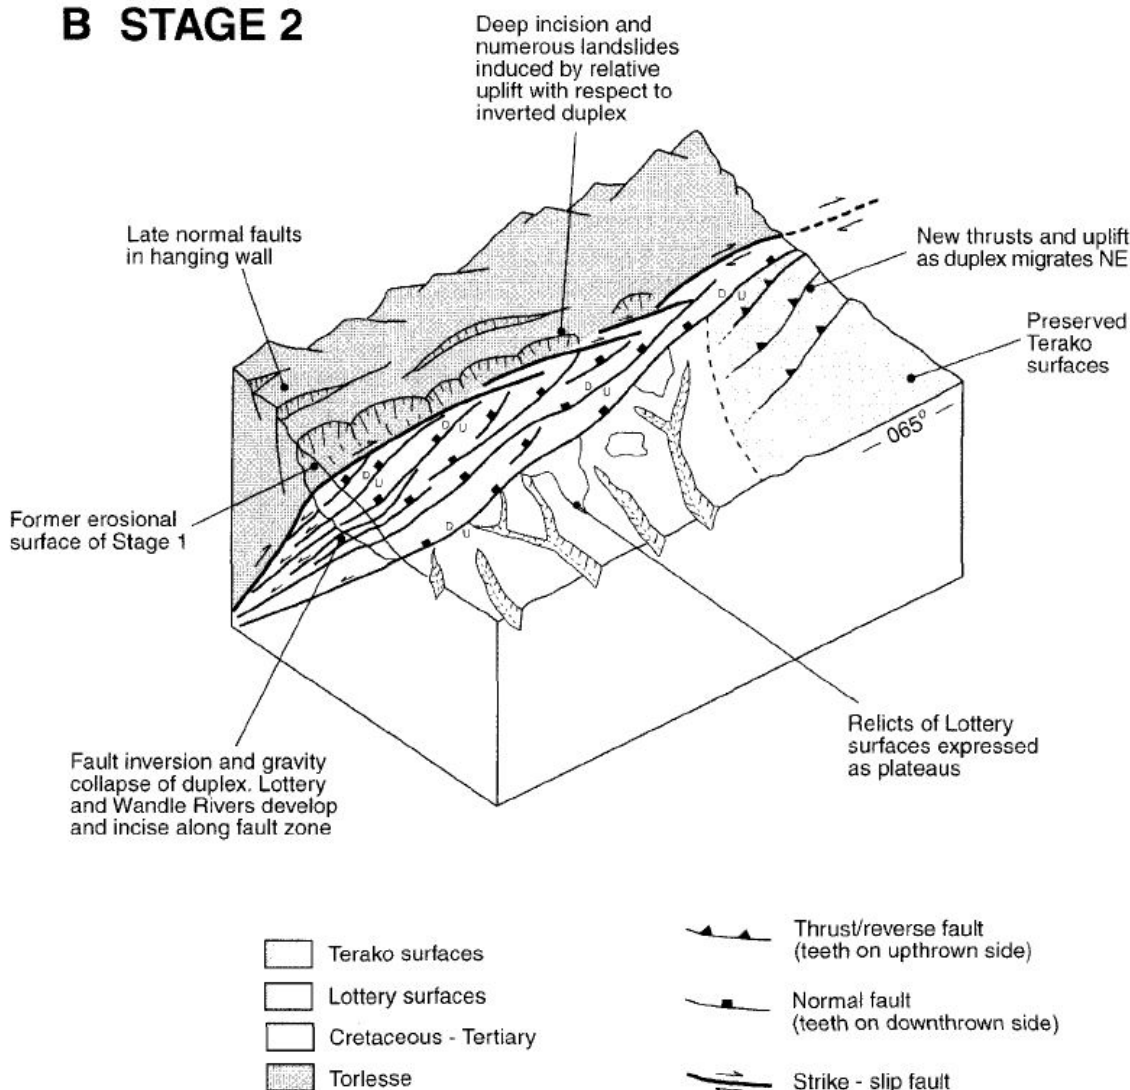
Figure 6: Faults inferred in TP_03 and TP_04 may represent new thrusts and uplift as duplex migrates. From Eusden et al 2000.

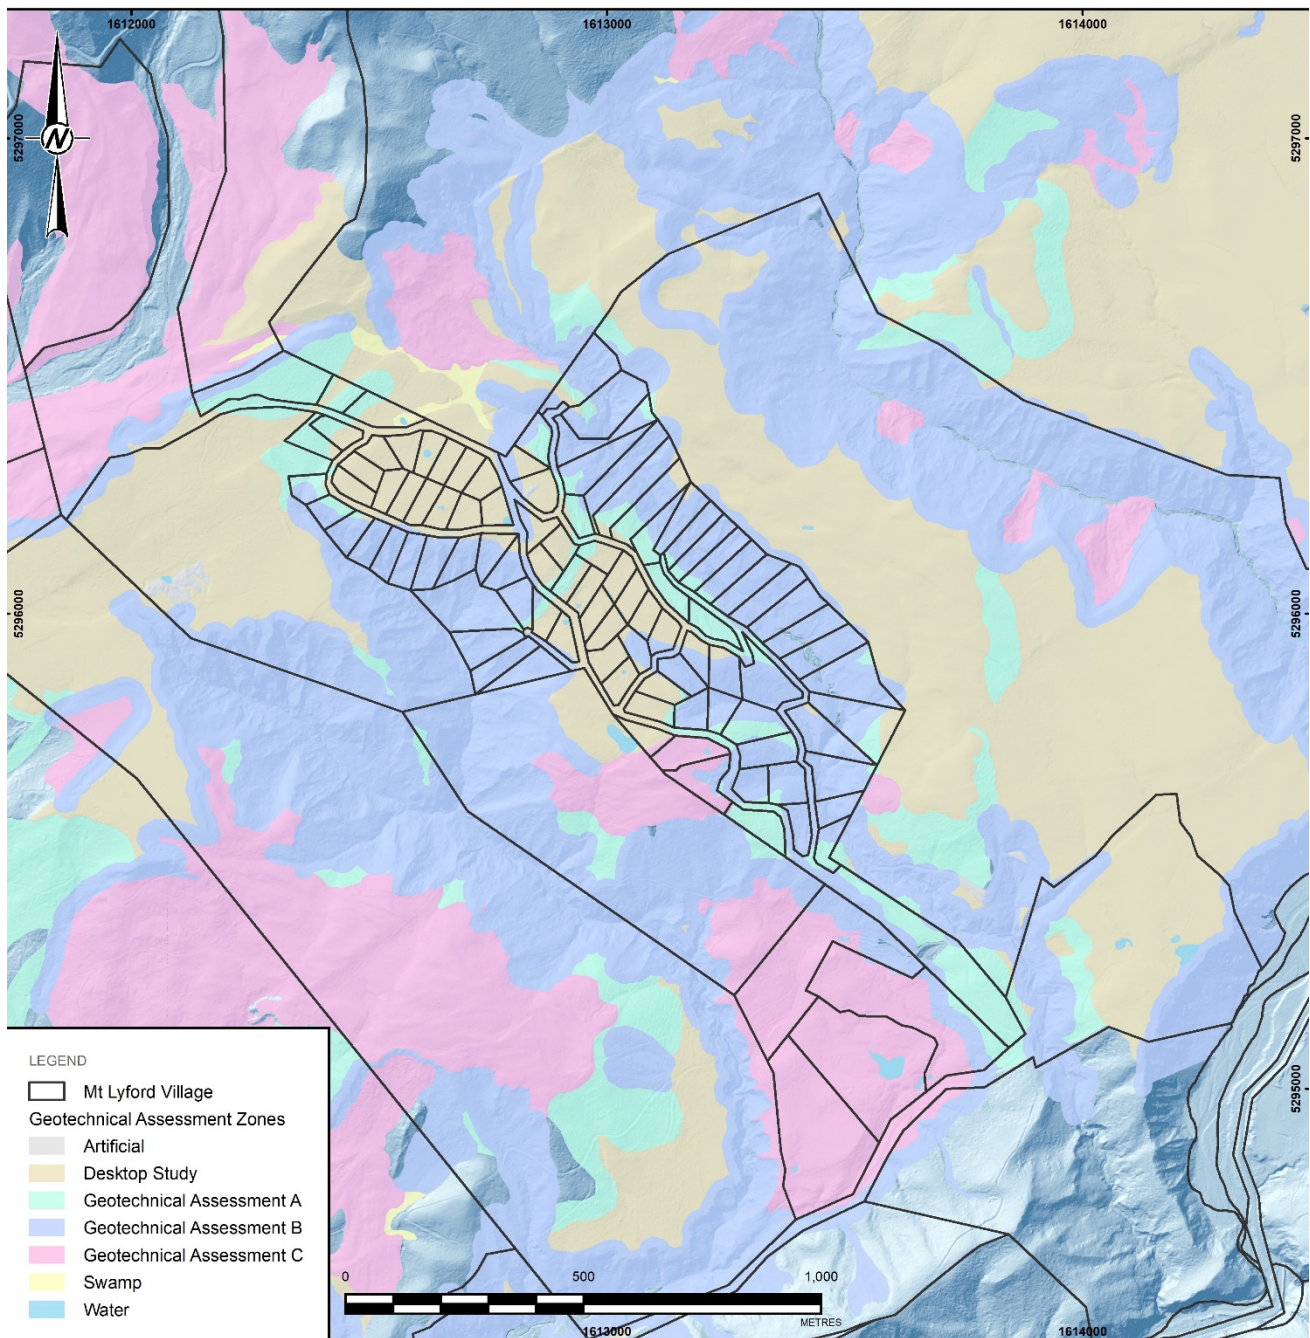
Figure 7: Geotechnical assessment Zones for Mt Lyford Village area.

Desktop Study: Based on field observations and previously reported information by GNS (2018a, 2018b), the likelihood of future slope instability causing deformation that damages a dwelling or residence in this zone is considered low. However, it should be noted that currently unrecognised features may be present; and therefore, a desktop assessment confirming that there are no geomorphological features such as significant lineaments, slopes, or tension cracks within the building footprint should be completed as part of the documentation prepared for site development. This assessment should be conducted by a suitably qualified engineering geologist or geotechnical engineer and refer to previous reports (including this report), LiDAR data and/or the results of a site walkover. If any topographic features are identified that could result from tectonic deformation or landslide activity, the procedure outlined in Geotechnical Assessment A should be followed.

Geotechnical Assessment A: This zone comprises sites with mixed topography, some flat lying, some terraced and some of which have slopes greater than 25°. GNS defined that some of these properties have the potential for adverse slope instability issues. We recommend that a geotechnical report, prepared by a suitably qualified engineering geologist or geotechnical engineer, assessing land stability be provided for any development to these sites. Any earthworks in proximity to the proposed building footprint should be assessed by an experienced geotechnical professional to address the potential slope instability risks. Investigations should include a geomorphological assessment of whether any evidence of past slope movement (cracking, terraces, bulging etc) is present. If identified, then foundations should be designed accordingly. Consideration can be given to founding in the competent siltstone beneath surficial soil layers. A geotechnical investigation such as borehole drilling or test pitting should be undertaken to confirm the depth and lateral extent of a suitable founding layer.

Geotechnical Assessment B: The investigation procedures outlined for Geotechnical Assessment A should be followed for this zone with the following additional considerations. This zone comprises the steepest sites within Mt Lyford Village and includes a 20 m setback zone from the crest of the slope. This zone is considered a high hazard area in terms of slope instability. Golder considers that a 20 m setback from the crest is an appropriate configuration to delineate this high hazard area. As is outlined in GNS 2018b, damage to dwellings or residences experienced in this area during the 2016 Kaikōura earthquake and afterwards were due to ground shaking, which has been exacerbated by rainfall events. To develop in this zone, an assessment of slope instability will need to be undertaken. It is likely that mitigation works to reduce the slope instability hazard would be required, and any mitigation works should be designed with input from a geotechnical engineer or engineering geologist. As is outlined in Section 5.0, geotechnical input is needed to confirm the suitability of any earthworks for the land such as cutting and filling. Any retaining walls should be designed with input from a chartered professional engineer. In this geotechnical assessment zone, drainage is particularly important due to the dispersive nature of the surficial soils, especially on steep slopes. The geotechnical assessment report for the properties in this zone should address any potential gully erosion, slope retreat, landslip and inundation from landslip material. If any of these hazards are observed on the site, they must be addressed and mitigated in the specific engineering design.

Geotechnical Assessment C: This zone is characterised by previously recognised ancient landslide deposits. Because these sites are not “in situ” ground and have experienced movement in the recent past, it is considered to have the potential to experience further deformation that could cause unacceptable damage to buildings on the sites. These landslide deposits were mapped by Bell (1987) using aerial photography and more recently by GNS (2018a) using LiDAR digital elevation models. A site-specific geotechnical report using the procedures outlined for land zoned Geotechnical Assessment A should be applied. Special consideration should be given to determine if the property has experienced any movement or settlement in the recent earthquakes.
