**Land damage and natural hazards in the Mt Lyford  
Village area following the 2016 Kaikōura earthquake**

**GNS Science Consultancy Report 2017/227  
April 2018**

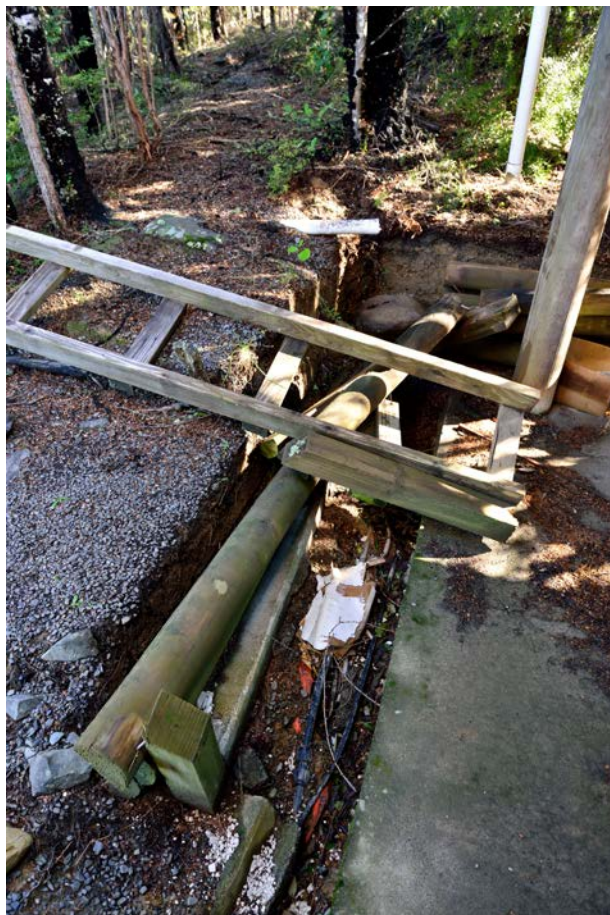
**Figure A1.1** Typical foundation settling adjacent to a split-level log house at Mt Lyford Village. Note the subsidence of the ground and ground cracking extending away from the house (concrete pad).

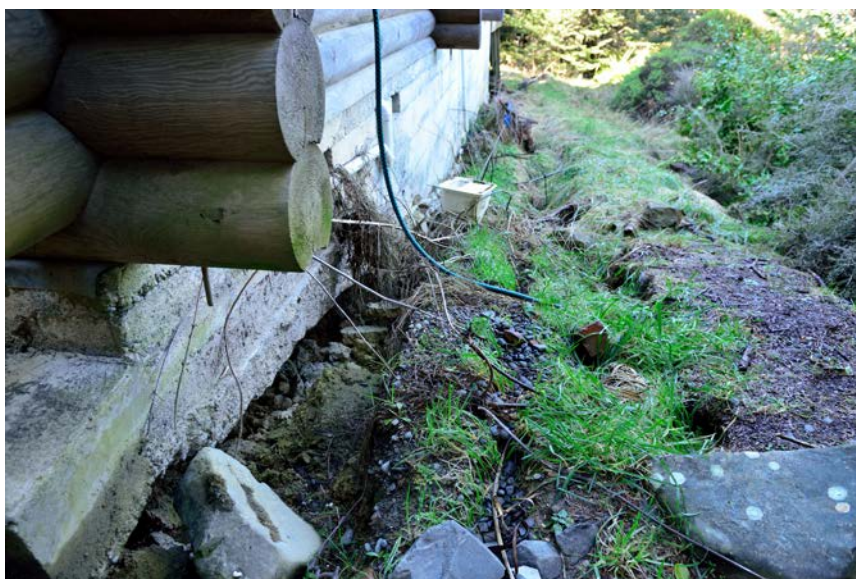
**Figure A1.2** Typical ground extension observed at the downhill-facing edge of a house at Mt Lyford Village.

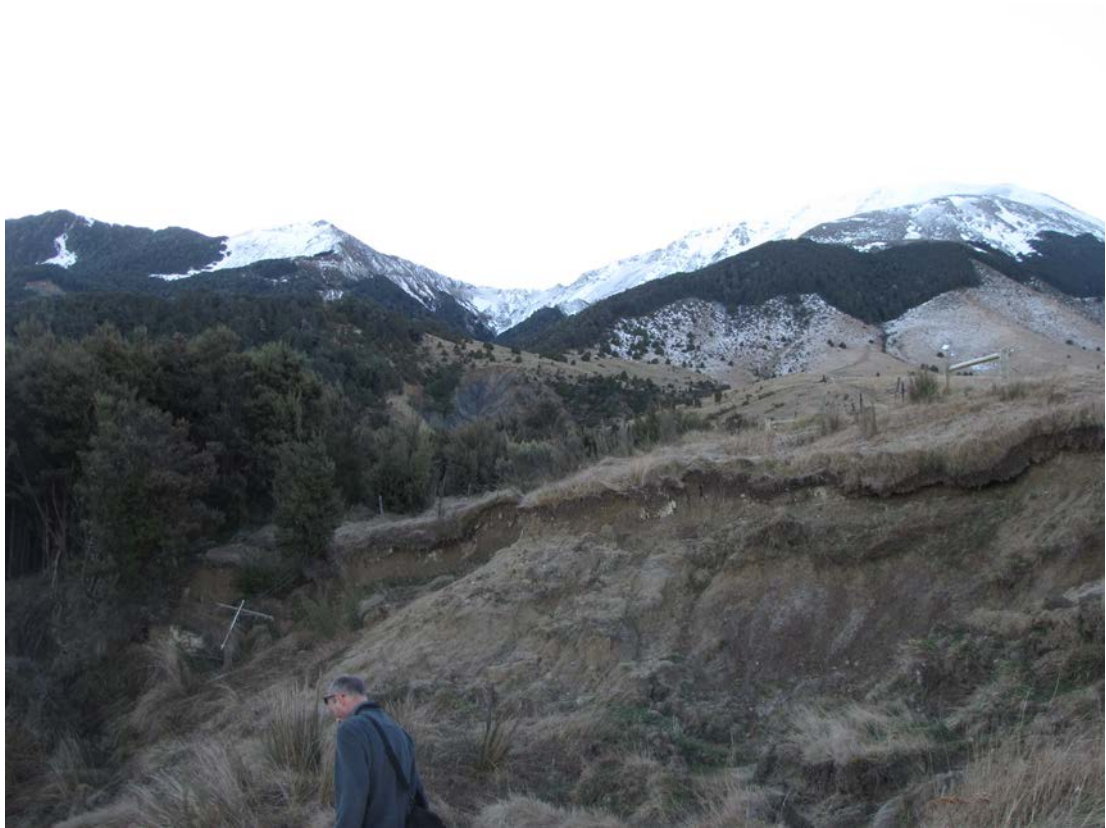
**Figure A1.3** Reactivated headscarp area of an arcuate landslide on the NE face of Lulus Creek.

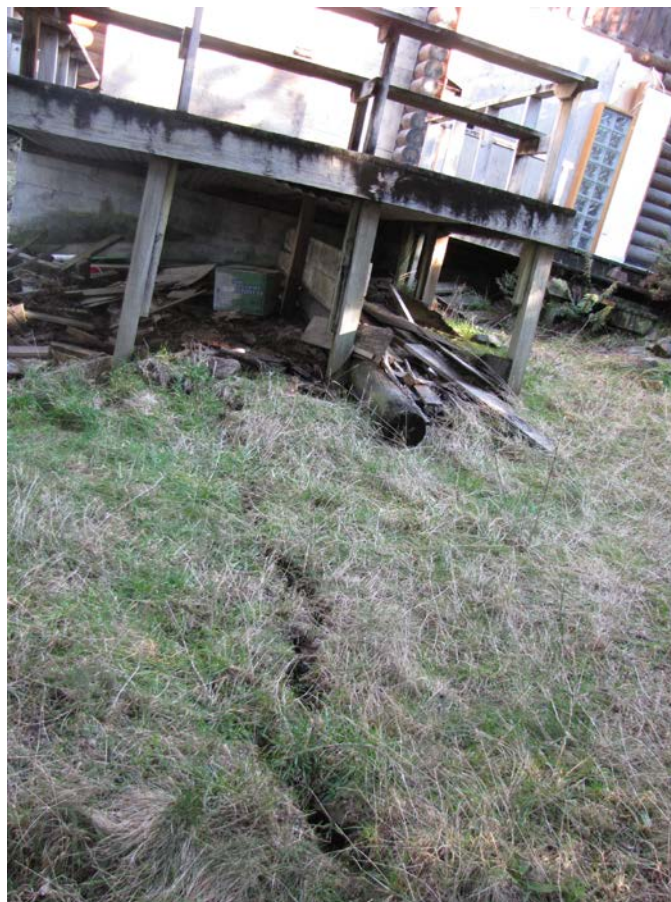
**Figure A1.4** Linear ground cracking related to slope extension projecting beneath a house.

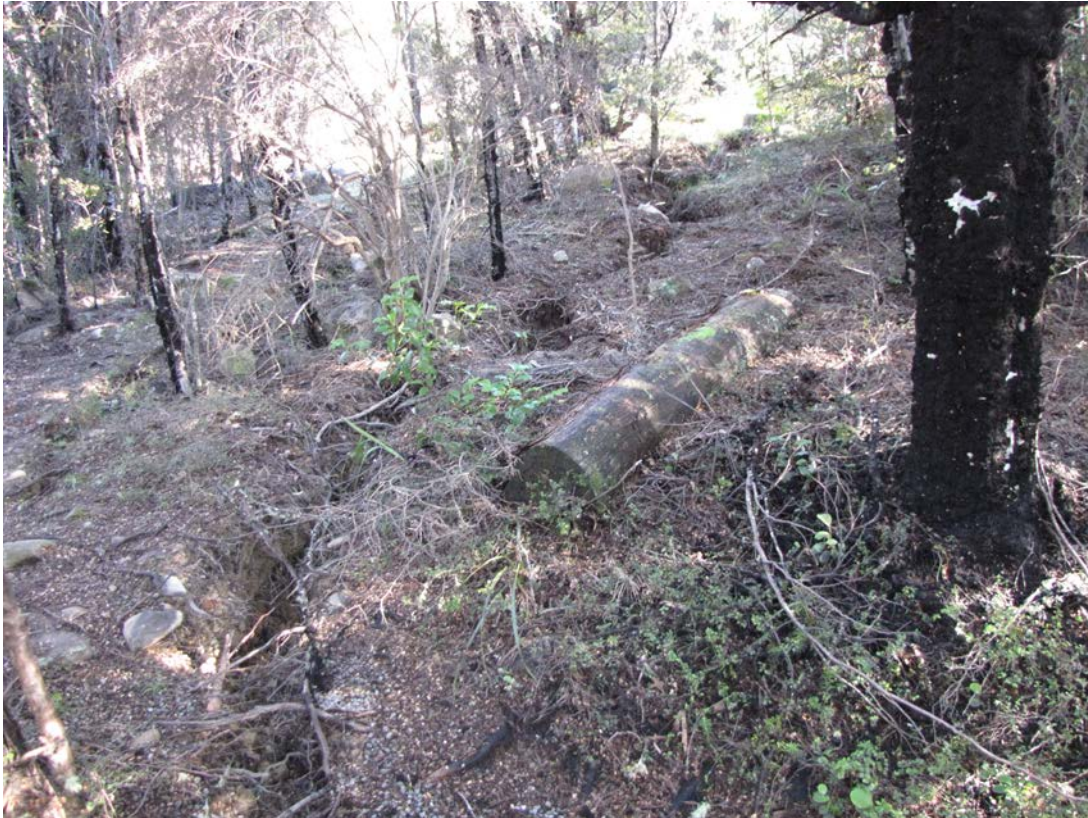
**Figure A1.5** Arcuate ground cracking related to slope extension within scrub above 'unnamed' stream.

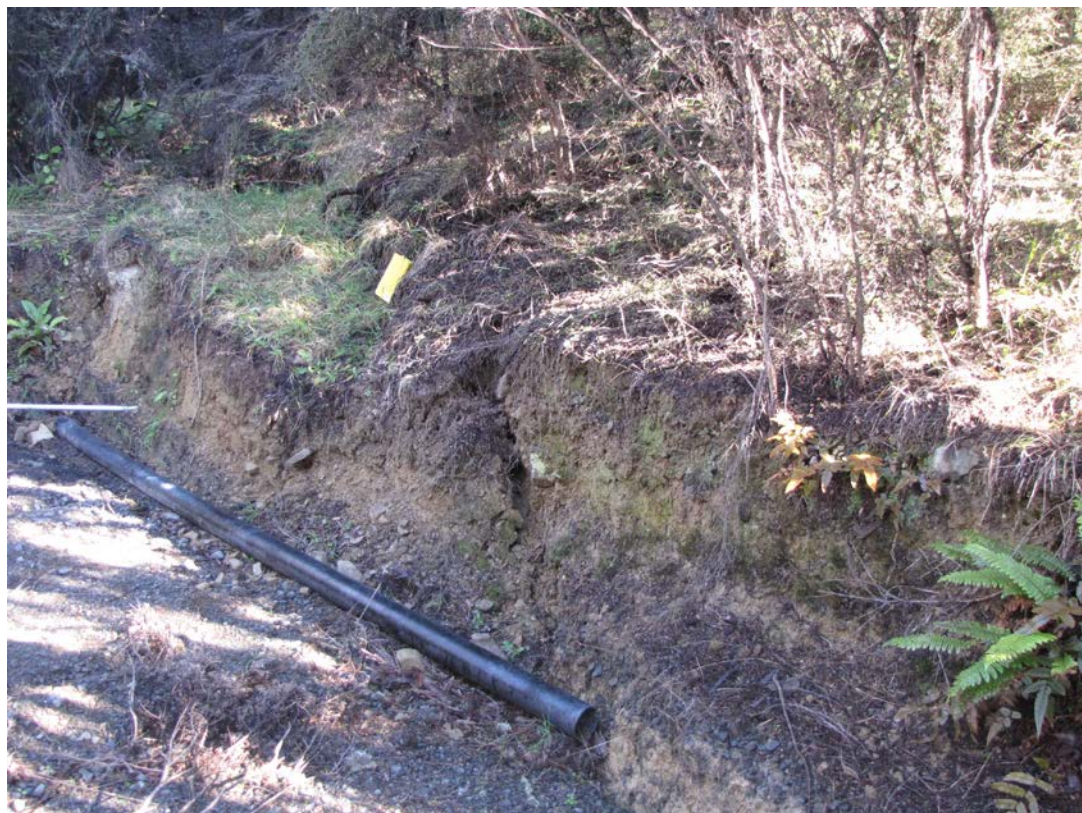
**Figure A1.6** Ground cracking and downslope failure (projecting to back of photo beyond yellow notebook) of c. 20 cm, exposed in a car parking bay cutting.

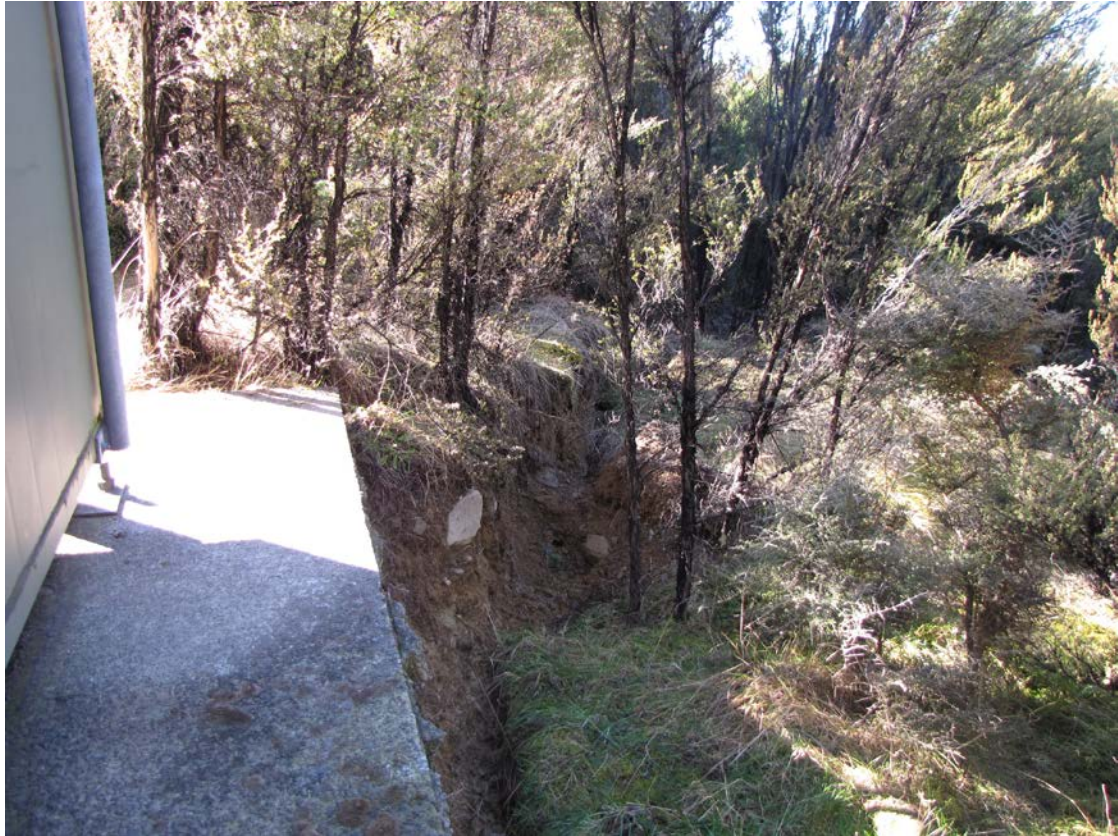
Cracking and land damage was also observed along the southwestern loop of Tinline Terrace. An oral account suggests that, following the Kaikōura earthquake, there were tensional cracks in this packed dirt road. Part of the road would be included in our 20-m setback exclusion zone (Figure 4.2). In addition, there was significant land damage (cracking and downslope movement) around the telecommunications repeater on Tinline Road (Figure A1.7).

**Figure A1.7** Down-slope ground failure related to slope instability at the Spark repeater, Tinline Terrace. The scarp in the centre is c. 0.6 m high.

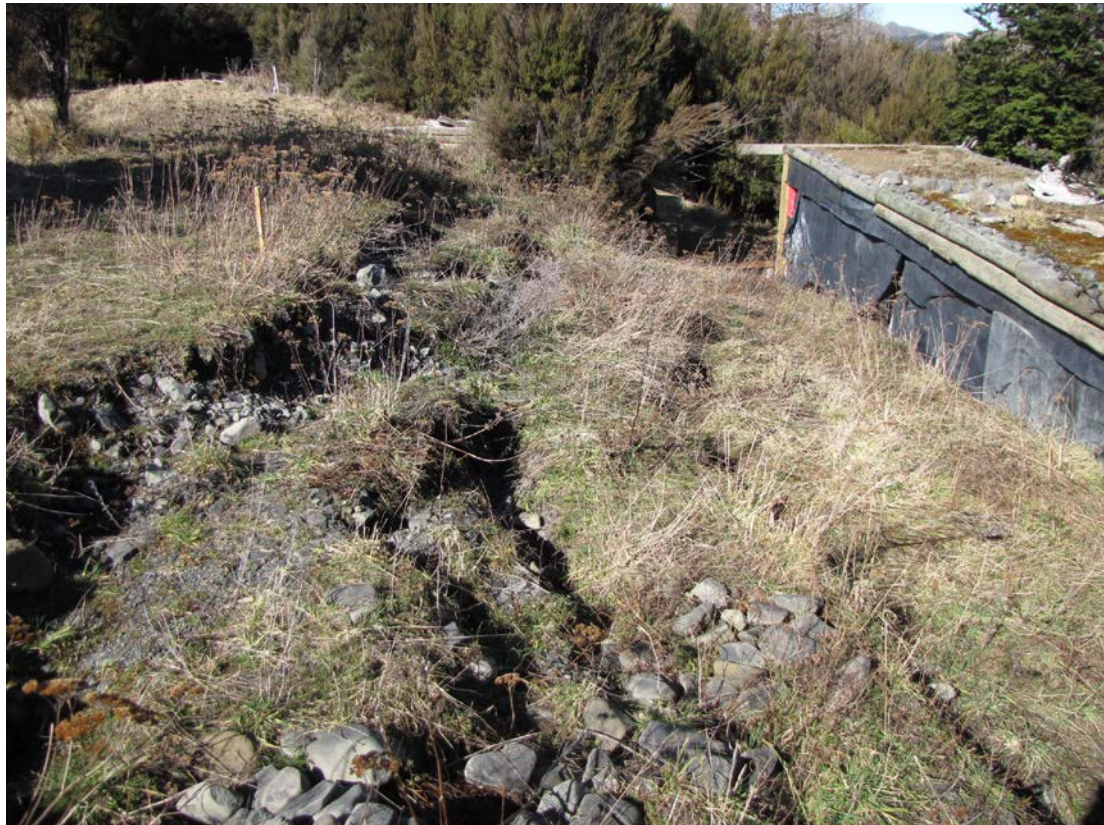
**Figure A1.8** Typical slope extension and ground failure above a cut slope where structure has been erected. Site is above the SW edge of 'unnamed' stream.

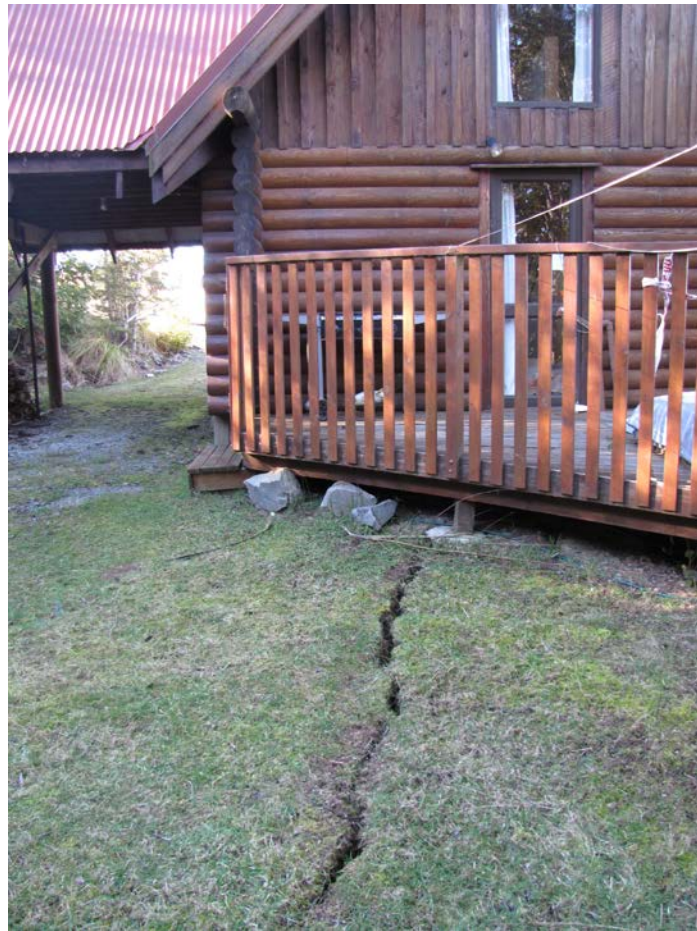
**Figure A1.9** Extension crack extending beneath a property on Charwell Terrace. Flat surface is a cut surface developed for the house foundation.

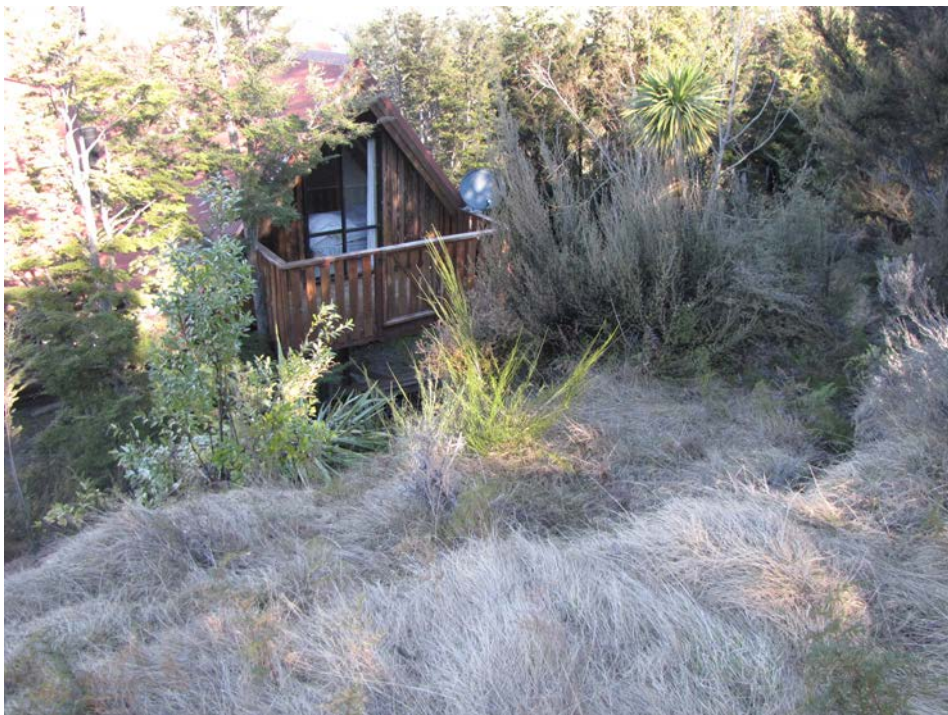
**Figure A1.10** Arcuate slope cracking (facing away from view angle) and ground failure (in foreground) above a cut slope at a property on Charwell Terrace.

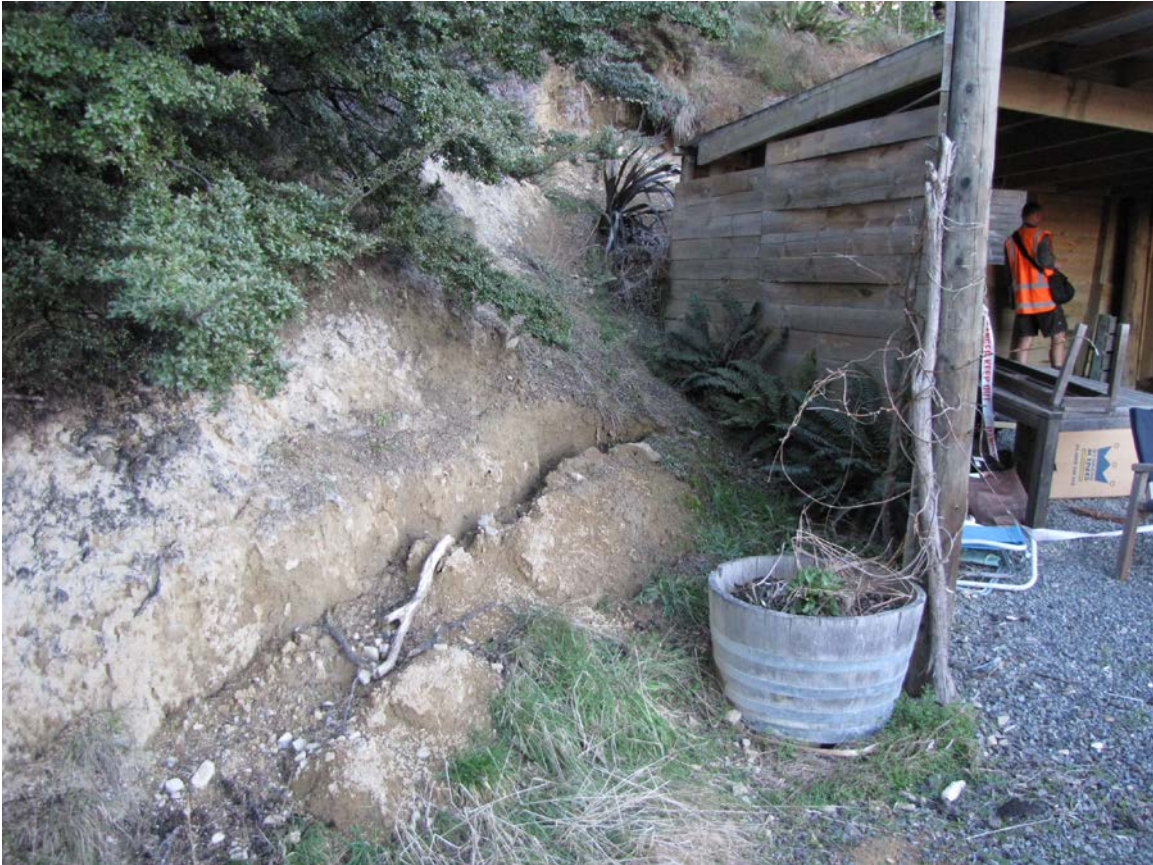
**Figure A1.11** Arcuate slope cracking and extension at the edge of a steep cut slope at property on Terako Terrace.

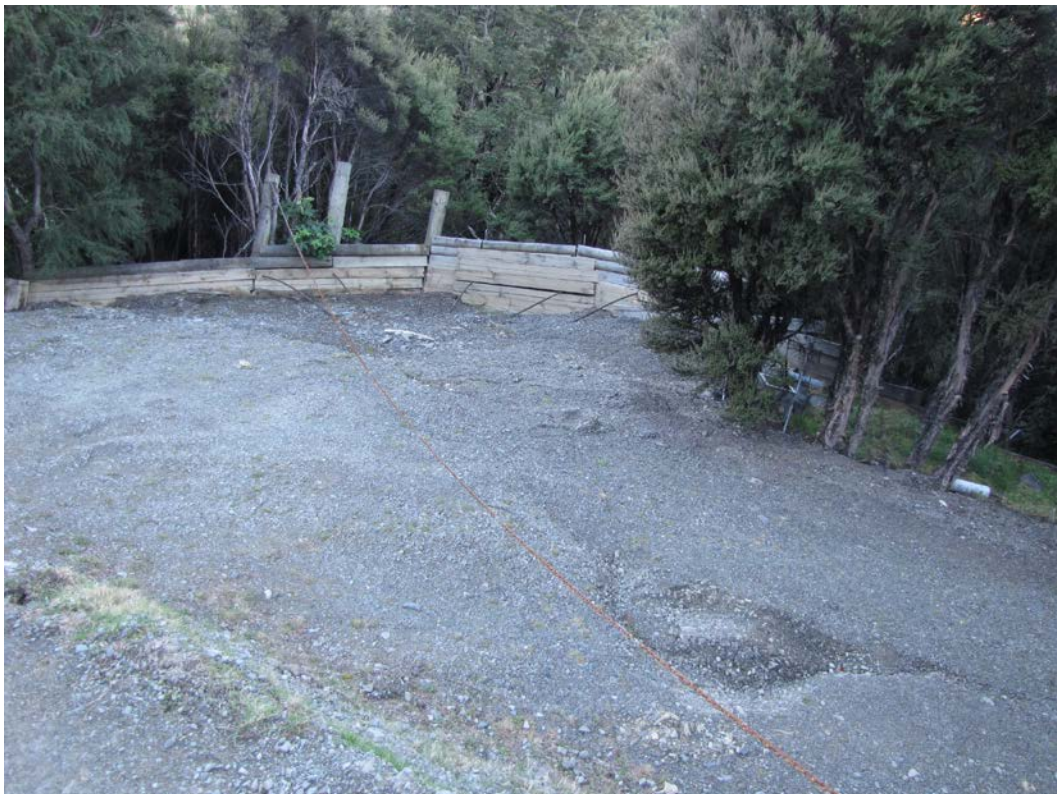
**Figure A1.12** Arcuate cracking and extension in fill forming an off-street parking pad supported by a retaining wall adjacent to a property on Cloudy Range Road.

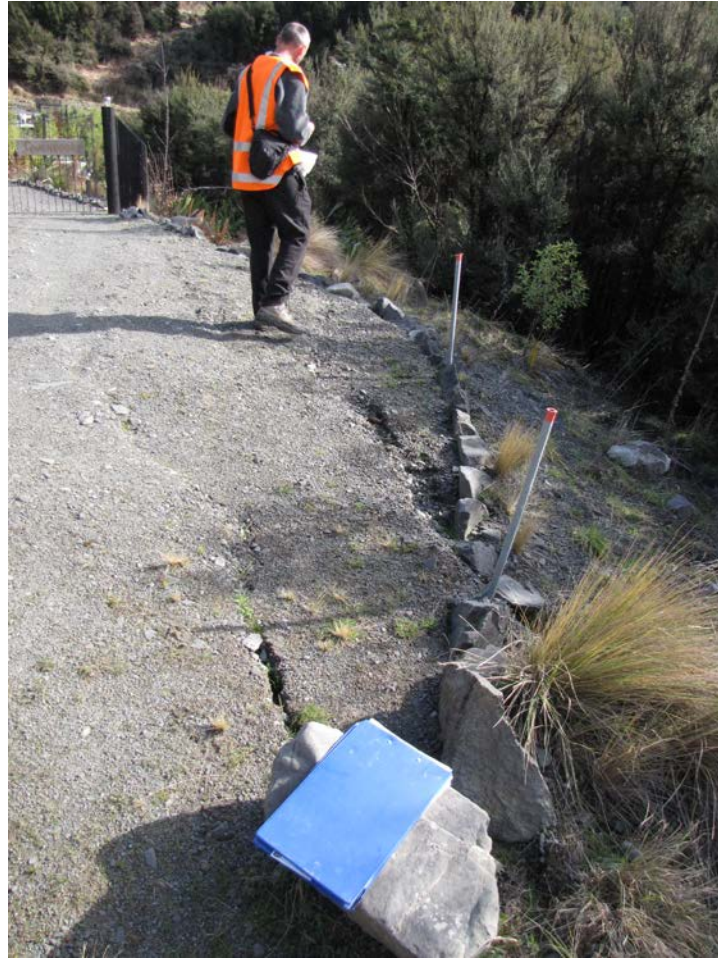
**Figure A1.13** Cracking and extension in fill at the edge of a driveway approach above a steep slope adjacent to a property on Mt Lyford Drive.

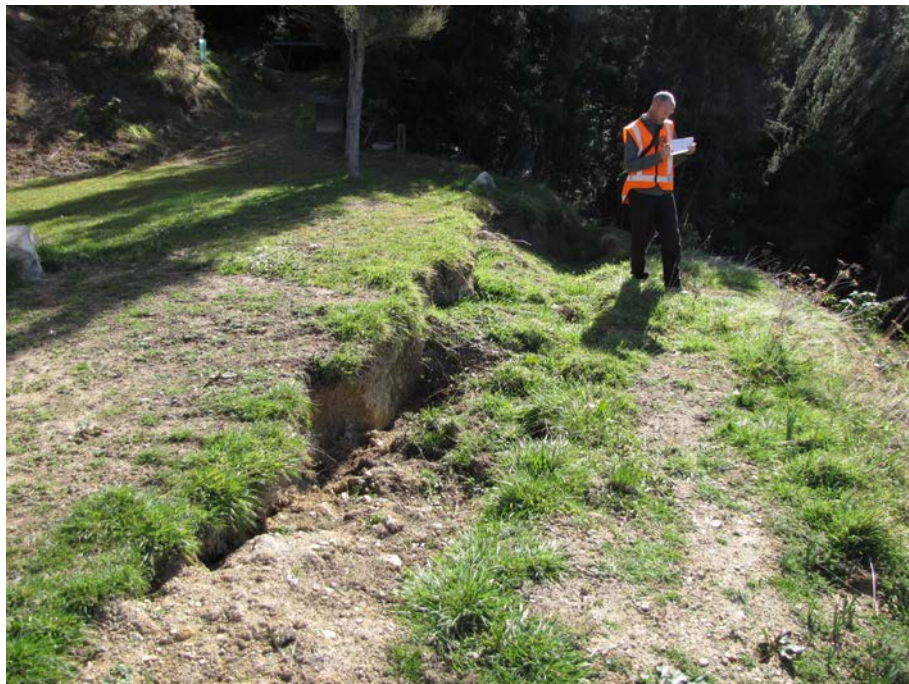
**Figure A1.14** Ground cracking and extension causing subsidence in a yard at a property on Lulus Lane, adjacent to a steep cut bank edge.
