# Te Tihi o Rauheia/Conical Hill Reserve

## Forest Management Programme 2022 – 2033

Conical Hill Reserve – Tree Assessment Report

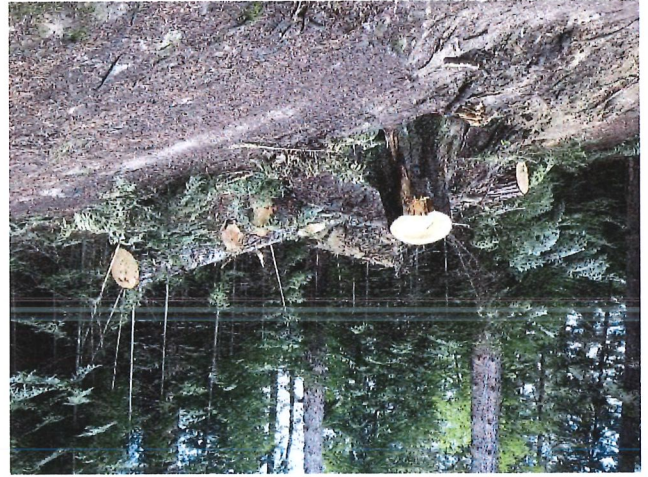
A very large Ponderosa Pine has recently blown over in strong winds taking a very large Noble Fir with it on the way down. The pine tree appears to have had very few large structural roots on the back side of the rootplate and mostly just smaller feeder roots. This would appear to be the cause for the catastrophic rootplate failure.

The pine tree hit the roof of a house (28 Alpine Ave), causing significant damage to the roof. Both trees when they fell also caused some damage to other trees, mostly just snapping branches on the way down (see photos below).

Figure 4: Showing the stumps of the recently fallen Ponderosa Pine and Grand Fir trees.

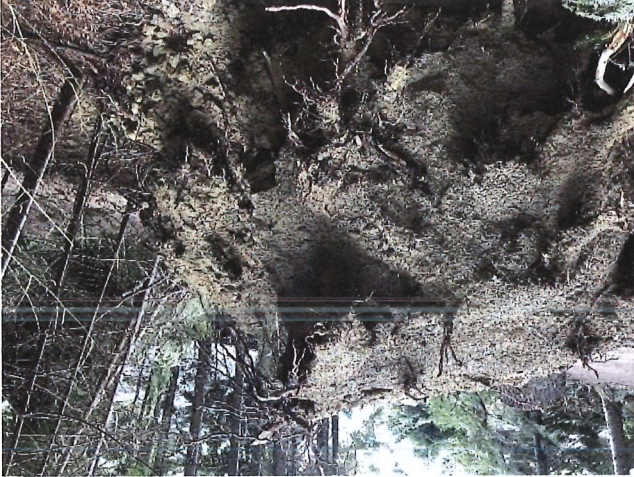
Figure 5: Showing a close up of the rootplate of the Ponderosa Pine with very few large structural roots visible.

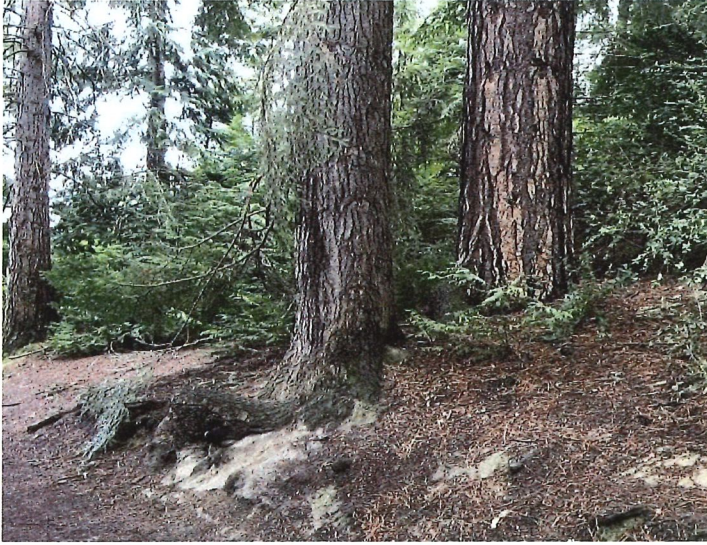
Tree CH08 is a very large mature Ponderosa Pine which is growing less than 2m away from an adjacent Noble Fir. The Noble Fir has a very large (3m, 0.55m), girdling root which is growing into the base of the trunk of the Ponderosa Pine tree for a length of up to 1.2m. The Pine tree also is twin-stemmed with a significant included bark union at approximately 15m from ground level. The tree has significant suppression as is usual in a forest environment. The tree has poor vigour with up to 40% foliage density loss within the canopy. Tree is approximately 20m from a private property and only 5m from the main walking track. On the uphill side of the trees rootplate the probe can be easily pushed into the ground up to 0.5m.

*Figure 6: Showing tree CH08 and its proximity to the adjacent Grand Fir and walking track.*

Tree ID	Common Name	Latin Name	Height (m)	Canopy Width (m)	DBH (m)	Tree Health	Tree Form	Overall Condition	Tree Details	Recommendations	Priority
CH08	Ponderosa Pine	Pinus ponderosa	30.0	10.0	1.35	4	4	4	Very large (3m, 0.55m), girdling root is growing into the trunk of tree 1.2m. Tree also is twin-stemmed with a significant included bark union at 15m up. Tree is growing less than 2m from adj Noble Fir. Significant suppression and die-back within the canopy. Tree is approx. 20m from private property and only 5m from walking track. On the back side of trees rootplate the probe can be easily pushed into the ground up to 0.5m.	Either removal of tree altogether or reduce height of tree by up to one third of its current height.	H
CH09	Ponderosa Pine	Pinus ponderosa	28.0	5.0	1.00	3	4	4	Tree appears to have poor vigour and up to 40% foliage density loss. Tree is approx. 3m away from large tree which has recently failed at the rootplate. Tree has some decay on rear side of trunk at the base going down into the roots. Probe easily goes 0.4m into ground at base of tree. Possibly not many live roots on this side of tree. Tree is sheltered by adjacent trees.	Either removal of tree altogether or reduce height of tree by up to one third of its current height.	H

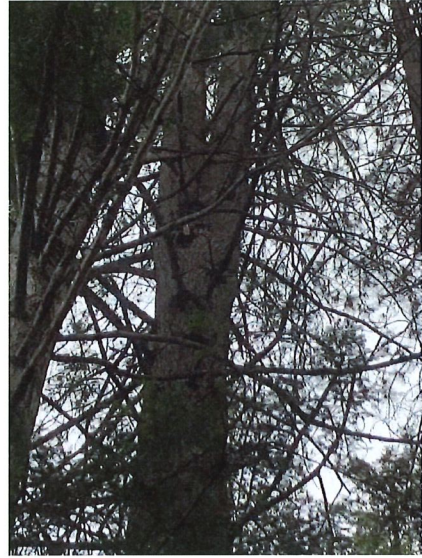
*Figure 7: Showing tree CH08 which is twin-stemmed with a significant included bark union.*

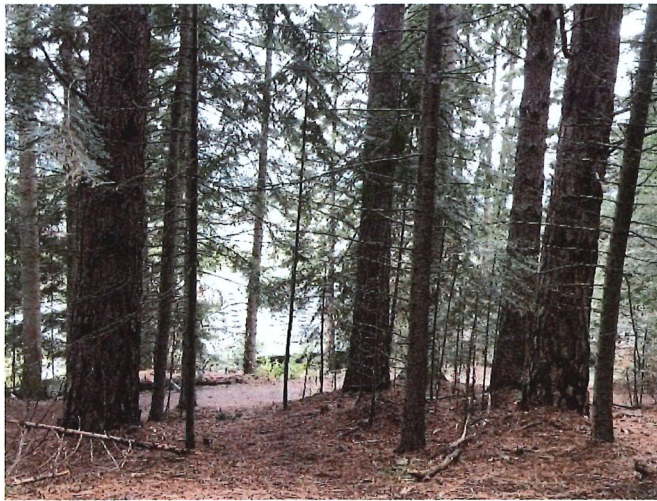
There is a group of very large Ponderosa Pines (CH10), on the South Eastern side of the hill, these are inter-planted with Grand Firs which appear to be some of the first exotic trees planted on Conical Hill circa 1910. It was one of these Ponderosa Pines which recently failed at the rootplate and fell onto an adjacent residential property. I found two of these trees to be twin leaved and to have significant included bark unions present where the trees split into two. These unions have the potential to fail and for either one or both of the twin leaders to split apart from the remaining tree. As these trees are both over 30m in height they have the potential to fall onto the walking track and potentially cause damage. There are approximately 16 of the very large Ponderosa Pines in this area that are all in a similar condition. They are all growing on a downward slope forest debris is building up at the rear of the trunk/base of tree and causing some rotting of the bark and possibly the roots of the trees. It is easy to see the buttress roots on the front side of these trees but not the backs. After probing the ground directly adjacent to these trees it was found that the probe can be pushed easily into the ground indicating the possibility that no large structural roots are present in these areas. The majority of these pine trees are in a fair condition for health, with poor vigour and up to 40% foliage density loss. All trees have some form of lateral suppression due to growing in a forest environment in close proximity to each other.

*Figure 8: Showing some of the Ponderosa Pines in group CH10 with younger Firs growing underneath.*

The first option would be to retain all of the trees at the current time and get a detailed risk assessment carried out on the trees, either a QTRA or TRAQ assessment. These risk assessments can give a more defined risk analysis of potential tree failures.

The second option would be to reduce the height of all the Ponderosa Pines, effectively reducing the sail area and therefore the wind loading of the crown. Also, by reducing the height of these trees by up to a third of their current height it would reduce the risk of any of the trees reaching private properties if they were to fail at the rootplate. This operation would need to be carried out in a sensitive way to prevent damage to the surrounding Grand Firs and the understory planting.

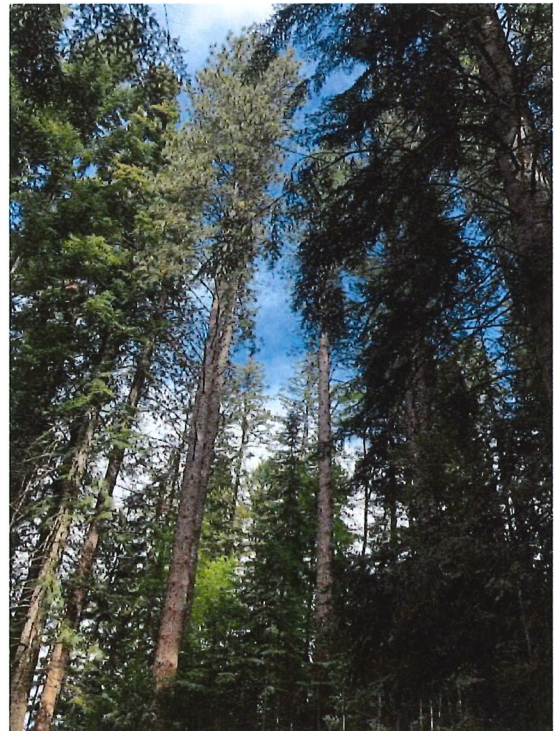
*Figure 9: Showing some of the Ponderosa Pines in group CH10 with younger Firs growing underneath.*

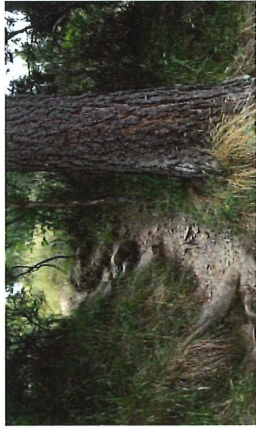
### 2. Eroded Short Cuts

Numerous shortcuts across the walkway are heavily eroded, steep and potentially dangerous.

*Opportunity to formalise a number of the shortcuts where appropriate and restrict access where shortcuts are not appropriate.*

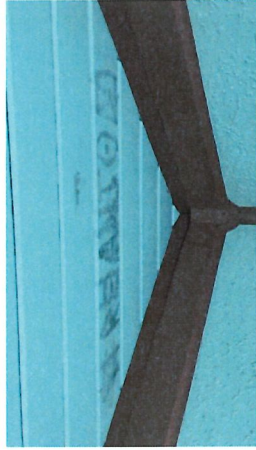
### 4. Key Area Refurbishments

Poorly developed key areas including Conical Hill Rd Entrance and the Conical Hill Summit Lookout, lacking public amenities and maintenance required.

*Opportunity to address maintenance issues and introduce enhanced public areas through landscaping features.*

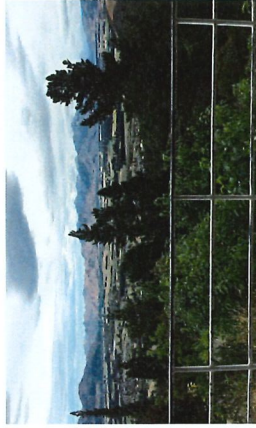
### 5. Ecological Design

Large areas of Conical Hill covered in exotic trees and groundcover plant species with pockets that block views across the Hammer Basin.

*Opportunity to remove weeds and exotic trees blocking views across the Hammer Basin. Target revegetation planting of native species in key areas.*

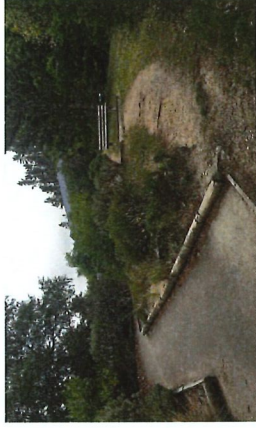
### 6. Path Routes

Current path alignment does not match walking desire-lines (tracks worn into grass or planting).

*Opportunity to formalise routes through hardsurface and planting relocation, removal or reinstatement.*
