**RE: High Level Geotechnical Assessment for Proposed Zipline - Conical Hill,  
Hanmer Springs**  
**(Our Reference: 17990.000.001\_01)**

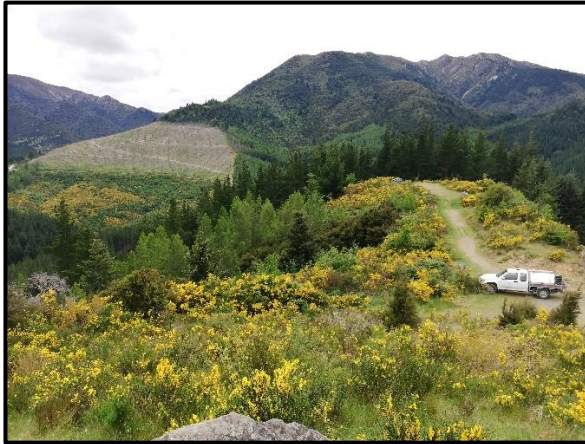
- Bedrock was observed at the surface along the ridgeline between Conical Hill lookout and the proposed top station location.
- Where tracks have been made within the hillside the cut has exposed the underlying bedrock. The underlying bedrock was described as moderately to highly weathered, grey to light brown, GREYWACKE, weak to strong with very close to moderately spaced defects. In generally the rock appears to be highly fractured.

Photo 1: Looking north from Conical Hill lookout along ridgeline towards proposed top station location.

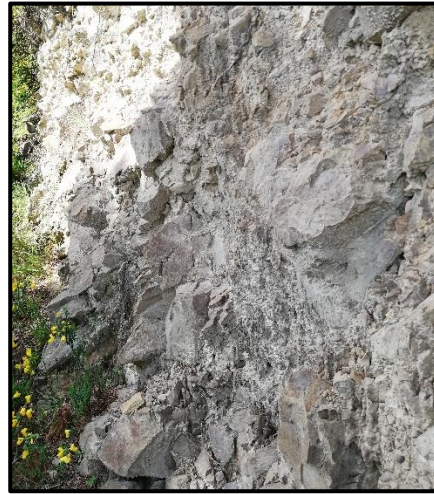
Photo 2: Observed cut slope above walking track, indicating near surface Weathered in situ Greywacke Sandstone

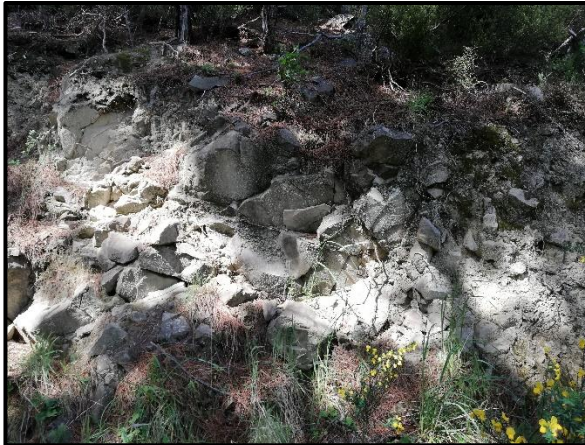
Photo 3: Example of highly fractured rock that is exposed near the surface

Therefore, it is recommended that the foundations for all of the structures be formed using ground anchors. The plant used to install ground anchors can be relatively small and manoeuvrable as would typically be used for anchor installation on rock faces for rock fall protection structures. Access on this site would likely be reasonably straight-forward, furthermore due to the small size of the drilling rig the amount of vegetation clearance required to operate would be minimised.

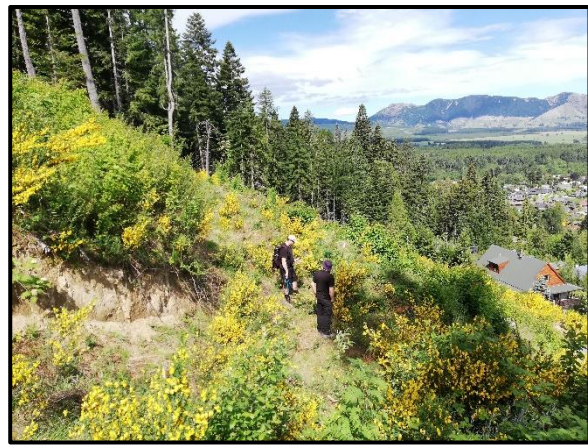
- Within the southern face of the hillside, near the base station, bedrock was not observed within the cut slopes. This suggests the overlying soil is thicker in this location, and extends to a depth of at least 1.5 m based on the cut face height. This area appeared to be relatively hummocky, however, it appears that earthworks have taken place as part of the forestry works so it was not clear if the hummocks were naturally occurring or not.

Photo 4: Southern face of hillside in area where base station is proposed.
