# Soldiers' Block, Hanmer Springs

Conservation Plan  
Prepared for the Hurunui District Council

31 July 2022

Ian Bowman architect and conservator

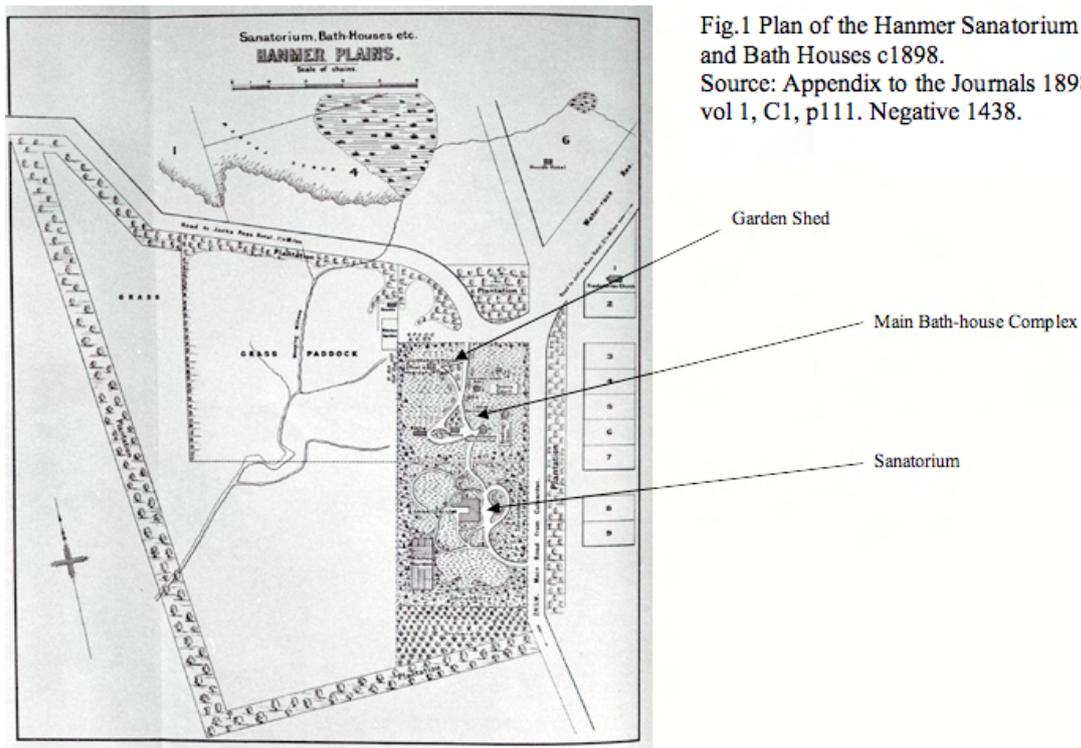
Fig.1 Plan of the Hanmer Sanatorium and Bath Houses c1898.  
Source: Appendix to the Journals 1898 vol 1, C1, p111. Negative 1438.

Figure 1 Plan of the Hanmer Sanatorium and Bath Houses c 1898 AJHR 1898 vol 1 C1, page 111

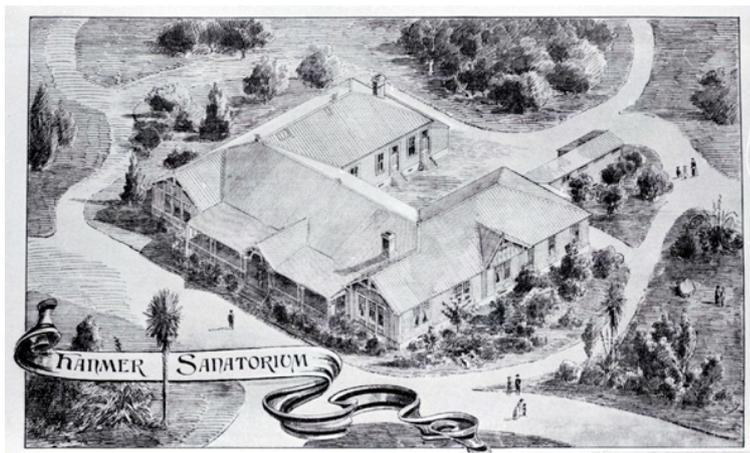
Figure 2 Sanatorium/Spa in c.1898. Source: *Appendix to the Journals 1898, vol 1, C1, p111. Negative 1437, Opus Report*

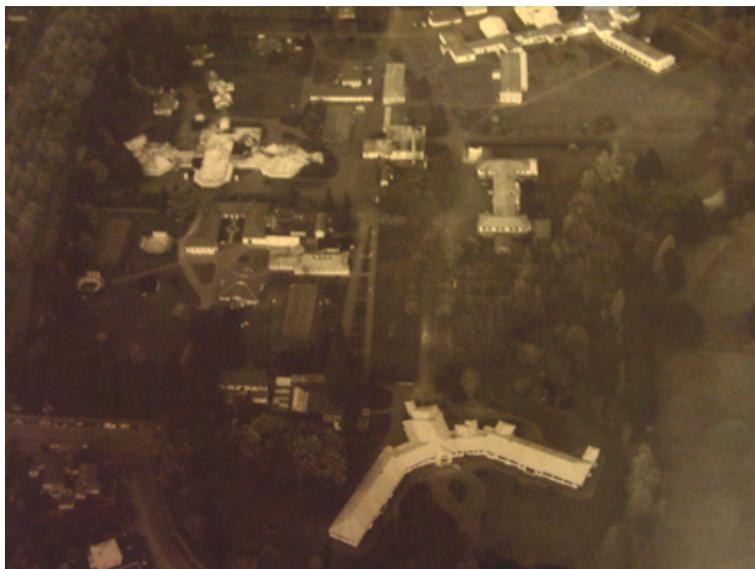
Figure 3 Digital photograph of an aerial photograph of Queen Mary Hospital Site displayed on the wall of the Maintenance Engineer's Office, dated 1966, RNZAF., from Opus Report

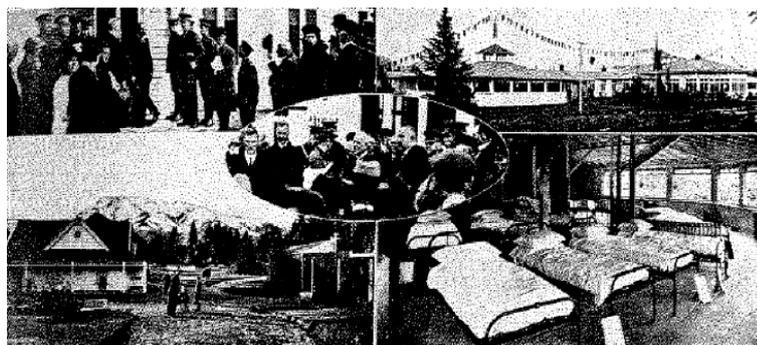
Figure 4 Copied from Silverson, page 121, *Soldiers' Block opening top left, right and centre. Arrangement of beds in Octagonal wards (note no glazing in window space)*, *Opus Report*

The building is 303 feet in length, and faces the north. It contains two octagons, dining-hall 64ft x 38ft, capable of seating 250 men, recreation hall room, non-commissioned officers' rooms, commandant's quarters, visitors' bedrooms, doctor's consulting and waiting rooms, dispensary, storerooms, kitchen, pantry, bathrooms, lavatories, and all the necessary sanitary arrangements. The interior is painted a dull white, and is splendidly lighted by electricity. The large dining-hall, which will also be used as a living-room, contains a piano and billiard table, and is heated by two large open fireplaces. The octagons will contain 100 beds each, and, if necessary, provision can be made for 400. They are heated with steam radiators and are very pleasant, cheerful rooms. A splendid view of the mountains and sanatorium grounds can be had from them. The sanitary arrangements are perfect. The recreation room is fitted with every comfort, and will contain a library. Books of every kind will be very welcome, as there is no library in the district for the men to get reading matter from. The commandant's quarters, N.C.O's rooms, etc., are all comfortably furnished. The large storerooms, capable of holding stores for a small army, are equipped with monster bins for flour, sugar, rice, sago, etc, and shelves to hold all other articles. The dispensary which is attached to the doctor's consulting and waiting-rooms, is well stocked and is in charge of a qualified chemist.

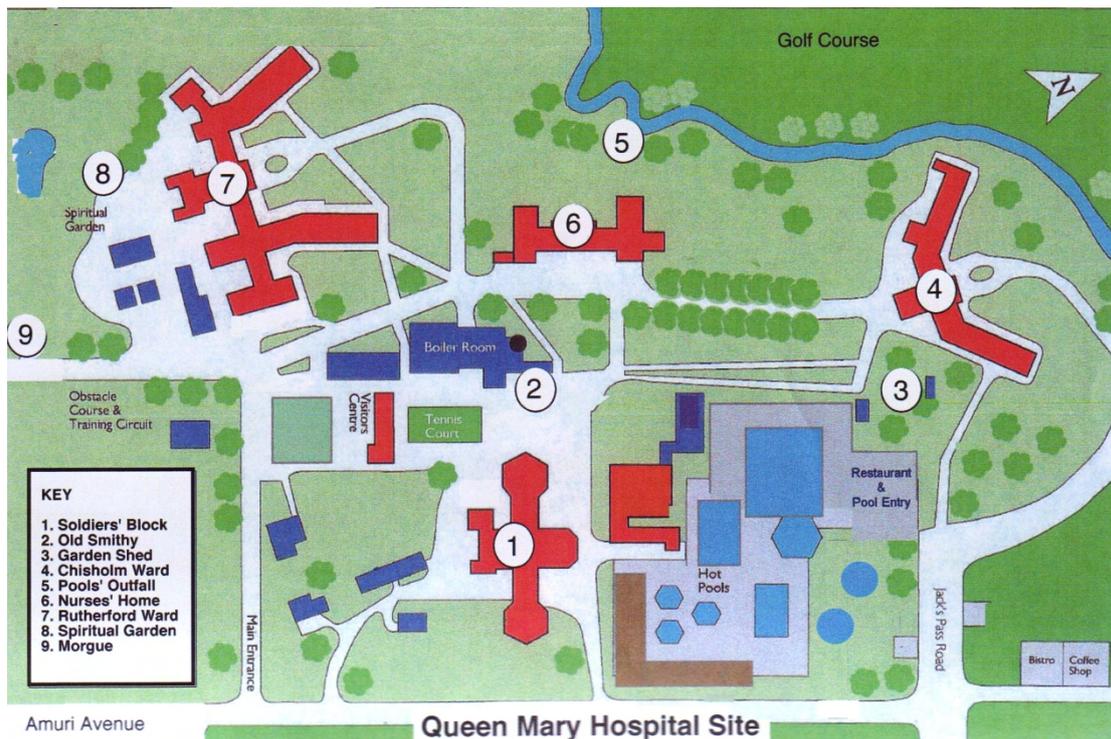
Figure 8 Site plan showing the main buildings of the Queen Mary Hospital, from inside front cover of Crawford, *The Queen Mary Hospital, Hanmer Springs, 1916-2003*

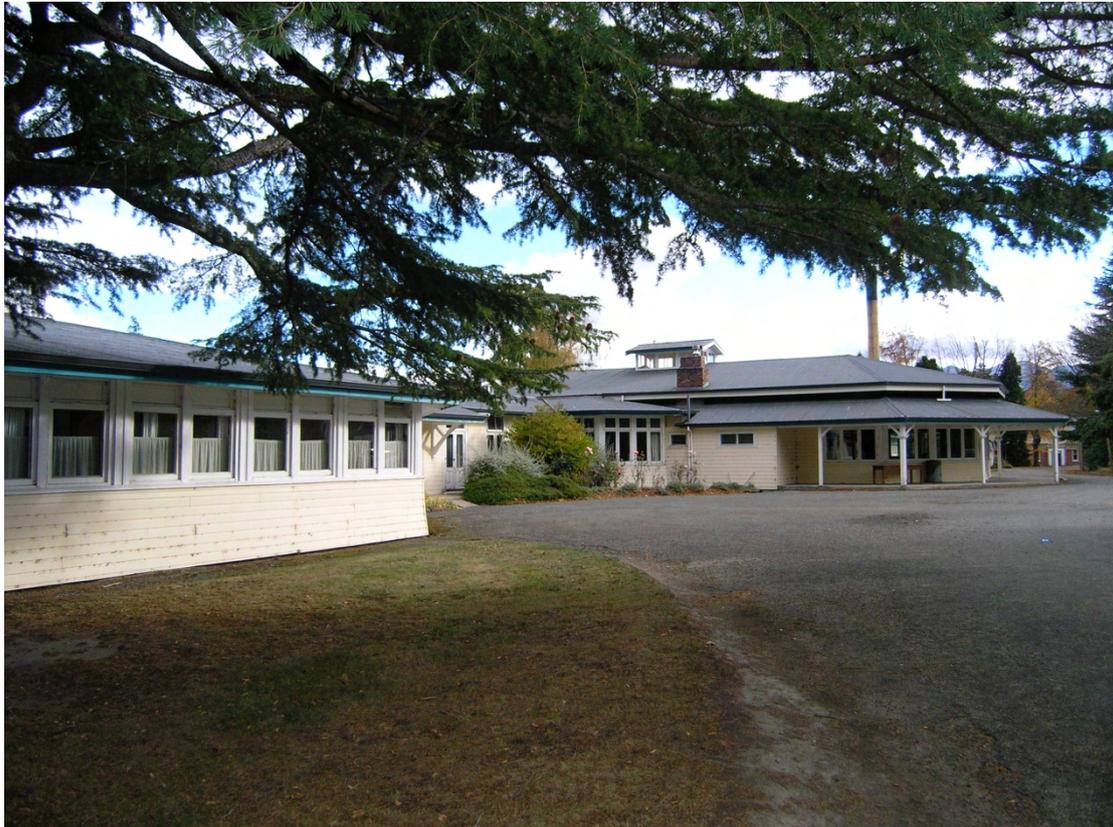
*Figure 13 Soldiers Block, photo Ian Bowman 2010*

The interiors of the wards and dining hall have exposed timber framing with match-lined ceilings. Large timber trusses with raking wall braces support the roof framing in the dining hall, while series of posts with similar raking braces support the ward roofs. Simple triangular trusses support the recreation hall roof.

Original rooms still have timber match lined ceilings and walls as well as original doors, which are vertical four panelled in the Bungalow style.

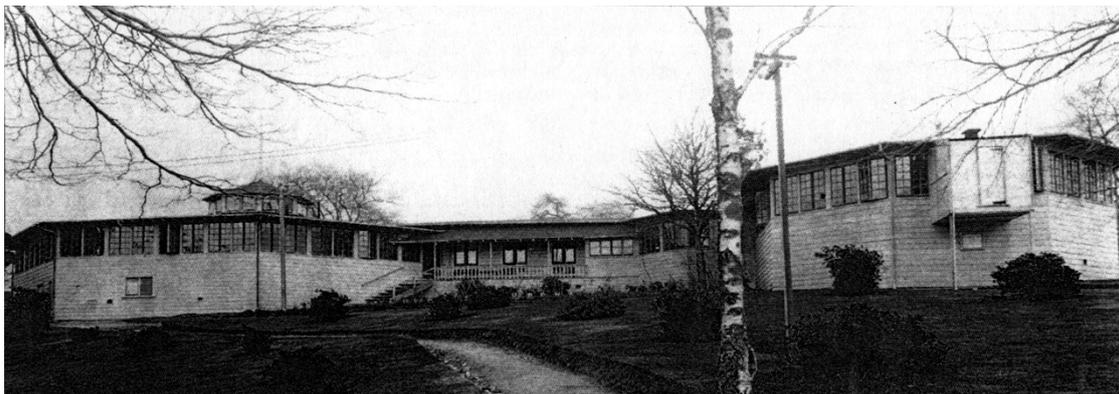
*Figure 14 ANZAC and Suvla wards at King George V Hospital, Rotorua, Health Camp Board Collection*

The description at the time of the opening of King George V Hospital helps to understand how this type of design was meant to work. The observation post was housed in the central octagonal space under the lantern, presumably for light and ease of supervision.<sup>90</sup> The rotundas, which could be opened up, made the most of the theory of the beneficial effects of fresh air. They had continuous glazing around the main walls, with the ceilings appearing more solid in comparison, hence the description of these buildings as having 'floating ceilings'.<sup>91</sup>

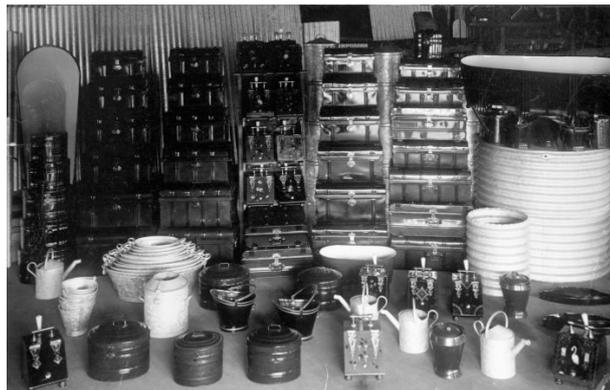
*Figure 15 Wares made by the Southern Cross Galvanized Iron Manufacturing Company Limited, Auckland, 1906. Reference number: PA1-o-371-38*

Early catalogues for corrugated iron showed several profiles were made. These varied in both the depth of the corrugations and their pitch or spacing. The greater the depth of corrugation, the wider the span between roof supports.

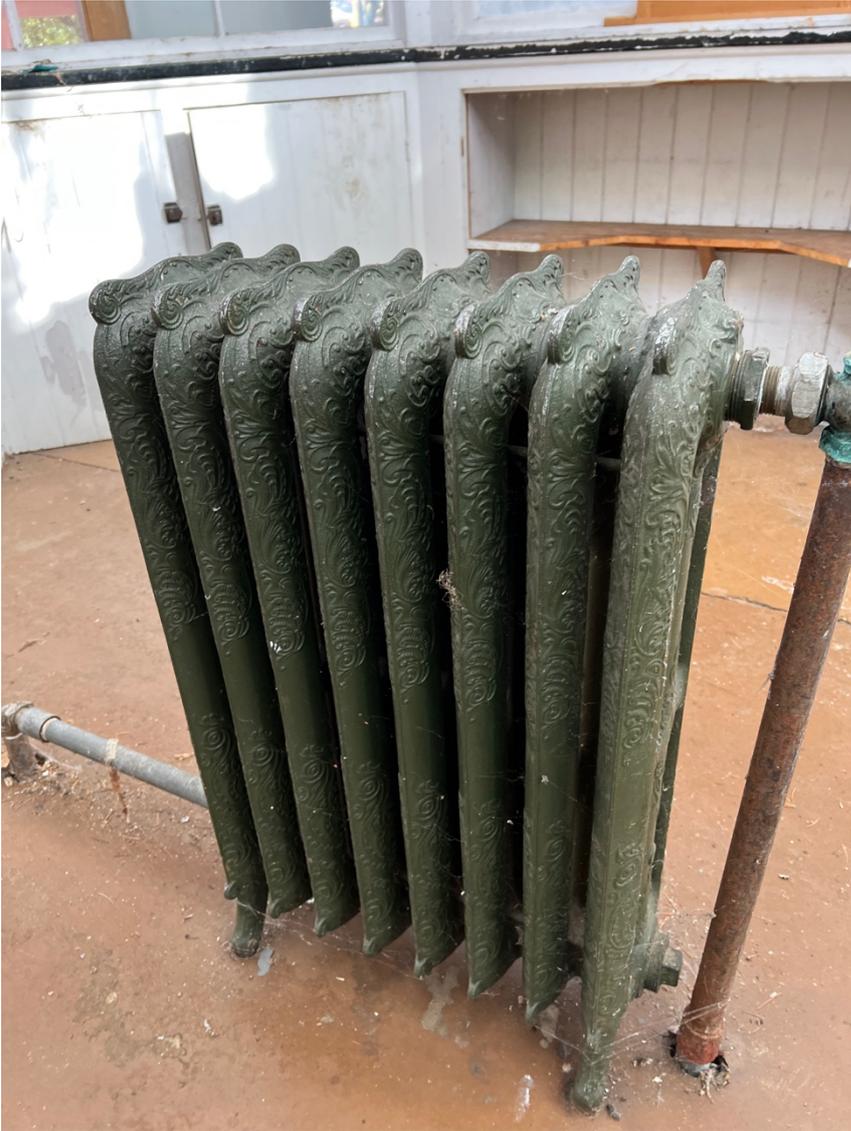
*Figure 30 Original cast iron radiator*

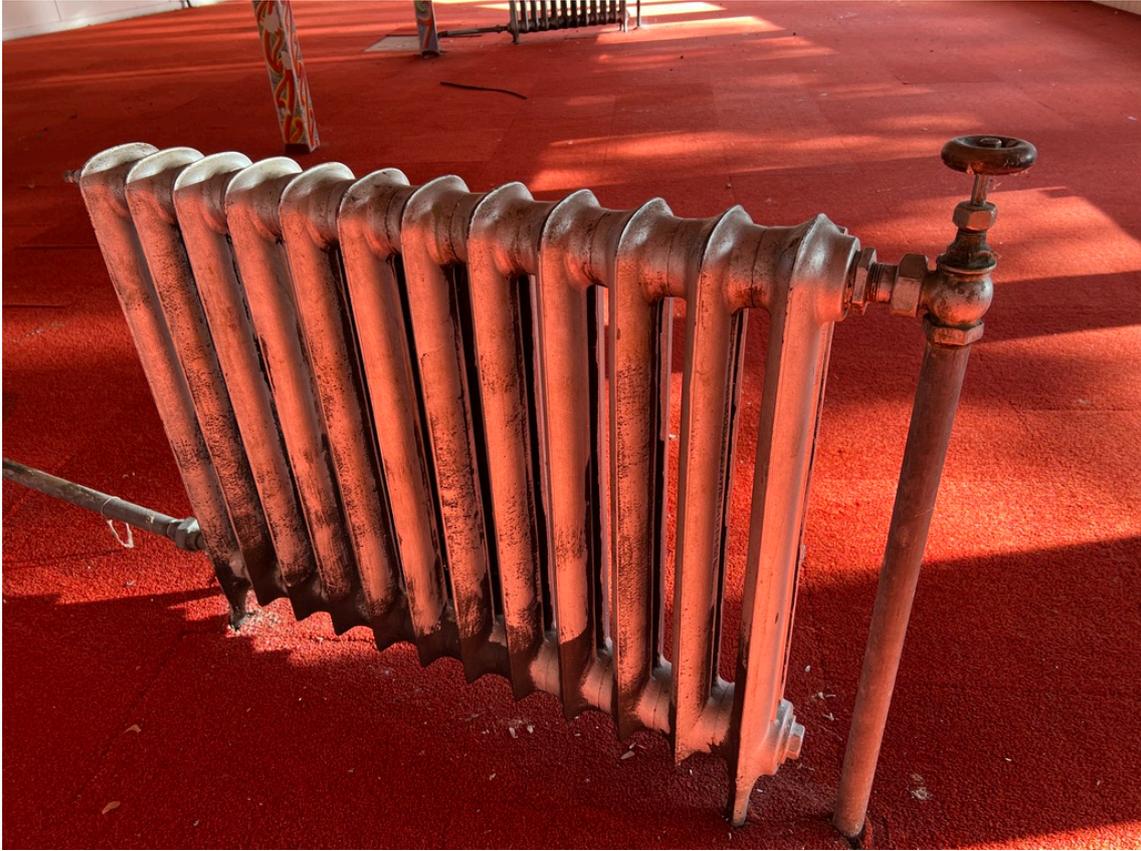
*Figure 31 Original cast iron radiator*

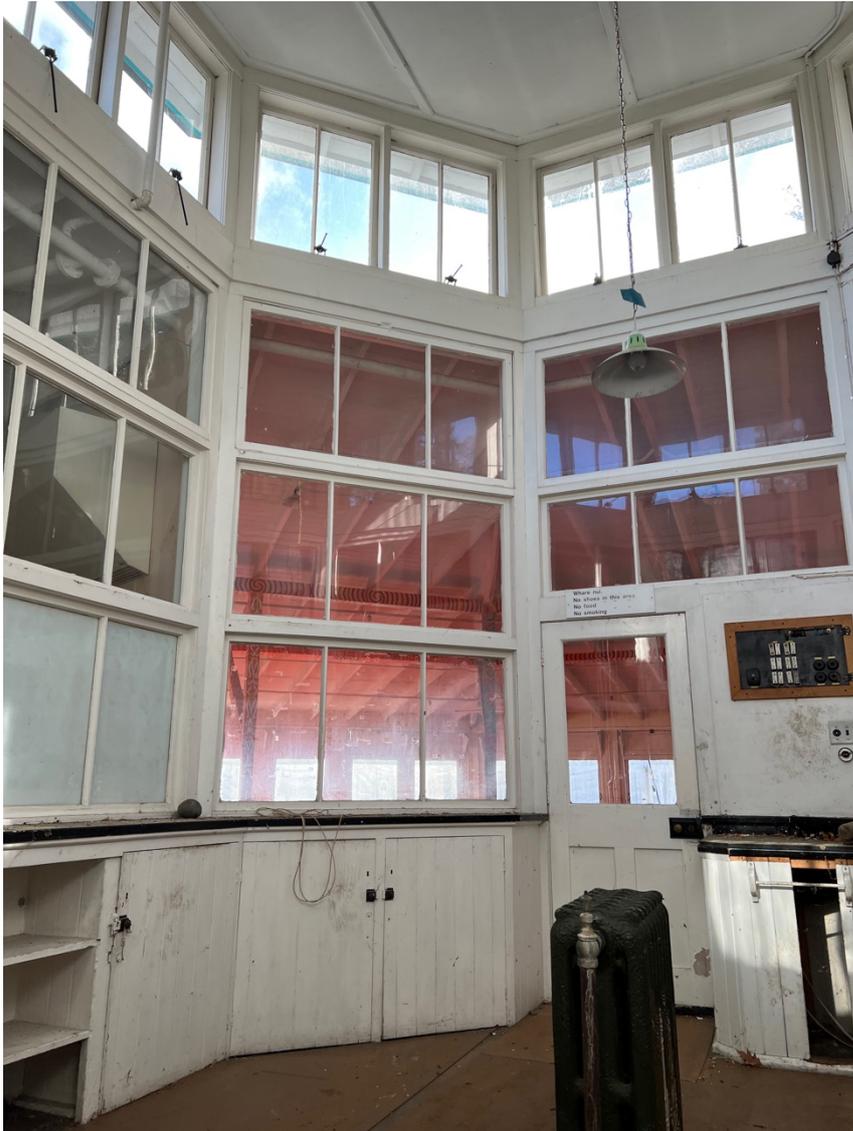
*Figure 32 Central observation room, east wing*

As at Rotorua, the Hanmer building had two octagonal wards linked by a corridor with a large hall between them. The octagonal wards had a nurses' station at their centre, which enabled the nurses to monitor the patients. The lantern roof at the centre and the large windows that encircled the wards maximised the available sun and air, considered vital for recuperating patients. Hospital designs of this type arose from a gradual recognition about the importance of fresh air, sunlight and cleanliness for healing, which began to have physical results from the late 19th century.<sup>86</sup> Today the Soldiers Ward at Hanmer Springs is believed to be the only one of this design to survive in New Zealand. Both octagonal wards from King George V Hospital at Rotorua were moved to the Otaki Children's Health Camp, where one of them still stands today – this remaining one at Otaki has been described as 'of outstanding national significance'.<sup>87</sup> The Soldiers Ward at Hanmer is of even greater significance as the only complex of this design to survive intact and still on the site for which it was designed.

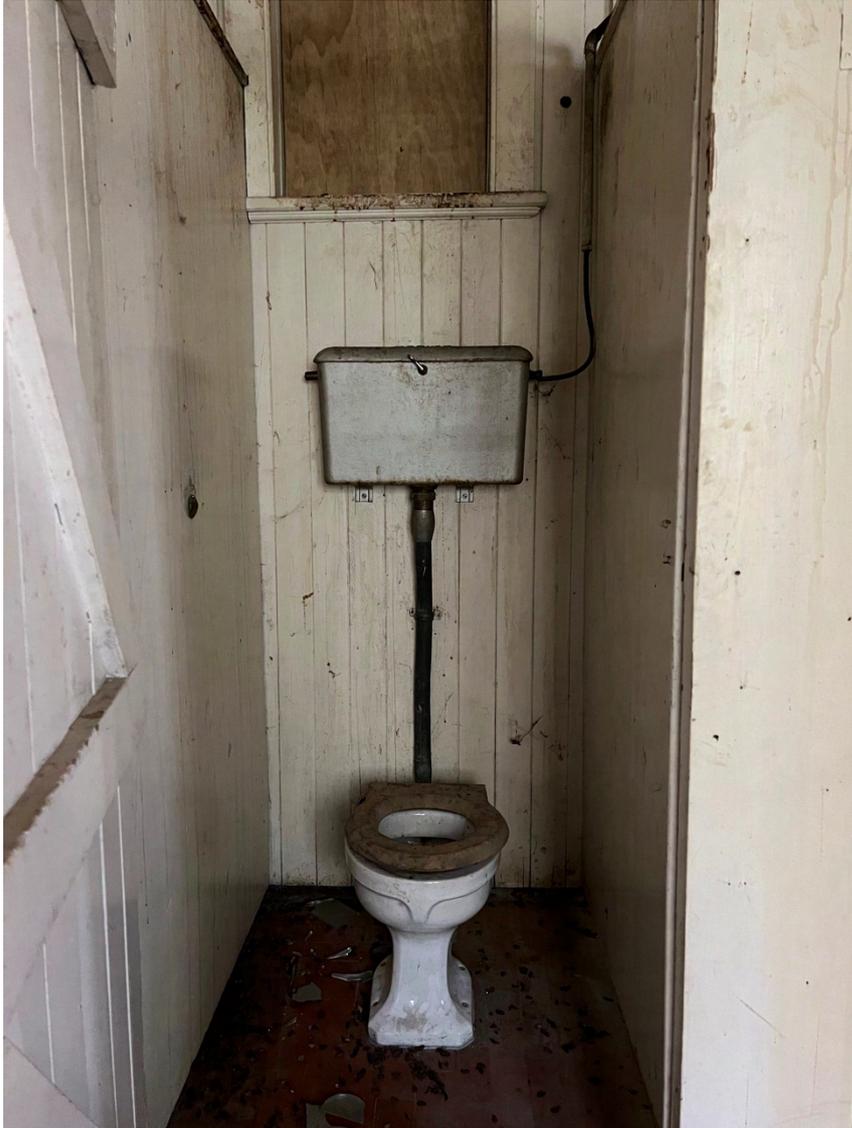
*Figure 34 Original toilet*

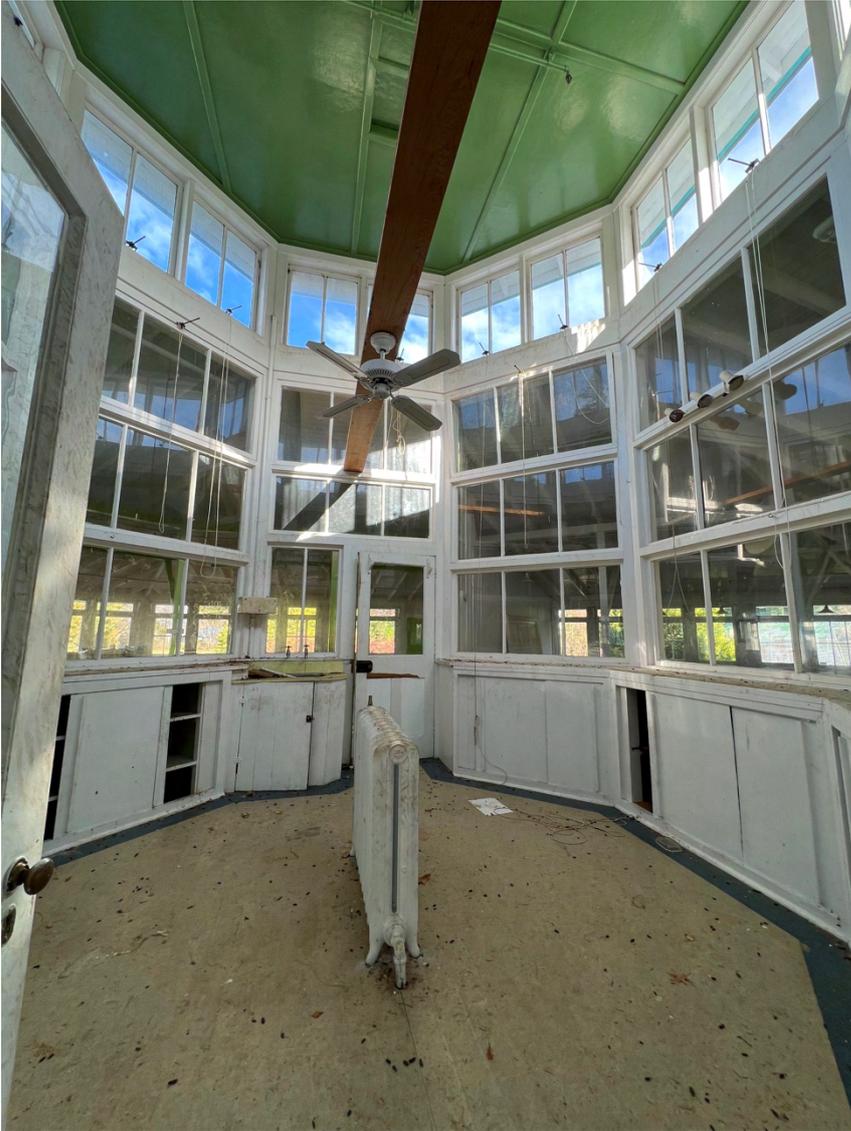
*Figure 37 West wing observation room*
