Prepared for Hurunui District Council

**An Appraisal of Archaeological Values within the
Queen Mary Hospital Site, Hanmer Springs**

Date: 15 June 2004
Reference: Hamner_Springs
Status:

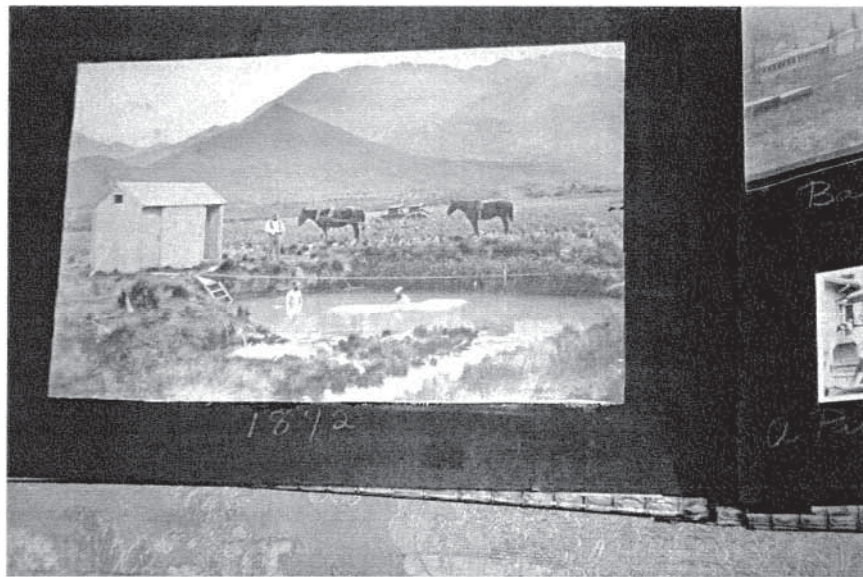
Figure 1: Changing Shed and Pool (1872?) (Held in collection of Dr. Robert Crawford, 2004).

In 1878, John Fry, owner of the Jollies Pass Hotel, constructed a small two-room Changing Shed next to the main pool in order to take advantage of the popularity of the springs (Fig. 1) (Watson, 2004:2).

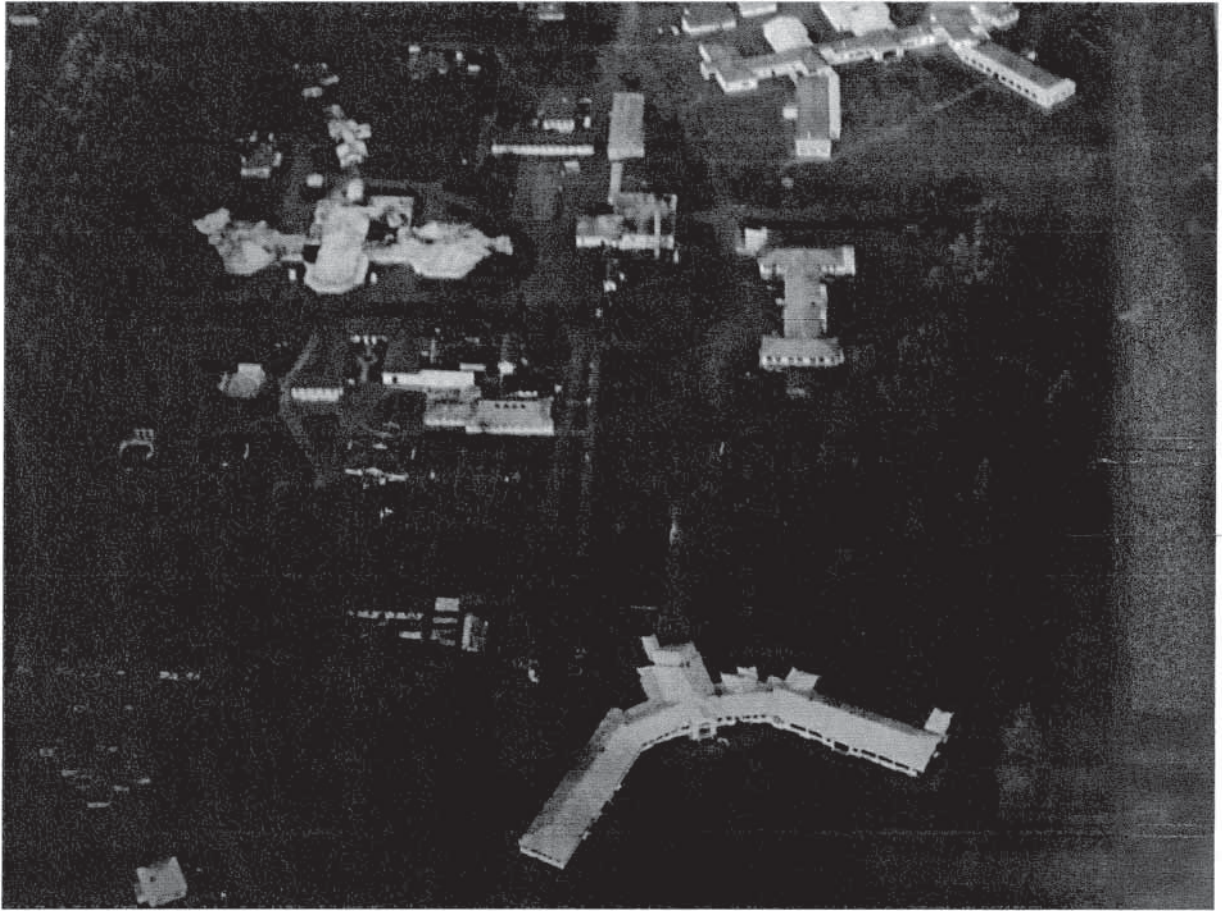
Figure 3: Aerial Photograph of Queen Mary Hospital Site, 1956 (Held in Maintenance Office, Queen Mary Hospital, 2004).

A number of later plans and photographs were also found in the maintenance office and Carpenters office of the current property. In particular, a large 1956 aerial photograph hanging on the wall proved useful in identifying locations from the earlier plan. Other plans of the entire site found included one dating to 1915, prior to the building of the Soldier's Block and still showing the Sanatorium which burnt down in 1914. Another plan was found from 1950. Specific plans relating to the construction of the current Fountain House were also discovered, dating to 1926 and 1929.

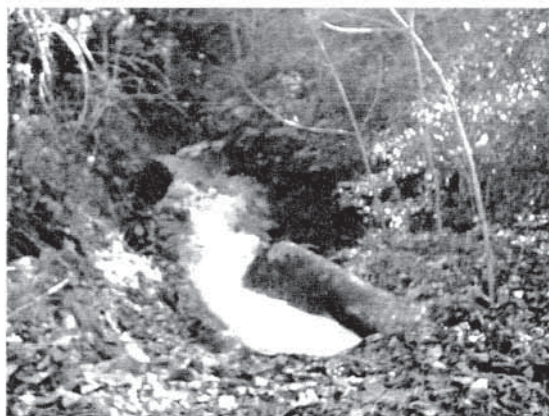
Figure 4: View of waterfall into creek behind Chisholm Building (© Author, 2004).

The ground survey began with an examination of the northern part of the Queen Mary Hospital complex, from Jacks Pass Road, around the Chisholm building to the Nurses Home. The northern area is landscaped with groves of trees and small gardens amongst the well-maintained grass lawns. The current concrete paths are also well kept. The western edge of the grounds descends a shallow bank to a tranquil creek (Fig. 5). Walking paths run along the creek and bank alongside the Chisholm building. Behind the building, set into the lawn is a small square rock feature of unknown date. Further along the creek, near the Nurses Home, the bank rises steeply. Wooden steps have been cut into the bank nearby a manufactured waterfall (Fig. 4).

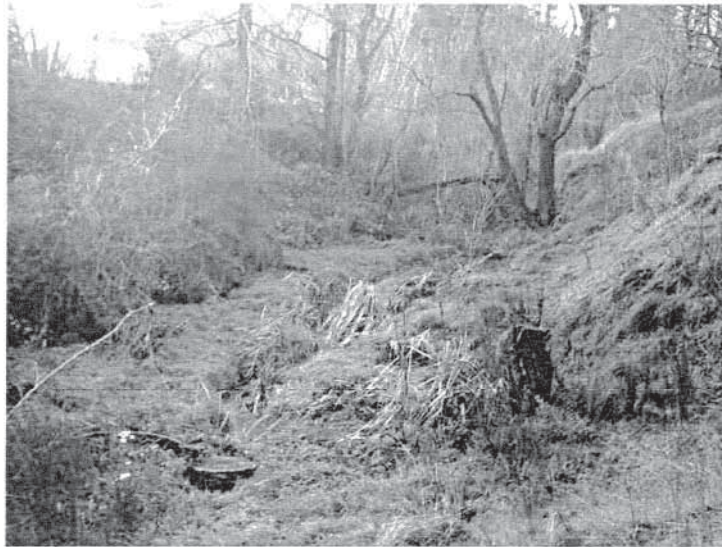
Figure 5: View of creek running down western boundary (© Author, 2004)

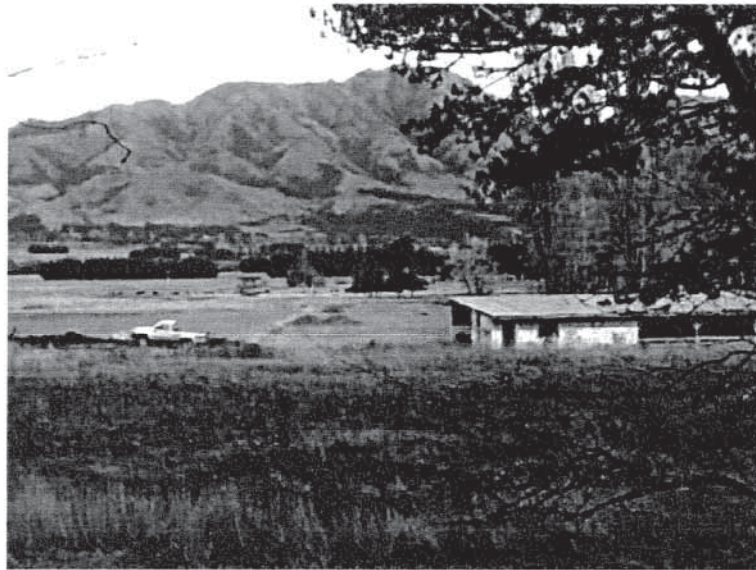
Figure 6: View of farm paddock, south-western area of Queen Mary Hospital (© Author, 2004).

Beyond an existing fence and tree line, the southwestern area of the site was examined. It is currently used as farmland, and appears to have been uncultivated for some years (Fig. 6). Near the centre of the paddock is a stone cowshed, remnant of the earlier farm use of the area by the hospital staff and local farmers. A smaller stone shed is also located near the southern border. The paddock is fenced off and leads to Argellins Road.

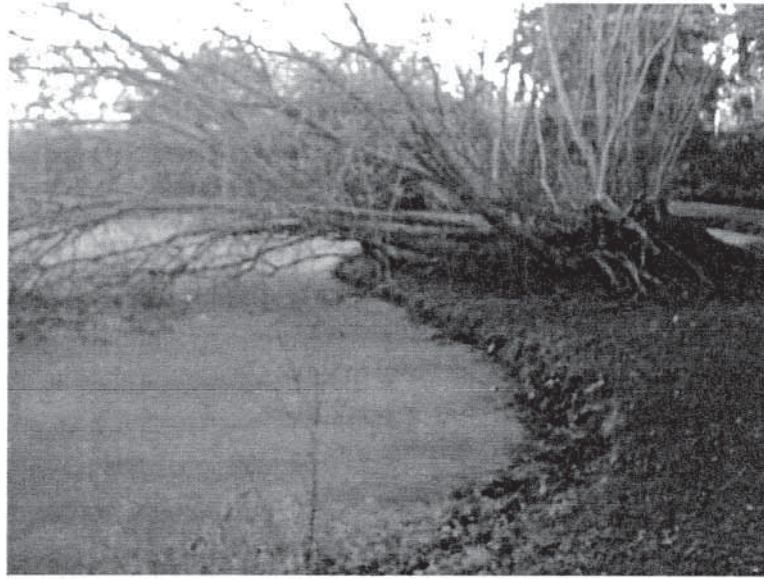
Along the southern border of the property, two open spaces defined as spiritual gardens are located within a dense strip of brush and trees. A septic pool of water runs along the southern edge of the larger open space, south of the Rutherford building (Fig. 7). The southern border, past the Rutherford building, follows a natural bank down to the fence-line, continuing the downhill slope of the property interrupted by the Rutherford terrace. Trees and bushes separate the bank from the developed areas proper. It appears that building rubble and rubbish are swept from the maintained areas and down this bank (Fig. 8). The material is of unknown origin and may in fact indicate earlier structures were located nearby.

Figure 7: View of septic pond, southern boundary of property (© Author, 2004)

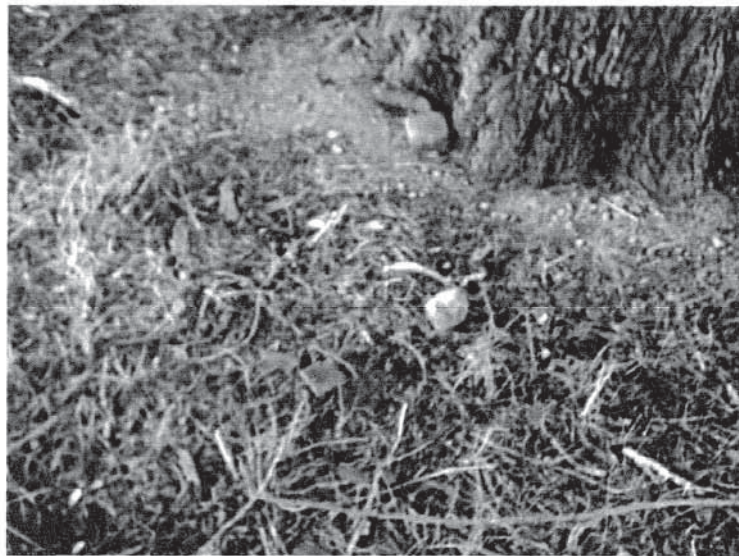
Figure 8: View of debris on southern boundary bank (© Author, 2004).

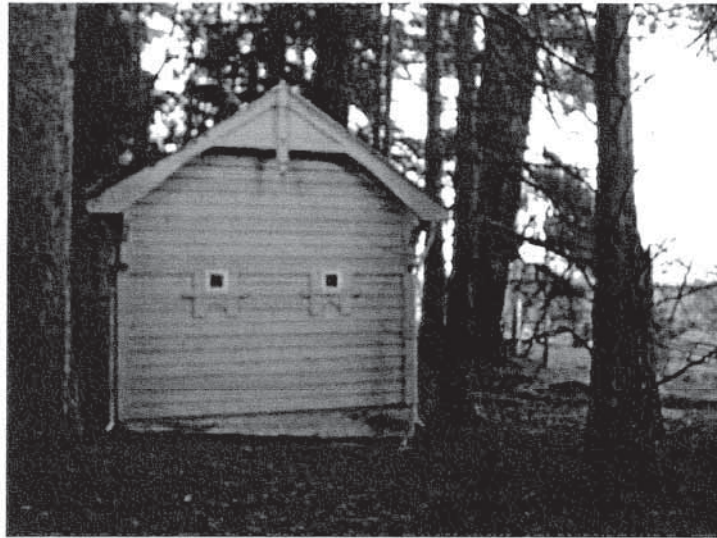
Towards the southeastern end of the property, amongst the belt shelter of trees is a small wooden building identified as the original Morgue, dating to the 1900s and shifted from its earlier position (Fig.9). The building is structurally intact and represents the earliest building on site. It was in use up to the 1980s according to the current caretaker.

Figure 9: View of Morgue, southern boundary of property (© Author, 2004).

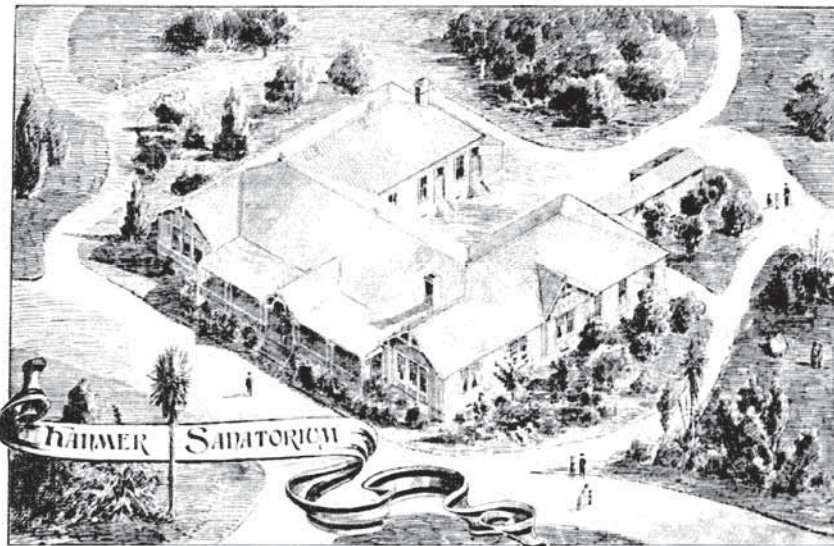
Figure 10: Plan of Sanatorium, 1898 (© Christchurch City Library Heritage Photo Collection, 2004).

In 1897, the Government also added accommodation at the springs. The 'Spa', later known as the 'Hanmer Sanatorium' was opened on the 9th December 1897 (Fig. 10). It contained a women's drawing room, smoking room and sitting room and first class accommodation. By January 1898, with many camping in tents outside, it was clear that second class accommodation was required and within a few years additions were made to the building (Rockel, 1986:67). The Sanatorium was destroyed by fire the day after World War One broke out in 1914.

The original Sanatorium building was identified as the site upon which the 1916 Soldier's Block was located (Figs. 18,19). The current concrete paths still match the original paths around the complex and help identify the original layout of the structure. The interior

courtyard matches the plan for the Sanatorium, whilst an outlying brick building also matches the location of such a structure next to the wooden building.

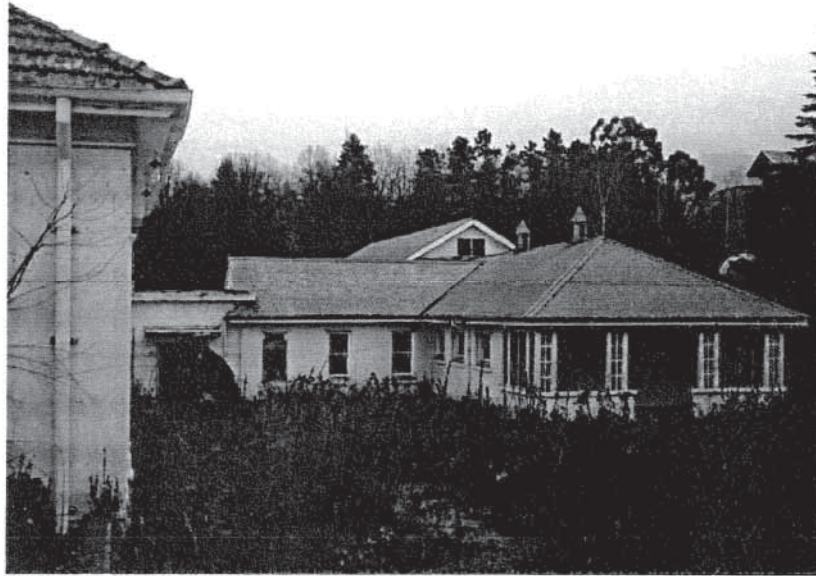
The Fountain House and Gymnasium building, situated adjacent to the southern boundary of the Thermal Pools complex and north of the Soldiers block, was identified as the location of the original bath house complex (Fig. 11). The northern wing of the building was identified as the same structure depicted in a 1930 photograph of the new bathhouse (Fig. 12). The photograph clearly shows the third bathhouse adjacent. Gas pipes are visible on the surface in front of this structure. The likely position of the original bathhouse appears to be in front of the Fountain House building (Fig. 13, see also figs. 16, 17). The area is covered with concrete slabs, although the imprint of a gas pipe under the slab is visible (Fig. 14). The original location of the main pool is located over the fence in the thermal pool complex. A gas pipe is visible in this location (Fig. 15). The tea kiosk was also located just over the fence, although the renovated structure currently used within the Thermal Reserve is further away.

Figure 11: View of Gymnasium block (© Author, 2004)

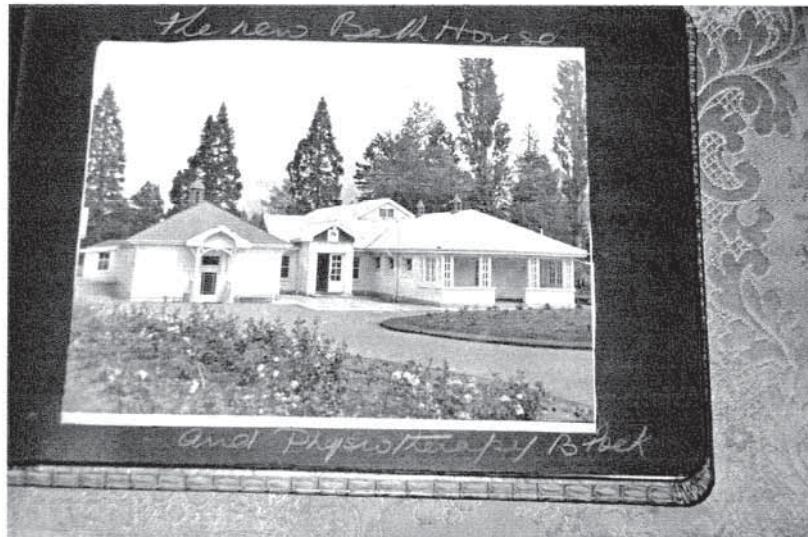
Figure 12: Original Gymnasium block including third bathhouse, 1929 (Held in collection of Dr. Robert Crawford, 2004).

The old bathhouses and fountain house were demolished in 1930 and a new private bathhouse and women's massage block were constructed (Fig. 12) (Rockel, 1986:72).

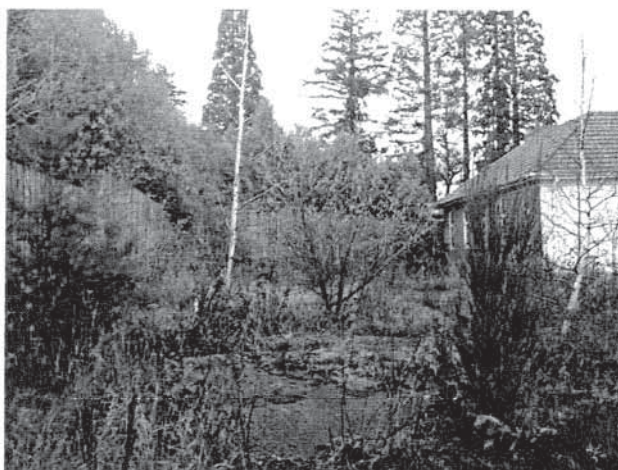
Figure 13: Site of first bathhouse, near current Fountain House (© Author, 2004).

Examination of the plans revealed that the foundations of some of the buildings are likely to be still intact under existing buildings: The first bathhouse foundation lies under the concrete slab that is placed in front of the Fountain House. It appears that the slab covers the gas pipe that fed the building. The main pool, east of the first bathhouse, lies in the Thermal complex, although piping from it may still exist. The second bathhouse is indicated as a concrete slab built over with the gymnasium. The third bathhouse complex was completely removed at some point after 1930. The site of the building is now the exercise yard next to the Gymnasium. It is unclear whether there are any remains still evident. The original Fountain House appeared in the plans under one wing of the later 1930 Fountain House. The rest of the Swimming Pool context attached to the original Fountain House still exists, the pool being filled in by the current caretaker. The Garden Shed indicated on the plans and reserved from the Thermal Complex still exists. The small building sandwiched between two trees may actually be the original Wash House. The Sanatorium was completely destroyed by fire in 1914. The concept of the building was retained in the design of the Soldier's Block. In particular, the courtyard and possibly one of the chimneys were retained. Foundations for the Sanatorium probably remain.

The location of the first bathhouse foundation is likely to lie beneath the concrete slab that is placed in front of the Fountain House. The main pool, east of the first bathhouse, lies in the Thermal complex, although piping from it may still exist.

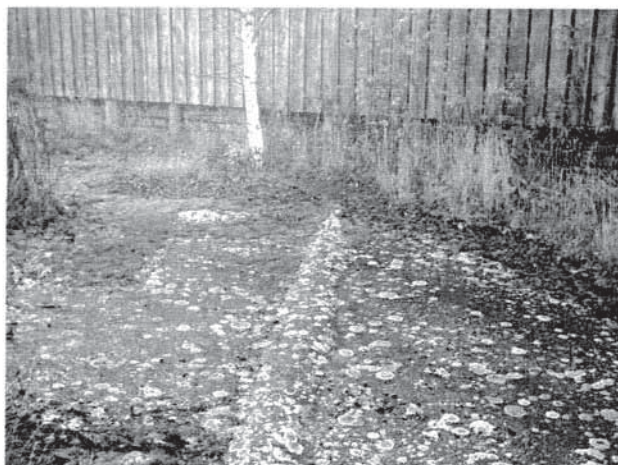
Figure 14: Gas pipe Imprint on site of first bathhouse (© Author, 2004).

No physical evidence of the original buildings dating prior 1900 was visible during the ground survey. Rubble of indeterminable age was found in numerous places around the site. More clear evidence may be seen in the gas pipes that lie around the locations of the original houses. These may well be the same pipes that ran from the Gasometer, established in 1898.

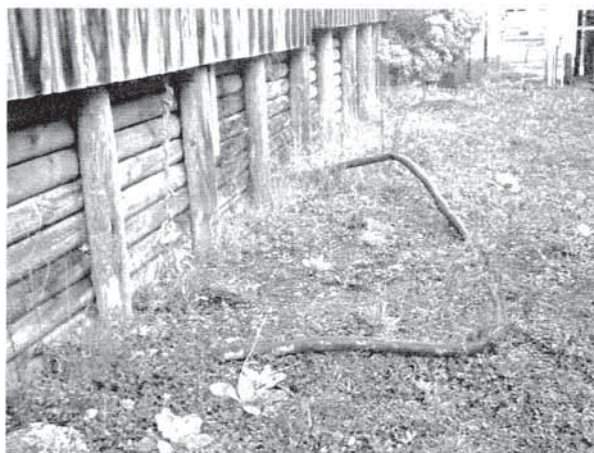
Figure 15: Gas pipe remains, possibly from main pool (© Author, 2004).

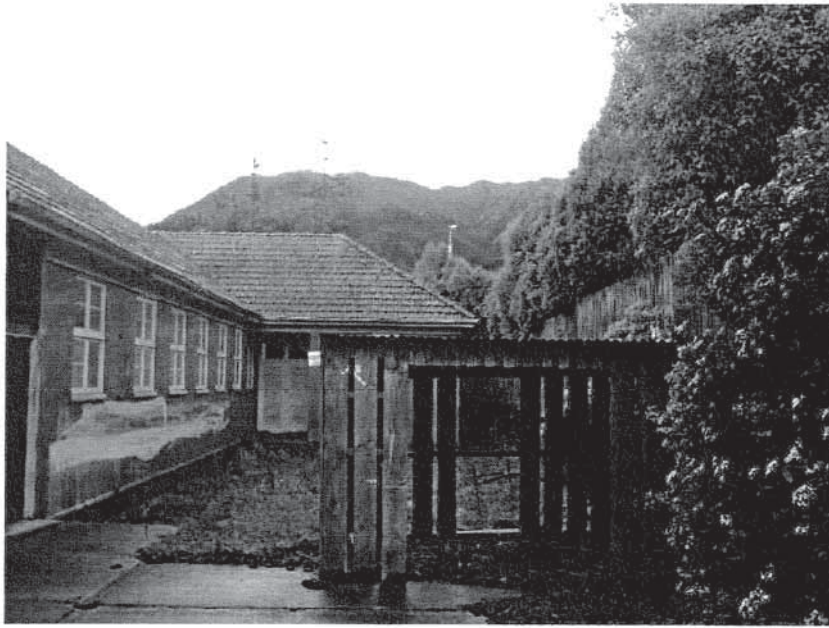
Figure 16: View from same spot as photo below, current Fountain House (© Author, 2004).

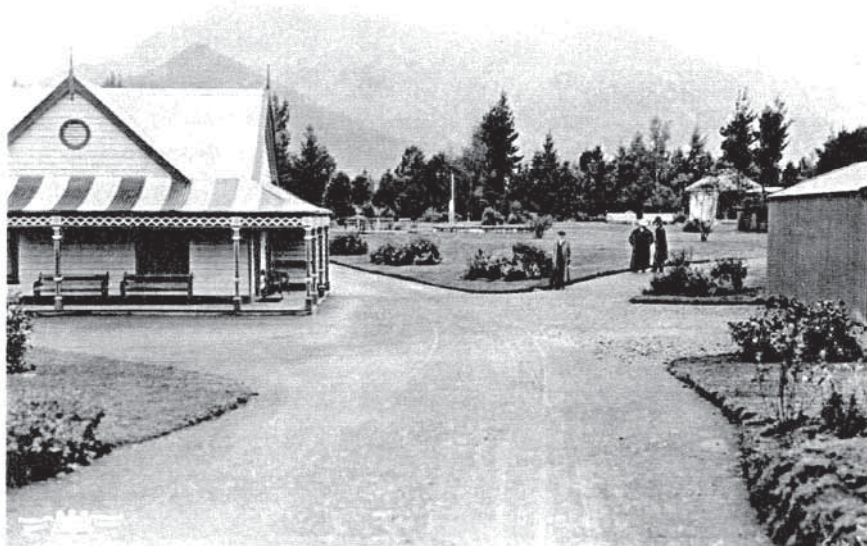
Figure 17: Photo of first bathhouse, c.1904 (© Christchurch City Library Heritage Photo Collection, 2004).

In 1884, a bathhouse, complete with four baths, was built around the main pool (Fig. 17) (Rockel, 1986:65).

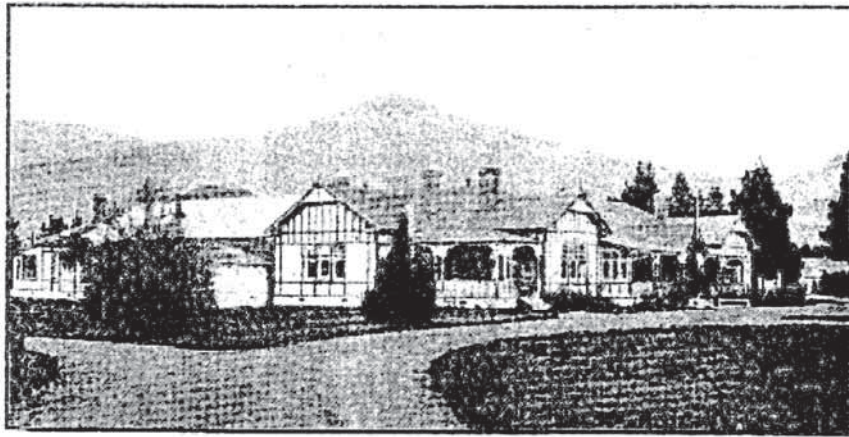
Figure 18: Sanatorium Block, c.1904 (McManaway, P. 1980, p.15).

The foundations and location of the Sanatorium are retained in the design of the Soldier's Block. In particular, the courtyard and possibly one of the chimneys were retained.

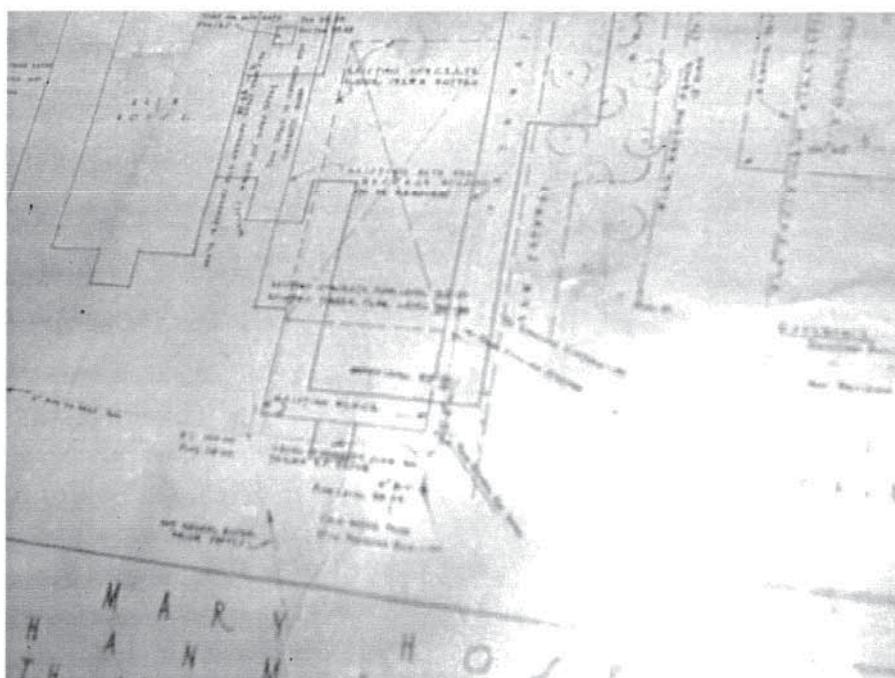
Figure 21: Plan showing concrete foundation of second bathhouse under current Gymnasium, c.1926 (Held in Carpenters Office, Queen Mary Hospital, 2004).

The second bathhouse is indicated as a concrete slab built over with the current gymnasium. Remains of this are still likely to lie under that building.

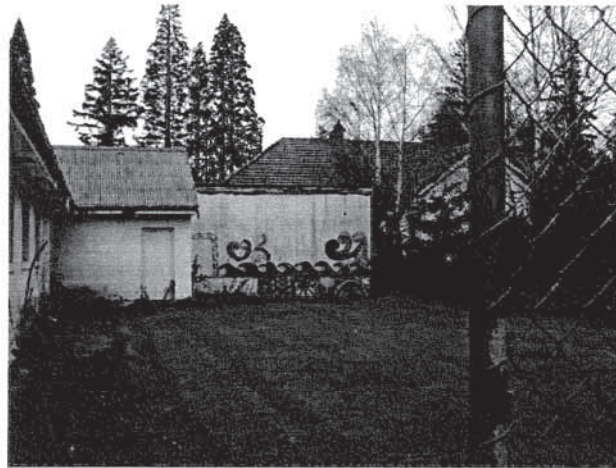
Figure 22: View of location of original third bathhouse (© Author, 2004).

The position of the original second and third bathhouse and the location of the original Fountain House, were able to be seen in relation to the developments of the 1930s. The 1929 plans outline the proposed removal of the third bathhouse building and the original Fountain House (Fig.20). The plans suggest that the first two bathhouses were removed prior to the originally recorded date of 1930, but the 1926 plan indicates the presence of a large concrete slab upon which the Gymnasium building is built, referring to the original second bathhouse foundation (Fig. 21). The site of the third bathhouse building is now a cleared exercise area (Fig. 22).

The third bathhouse complex was completely removed at some point after 1930. The site of the building is now the grass-yard the Gymnasium and the Men's swimming pool. It is unclear whether there are any remains still evident, but the location is intact.

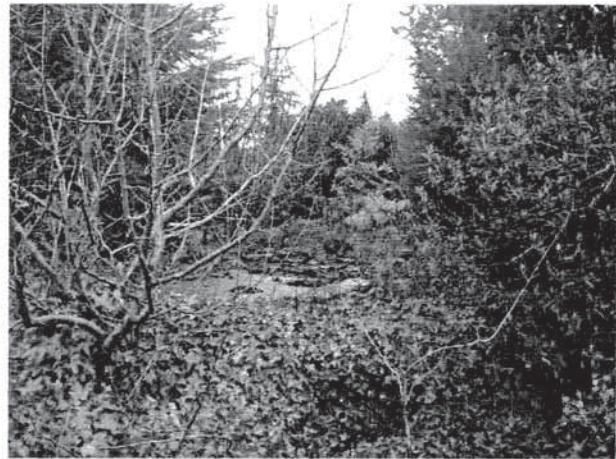
Figure 23: View of Men's Swimming Pool, next to third bathhouse (© Author, 2004).

The original fountain house appears in the plans to form a complex including the Men's Swimming Pool that is still extant (Fig.23). Another structure at the opposite end of the pool is no longer there, although a small toilet is located here.

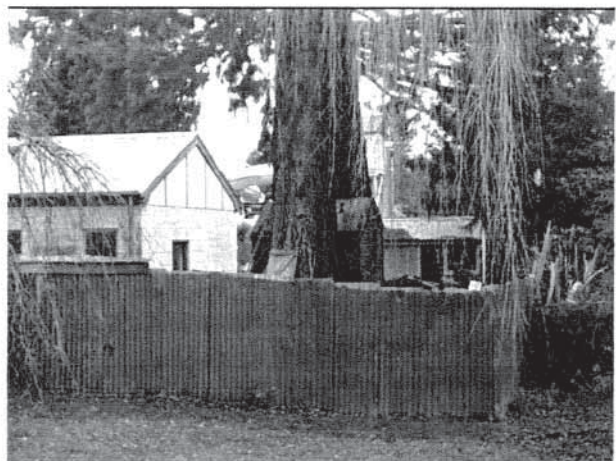
Figure 24: View of Garden Shed area showing small building between Macrocarpas (© Author, 2004).

Also evident in the plans and on site is the garden shed complex, near the Chisholm block (Fig.24). Because the area is currently in use, further research is required to fully examine the area.

The group of buildings around the original Garden Shed indicated on the plans in the northern part of the complex still appears exists. The small building sandwiched between two trees may actually be the original Wash House.
