Conservation plan

**Chisholm Ward, Queen Mary Hospital,
Hanmer**

June, 2010

IAN BOWMAN

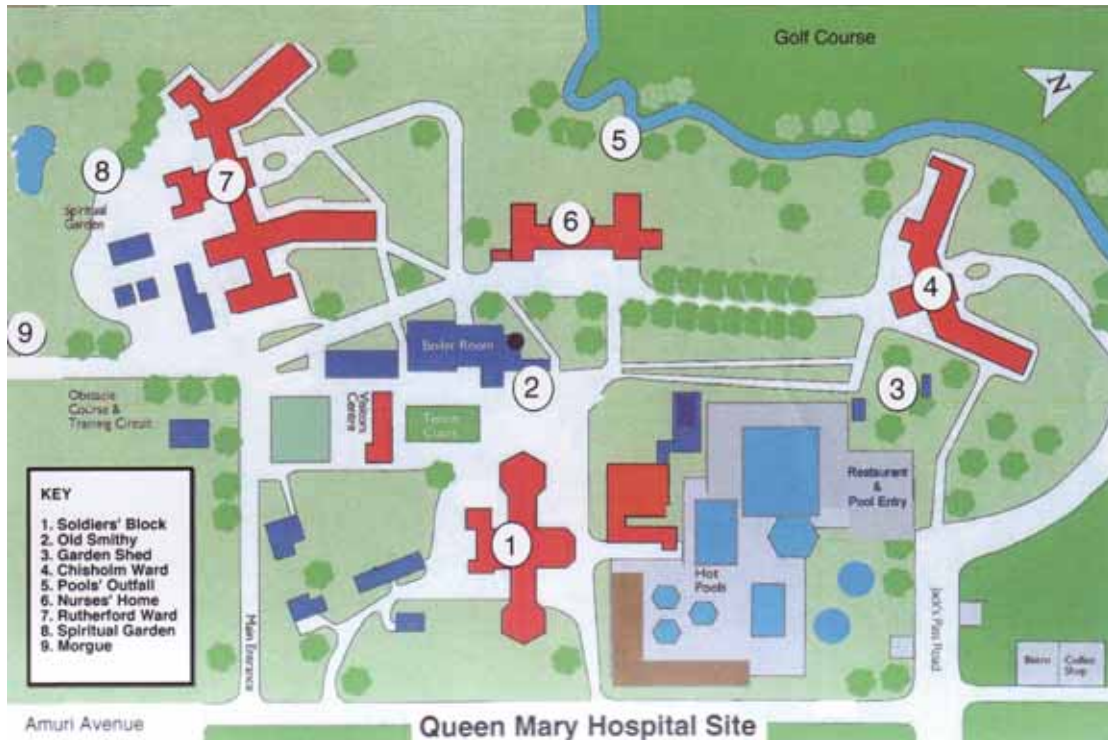
Site plan showing the main buildings of the Queen Mary Hospital, from inside front cover of Crawford, *The Queen Mary Hospital, Hanmer Springs, 1916-2003*

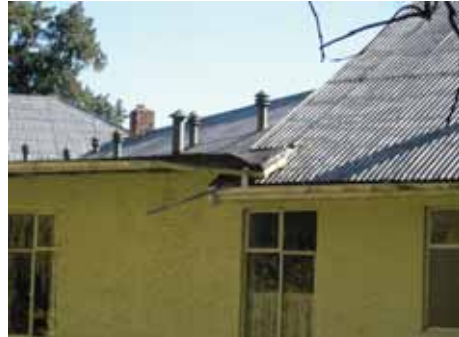
East elevation

- Painted rough cast render (hf)
- Painted cement pilasters with brackets (hf)
- Painted timber windows (hf)
- Painted metal vents (hf)

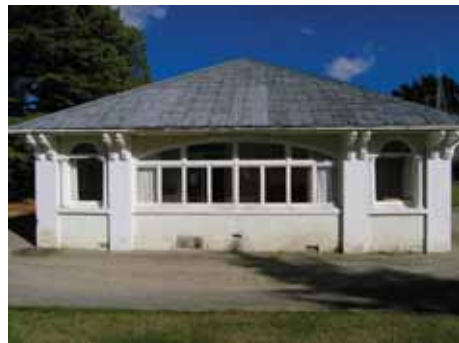
South east elevation

- Painted rough cast render (hf)
- Painted steel windows (hf)
- Painted metal vents (hf)
- Painted timber glazed doors with toplights (hf)

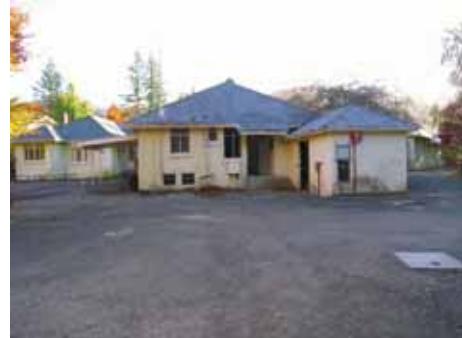
South west elevation

Painted rough cast render (hf)
Painted steel windows (hf)
Painted metal vents (hf)
Painted timber glazed doors with toplights (hf)
Concrete patio and steps (hf)

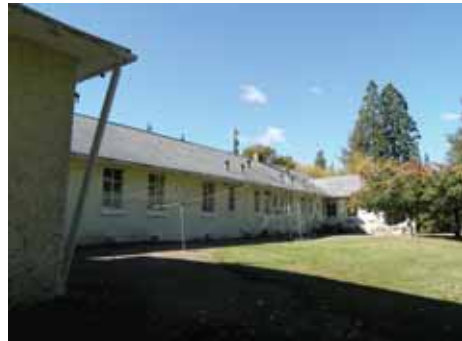
West elevation

Painted rough cast render (hf)
Painted cement pilasters with brackets (hf)
Painted timber windows (hf)
Painted metal vents (hf)

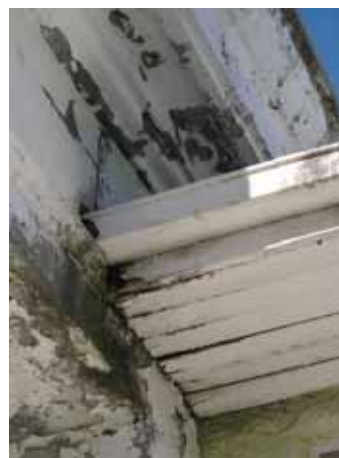
- minor rusting of roof
- loose bricks and render on chimneys
- damaged and missing guttering and downpipes
- debris in guttering and valley gutters
- blocked and overflowing pipes and gully traps

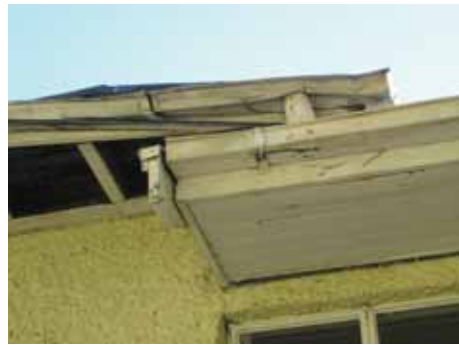
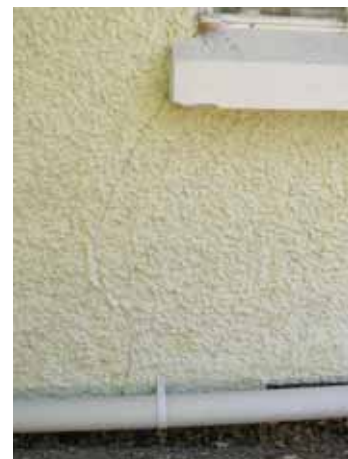
- peeling paint off all painted surfaces and areas not painted
- rotten soffit to the exterior of the offices opposite the lounge
- rotten soffit above the main north entry
- damaged soffit at the junction between the central and east wing on the south elevation
- broken light to the main entry
- missing seats to the north elevation
- missing light fittings to open verandahs
- broken, cracked and missing windows
- rusting steel windows
- extensive cracking on the south east elevation of the east wing
- extensive mildew and lichen growth on the exterior, especially over the portico
- damaged concrete to south west patio

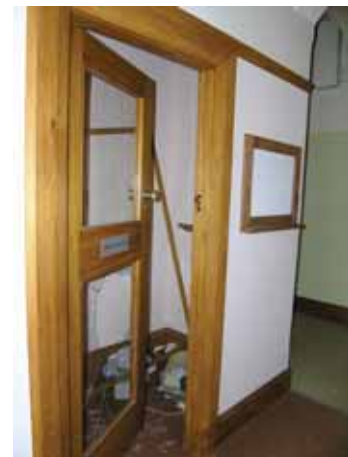
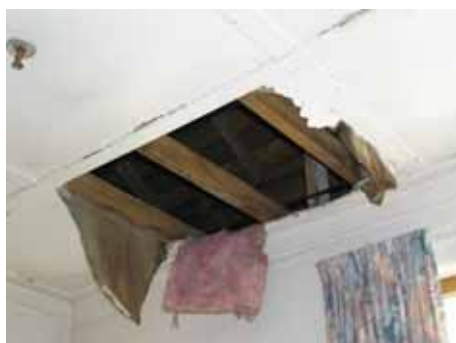
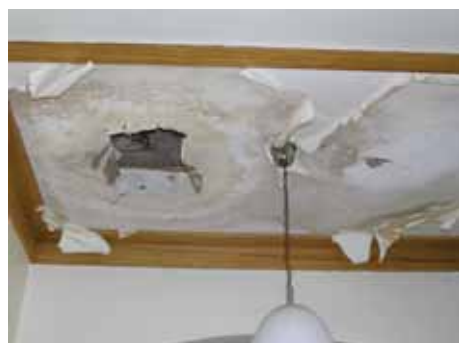
Interior

- cracked, broken and missing windows as per the exterior
- cracked and missing glass to interior glazed doors
- cracking of plasterwork to the dining room above the fireplace
- some missing door numbers, name slots on doors
- impact damage to walls, skirtings, architraves and timber panelling
- peeling paint to ceiling
- areas of rot and collapsed ceilings in the central east corridor and in then centre of west wing
