*Conservation plan*

**Soldiers' Block, Queen Mary Hospital,  
Hanmer**

June, 2010

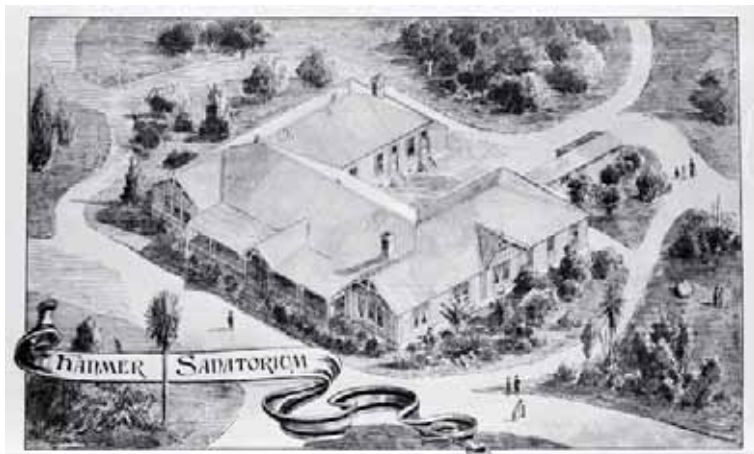
Sanatorium/Spa in c.1898. Source: *Appendix to the Journals 1898*, vol 1, C1, p111. Negative 1437, Opus Report

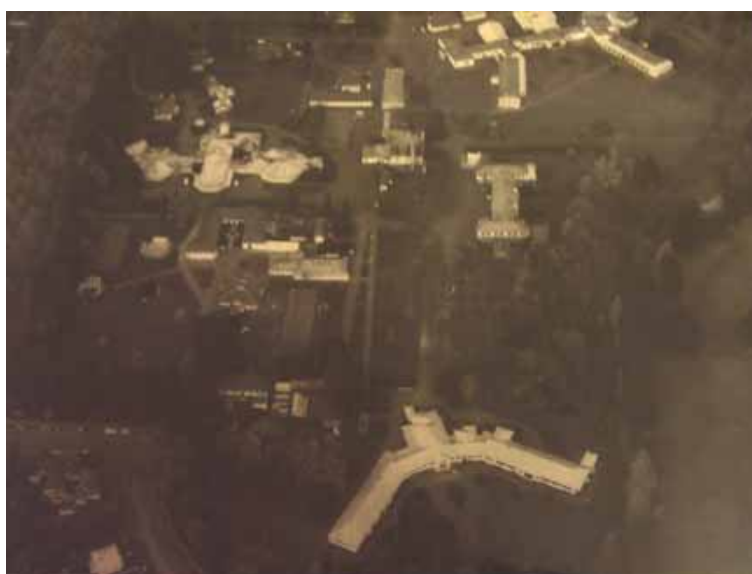
Digital photograph of an aerial photograph of Queen Mary Hospital Site displayed on the wall of the Maintenance Engineer's Office, dated 1966, RNZAF., from Opus Report

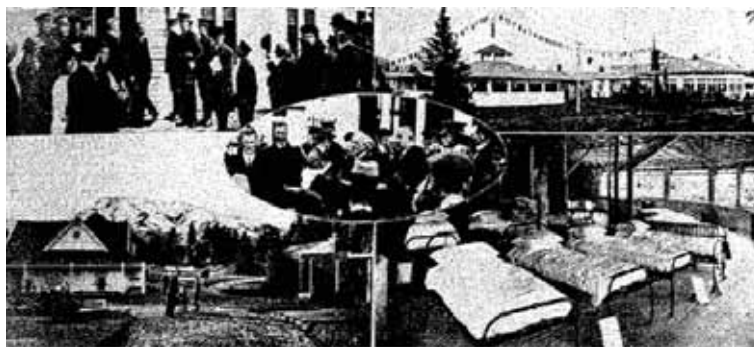
Copied from Silverson, page 121, Soldiers' Block opening top left, right and centre. Arrangement of beds in Octagonal wards (note no glazing in window space), Opus Report

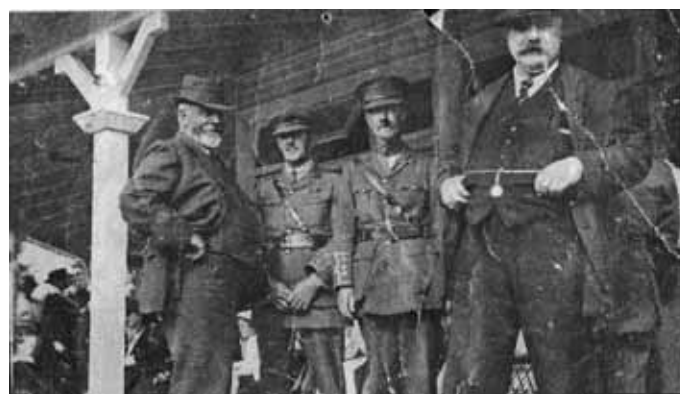
Opening of the verandah, Duncan Rutherford (pictured on left) paid for the verandah added to the front of the building in 1917. John Dodds, the local storekeeper stands to the right, Crawford, *The Queen Mary Hospital*, page 2

By Easter 1917 the building housed nearly 100 men.<sup>58</sup> At that time a spacious verandah was added, "built in something like ten days by a gang of carpenters from Christchurch", as it was brought from Christchurch partly pre-fabricated.<sup>59</sup> Chairs were put on the verandah specifically for the comfort of the soldiers. Everything was said to be painted white – the building, the ironwork of the bedsteads, and the coverlets of the beds.<sup>60</sup> In early 1918 the hospital had 130 men.<sup>61</sup>

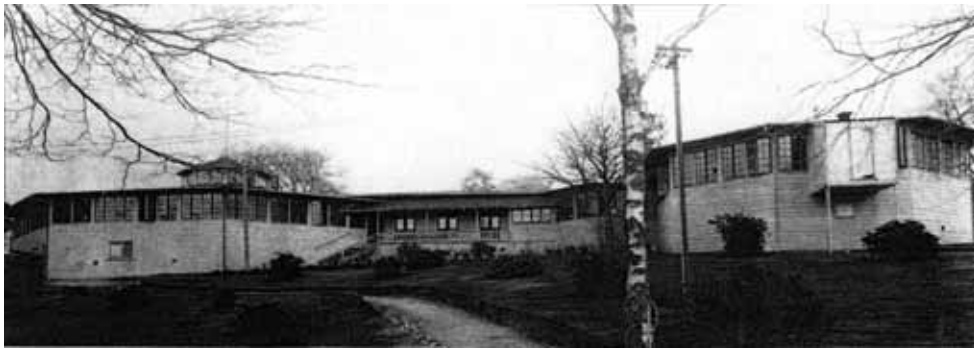
ANZAC and Suvla wards at King George V Hospital, Rotorua, *Health Camp Board Collection*

As at Rotorua, the Hanmer building had two octagonal wards linked by a corridor with a large hall between them. The octagonal wards had a nurses' station at their centre, which enabled the nurses to monitor the patients. The lantern roof at the centre and the large windows that encircled the wards maximised the available sun and air, considered vital for recuperating patients. Hospital designs of this type arose from a gradual recognition about the importance of fresh air, sunlight and cleanliness for healing, which began to have physical results from the late 19th century.<sup>82</sup> Today the Soldiers Ward at Hanmer Springs is believed to be the only one of this design to survive in New Zealand. Both octagonal wards from King George V Hospital at Rotorua were moved to the Otaki Children's Health Camp, where one of them still stands today – this remaining one at Otaki has been described as 'of outstanding national significance'.<sup>83</sup> The Soldiers Ward at Hanmer is of even greater significance as the only complex of this design to survive intact and still on the site for which it was designed.

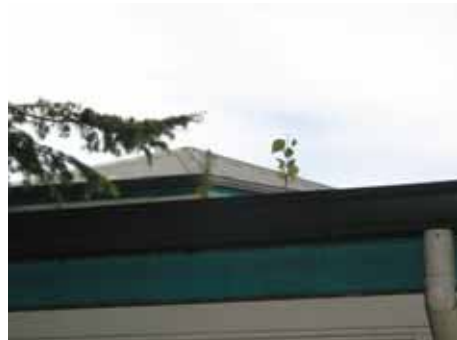
**East wing**

Painted splayed plastic rusticated weatherboards (nhf)

Painted timber ledged and braced door from toilets and from ward to west (hf)

Painted timber architraves and sills to doors and windows (hf)

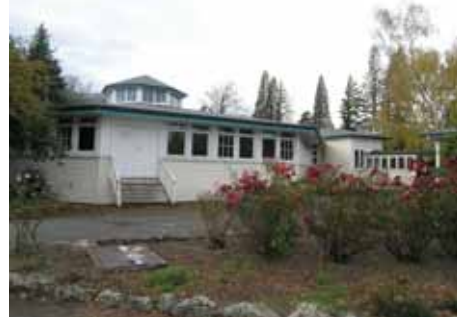
**Joining corridor to west wing**

Painted splayed plastic rusticated weatherboards (nhf)

Painted timber architraves and sills to windows (hf)

Painted timber glazed panelled French doors with toplights (hf)

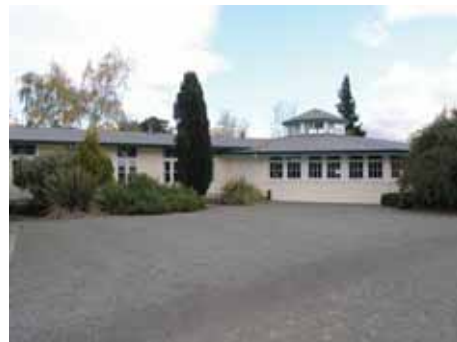
**South wing**

Painted timber verandah with timber posts and uncoated flooring (hf)

Painted timber walkway with shiplap weatherboards, painted timber fixed windows, timber posts and painted timber flooring (hf)

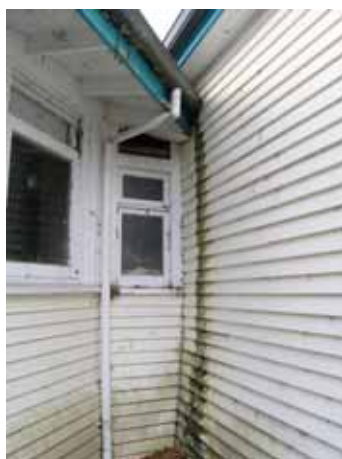
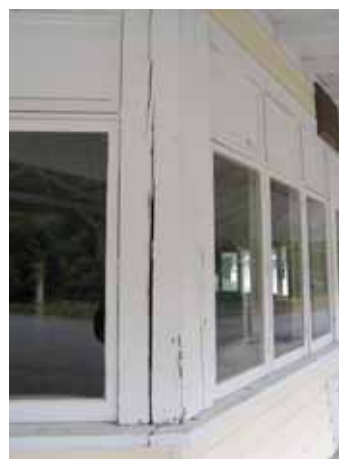
- Vegetation growing in guttering
- Missing mortar to chimney

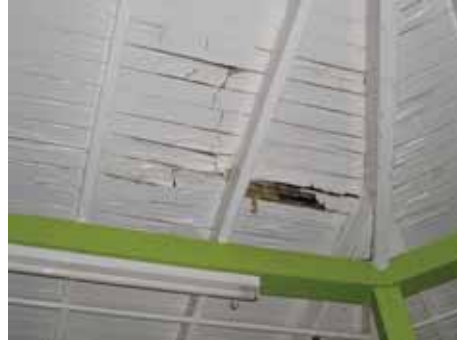
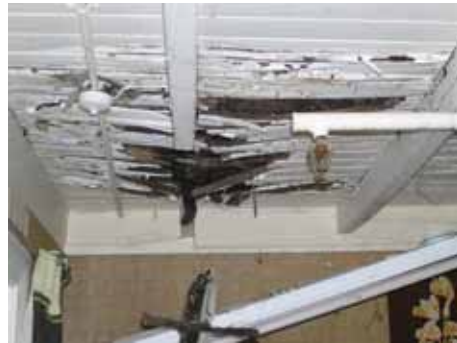
- Moss and lichen growth on chimney
- Extensive peeling of paint from painted timber surfaces, especially doors and fascia
- Cracked and crazed render to brick and rendered steps outside east wing corridor
- Missing bracket to east post of verandah
- Parting architraves to central wing bay
- Rotten sarking to verandah soffit
- Cracked and broken windows
- Rot and algae growth at junction of west octagonal ward and link

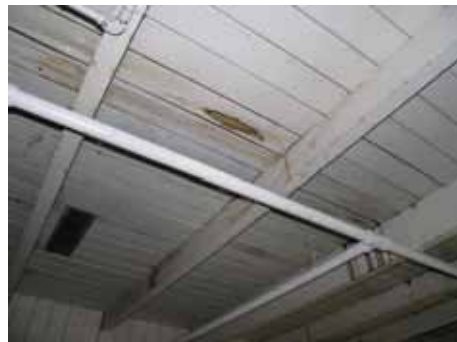
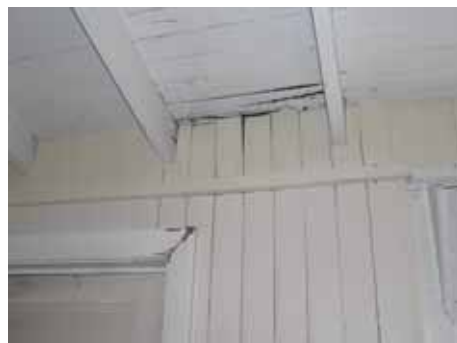
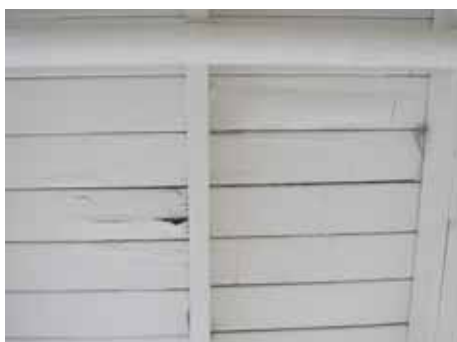
- Rot in east octagonal ward ceiling
- Impact damage to walls, skirtings, architraves and timber panelling
- Worn lino to east wc corridor
- Rot in north and south rooms off east wc corridor
- Wc extensive rot to the ceiling of the room off the east octagonal ward
- Rotten ceiling to locked room off west octagonal ward off
- Broken glass in door to locked room off west octagonal ward
- Rotten timber ceiling to west octagonal ward
- Missing louvres to east wc corridor
- Peeling and damaged paintwork
- Borer?
- Debris scattered within the interior

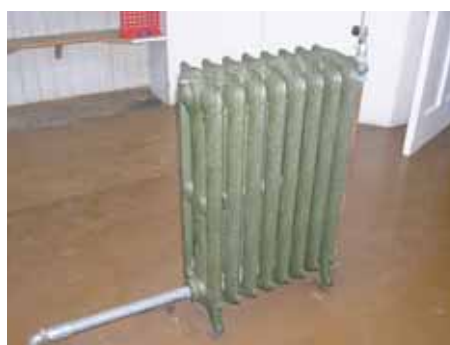
The building has a number of items of special fabric that were constructed and designed with the building. These include the brass and marble plaques on the exterior of the central wing, fire surrounds in the dining hall, match lining to ceilings and walls, timber scotia moulding, cast iron radiators and the joinery in the nurses’

station in the centre of the octagonal wards. Because of their age and relative rarity, the following elements have especial significance: the urinals, toilet pans and cisterns, toilet partitions, concrete and ceramic receptacle, and door hardware and furniture

including hinges, pull handles and indicator bolts.
