**General distribution and characteristics of
active faults and folds in the Hurunui District,
North Canterbury**

D.J.A. Barrell

D.B. Townsend

GNS Science Consultancy Report 2012/113
Environment Canterbury Report R12/39
June 2012

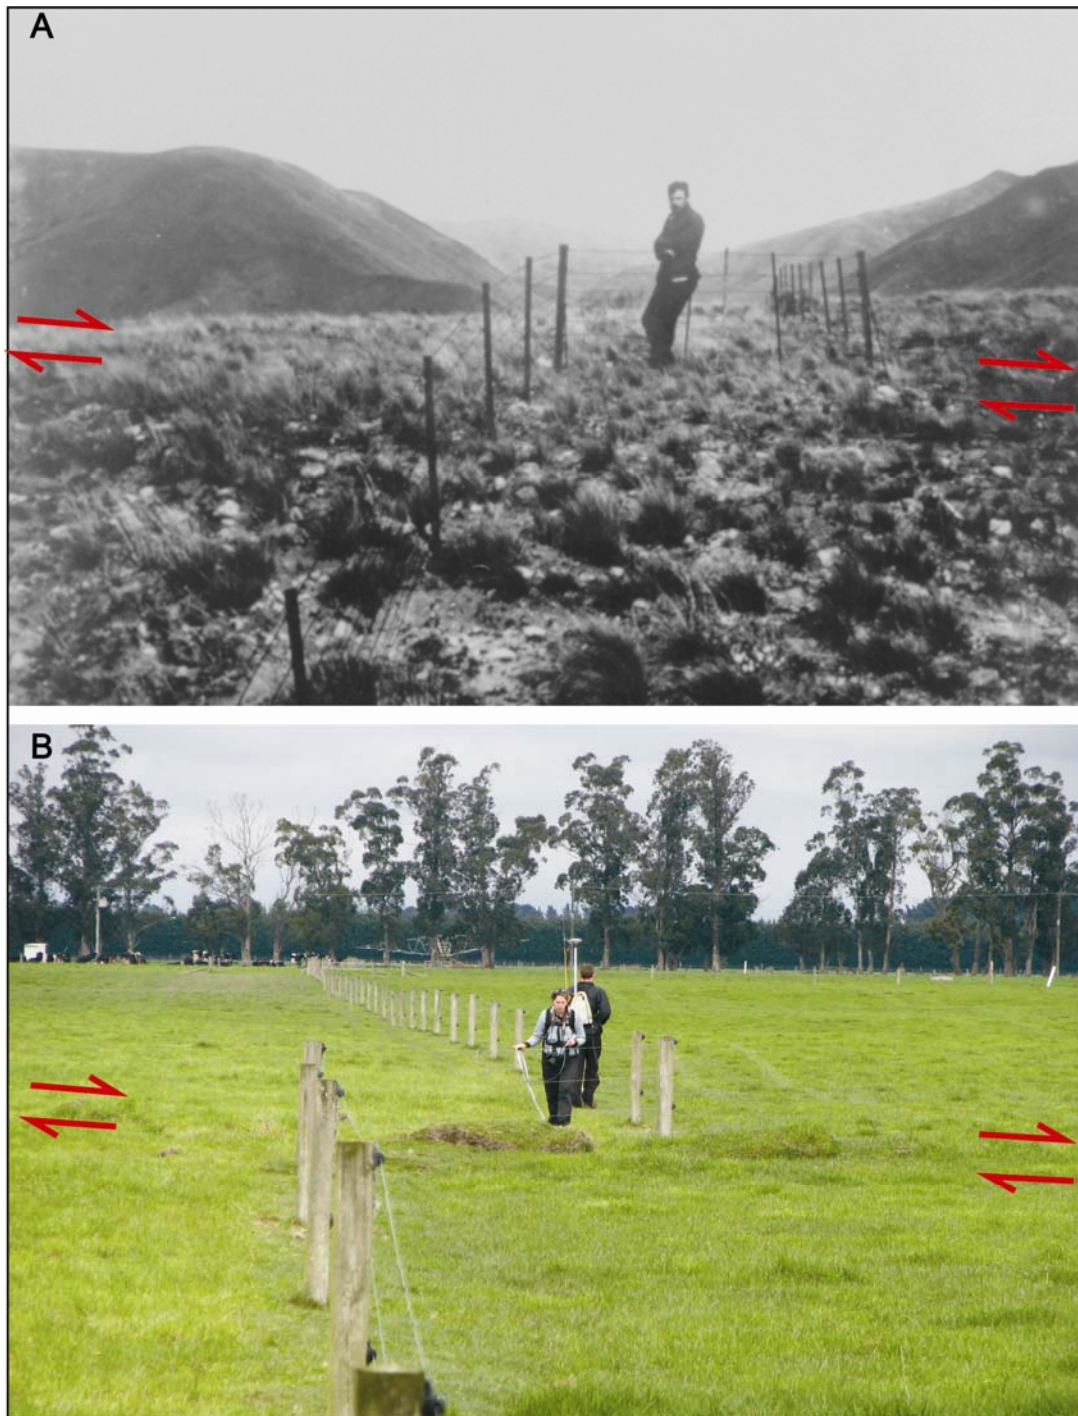
Figure 2 A: A fence offset sideways by ~2.4 m of strike-slip rupture on the Hope Fault at Glynn Wye during the 1888 North Canterbury Earthquake (Photo: A. McKay, GNS Science CN4852). B: A fence offset sideways by ~4.5 m of strike-slip rupture on the Greendale Fault during the 2010 Darfield Earthquake (Photo: N.J. Litchfield). Half-arrows either side of the fault indicate the direction of movement. In both cases, the movement is 'right-lateral', sometimes called 'dextral'. This means that to an observer, the ground on the far side of the fault has shifted sideways to the right. The effect is the same regardless of which side of the fault the observer is standing. The other type of strike-slip movement is 'left-lateral', sometimes called 'sinistral', but is not common in New Zealand.

Although the movement along the plate boundary is continuous, and can be measured by ground and satellite (GPS) surveying, rock of the Earth's crust is remarkably elastic and can accommodate a lot of bending before letting go and breaking suddenly (rupturing) along a fault, causing an earthquake. On large faults, the break may be big, and extend up to the Earth's surface, causing sudden offset and breakage (faulting), or buckling and warping (folding), of the ground surface, and generating a large earthquake. The 2010 Darfield Earthquake has provided a good example of the nature and effects of a large, ground-surface-rupturing earthquake on a geological fault (e.g. Barrell et al. 2011) (Fig. 2).

Figures 2, 5 and 10 illustrate examples of the types of ground-surface deformation hazards that may arise from active faults or active monoclines, noting that at any location, elements of both faulting and folding may be present within a deformation zone. In general, faults and monoclines present the most focused forms of ground deformation, in regard to direct rupture or significant tilting of the ground surface. Such effects may occur in a sudden event. Active anticlines are likely to present a much lesser level of ground surface deformation hazard with regard to buildings, but may pose relevant hazards to developments such as canals or power stations (e.g. by tilting the ground). Furthermore, the presence of active folds suggests that there may be an underlying active fault at depth that may potentially generate a local, large, shallow earthquake, were it to rupture.

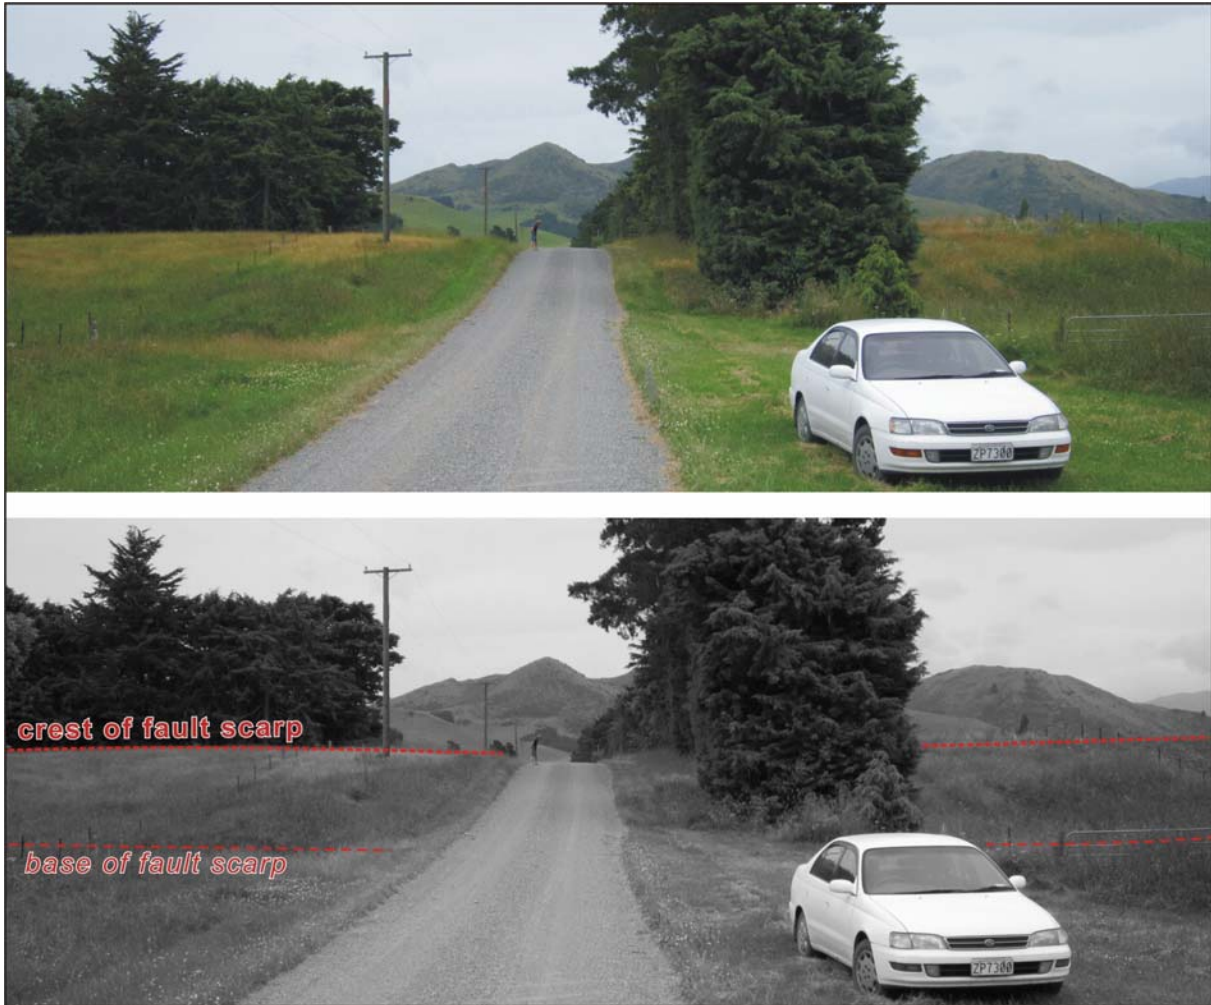
Figure 4 A view northwest towards a ~3 m high fault scarp, traversed by Creans Road ~260 m southeast of the Hewetts Road intersection. The ground surface here, southwest of the Hurunui River and about 13 km north-northwest of Hawarden, is part of the ~18,000 year old Balmoral Plain formed by the Hurunui River. This well-expressed fault, part of the Hurunui Peak fault zone (Fig. 6, feature 12), is classed as 'definite' because it cuts across 'fossil' Hurunui River channels, although these are not visible in this image. Photo: D.J.A. Barrell.

The key evidence for recognising active faults or folds is the offset or buckling of landforms or young geological deposits. This is seen most clearly on old river terraces or river plains, where the original channel and bar patterns of the former riverbed are 'fossil' landforms dating from when the river last flowed in that location. Topographic steps or rises that cut across such river-formed features could not have been created by the river, and therefore result from subsequent deformation of the ground. As long as factors such as landsliding can be ruled out, these topographic features may confidently be attributed to fault or fold movements (Figs. 2 to 4). Note that in the captions accompanying the photos of Hurunui district faults in this report, sufficient information is given so that an interested reader would be able to go to the location where the photo was taken, and examine the feature first-hand.

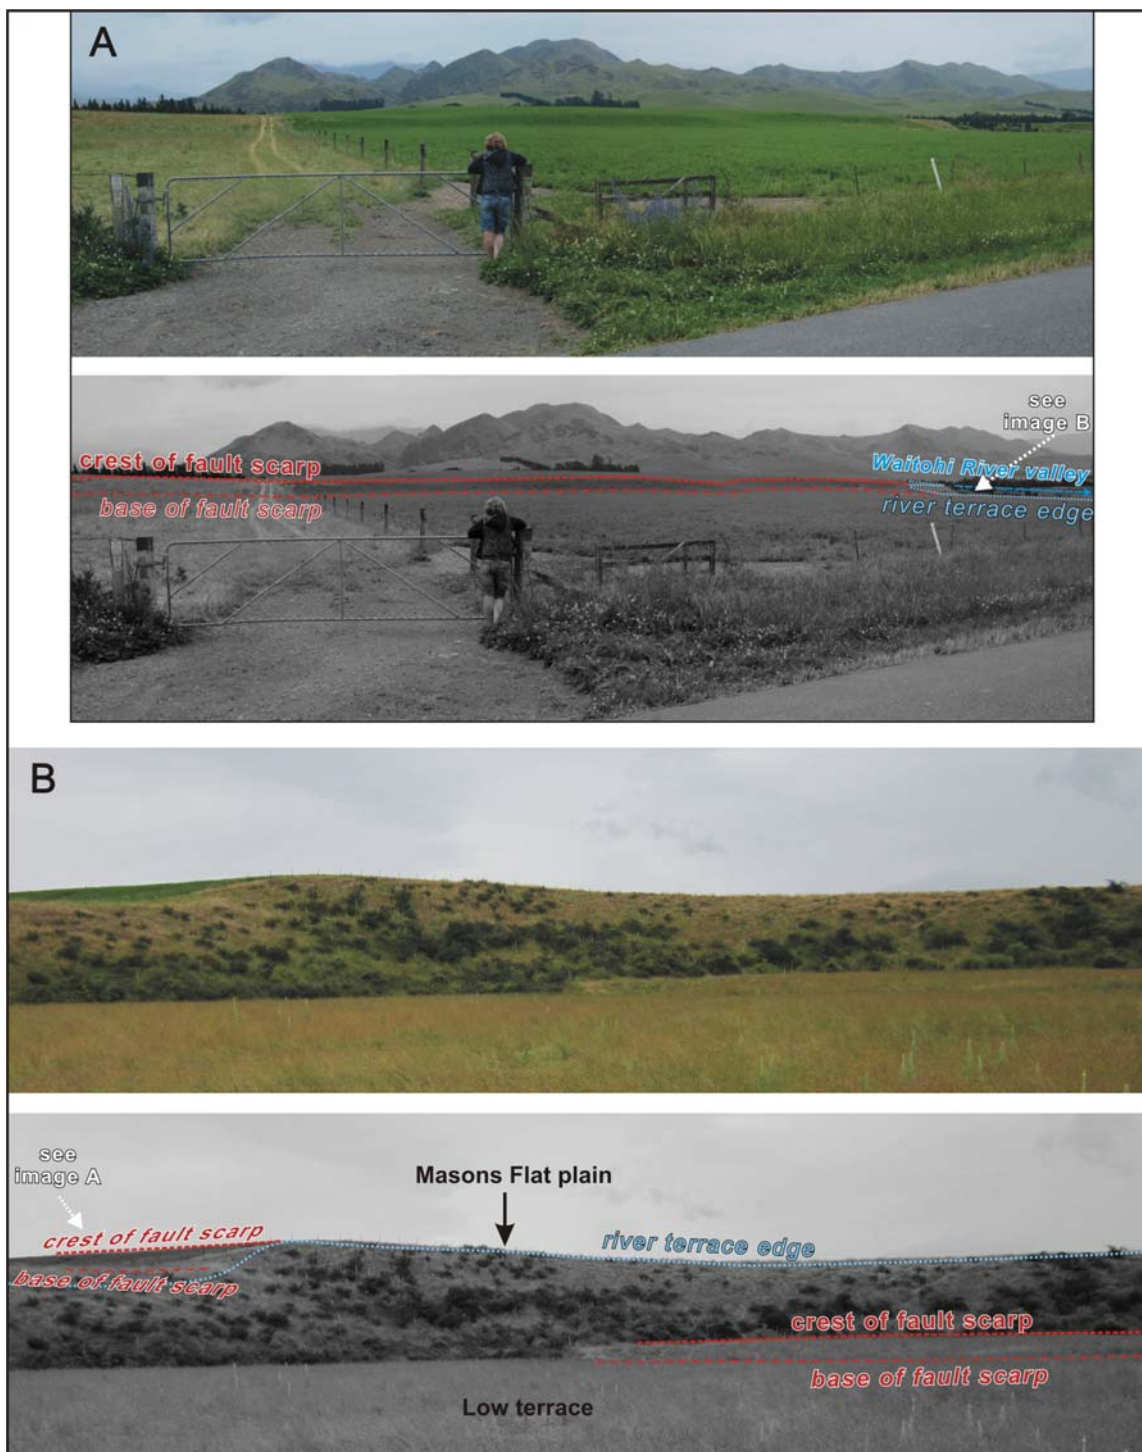
Figure 7 A: A view west-northwest from Powers Road, ~960 m north of the Lake Sumner Road intersection, towards a ~3 m high fault scarp within the Hurunui Peak fault zone (Fig. 6, feature 12). Here, ~10 km northwest of Hawarden, the ground surface is the ~18,000 year old Masons Flat plain, this sector of which was formed by the Waitohi River. B: This view west from Powers Road, ~1280 m north of Lake Sumner Road and ~280 m south of the Waitohi River bridge, reveals that the fault scarp is only ~1 m high on a low, relatively young, terrace of the Waitohi River. This shows that the most recent ground-rupture earthquake on this fault involved no more than ~1 m of vertical movement, and that the ~3-m high scarp on the Masons Flat plain (forming the skyline) is the product of at least two ground-surface rupturing earthquakes since ~18,000 years ago. Photos: D.J.A. Barrell.

Of the various methods for estimating the SED on a particular fault, the best is to excavate a trench across the scarp of the fault in question, and make measurements of the deformed deposits (i.e. site-specific investigation). However, there are other, less direct, methods, such as those described by Wells & Coppersmith (1994) who used a catalogue of observed earthquake events worldwide to define formulae for estimating SED values, based on, for example, the mapped length of a fault¹. A disadvantage of the catalogue-estimation approach is that the length of a fault may be uncertain. To illustrate this with the Hurunui Peak fault zone, the length of definite or likely faults/folds comprising the Hurunui Peak fault zone is about 15 km. However, if this fault zone is linked southwest with, for example, the Heathstock fault and Virginia faults (Fig. 6, features 21 and 20), then the total length would be about 45 km. The Wells & Coppersmith (1994) formula implies a maximum SED of 0.8 m for a 15 km long fault, increasing to 1.4 m for a 45 km long fault. Either value is broadly compatible with the observations at Powers Road, outlined above.

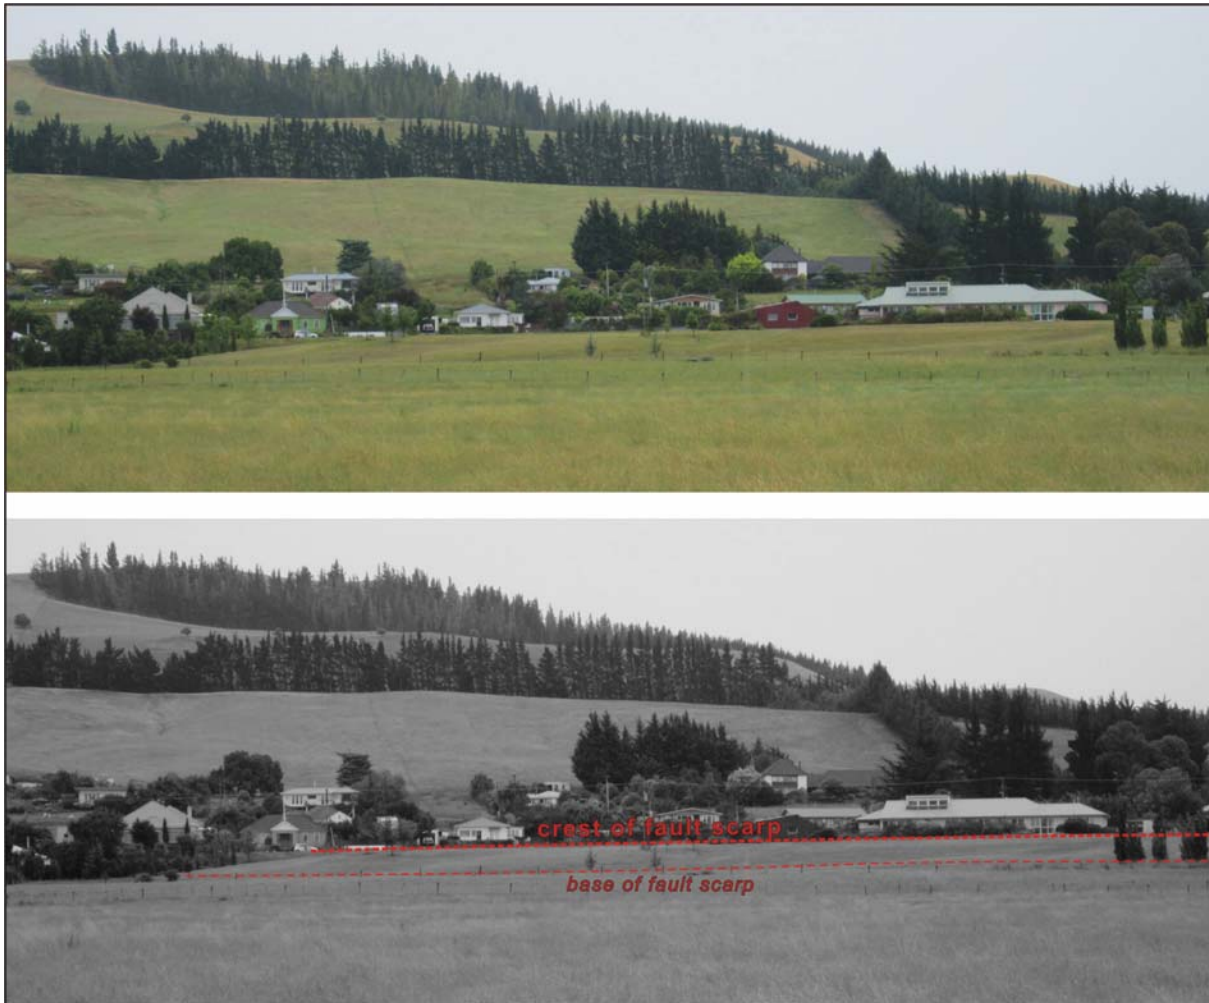
Figure 9 A view south from Kermode Street towards part of Waikari township, medical centre building on the right. The broad ~3 m high step running right-left in front of the buildings is thought likely to be a fault scarp, or possibly a monoclin flexure, associated with the Moores Hill Fault (Fig. 6, feature 27). A feature such as this could be investigated by trenching to establish whether it is in fact a fault, or of some other origin, such as a stream-trimmed terrace margin. Photo: D.J.A. Barrell.

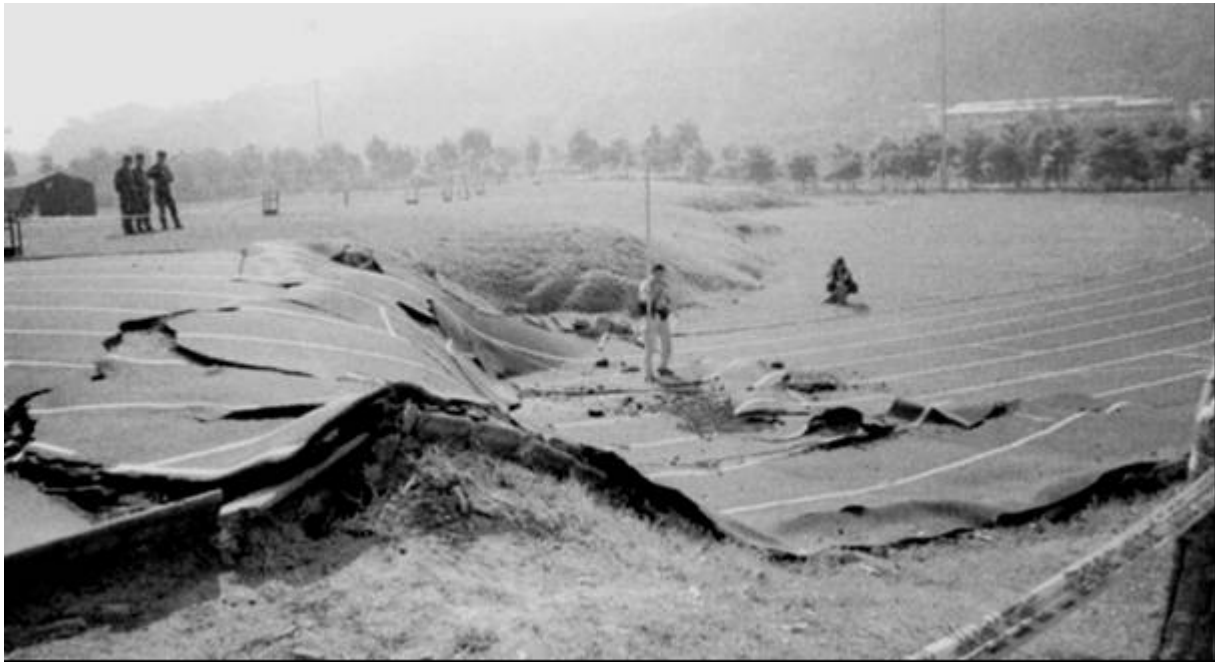
Figure 10 Fault scarp formed on the Chelungpu Fault during the magnitude 7.6 Chi-Chi Earthquake, Taiwan, 1999. The disrupted running track shows damage typical of a reverse fault ground-surface rupture, which is well expressed on the brittle surface (note the smoother rupture across grass behind). This location lies on a stream terrace that is younger than the previous rupture event on the fault, so that there was no scarp here before the earthquake. This example illustrates the sorts of effects that can be expected on active reverse faults of the Hurunui District the next time any particular fault experiences a surface rupture earthquake. Photo and information from Kelson et al. (2001).
