Late Circulation
Regulatory Committee Meeting
7 December 2017

Cliff Erosion / Stability Assessment Report for 31 Moody Street, Gore Bay

CLIFF EROSION/STABILITY ASSESSMENT REPORT

31 MOODY STREET
GORE BAY

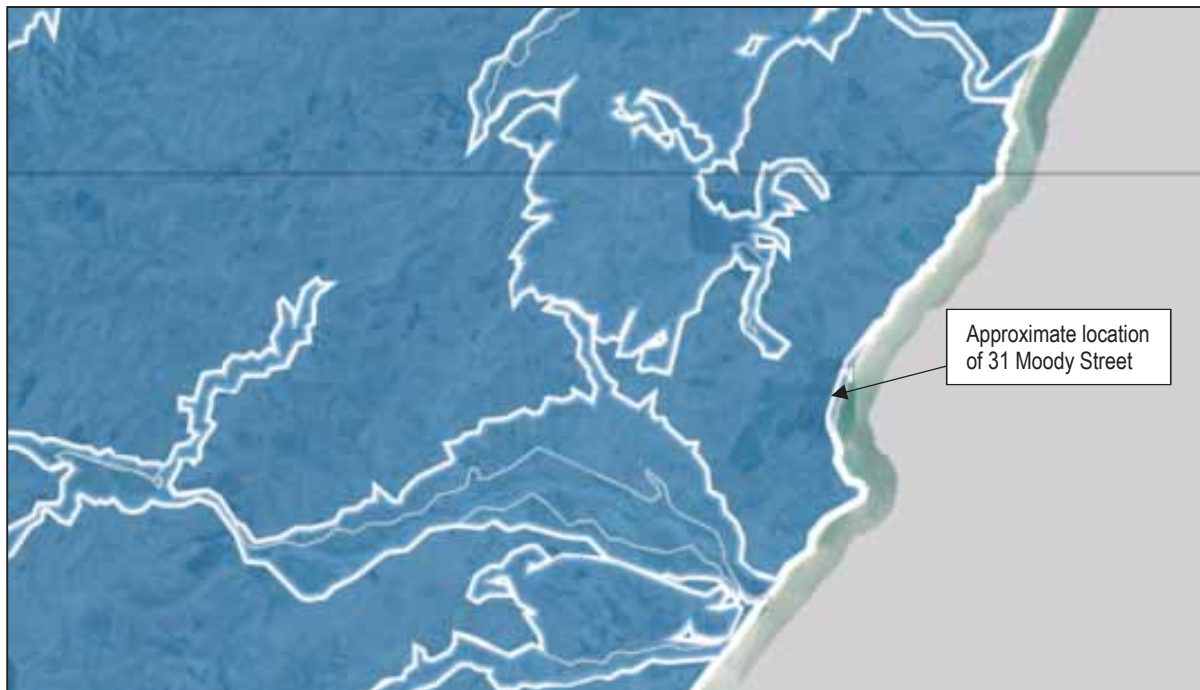
Figure 5.1: Hurunui Liquefaction Susceptibility (Canterbury Maps).

Liquefaction susceptibility mapping for the Hurunui District Council is presented on the Canterbury Maps database (refer to figure 5.1). The subject property at 31 Moody Street is located within a zone of nil to extremely low liquefaction potential and is designated as rock or hill soils.

Based on this information we consider the risk of cliff instability due to liquefaction of susceptible soil at 31 Moody Street to be extremely low.

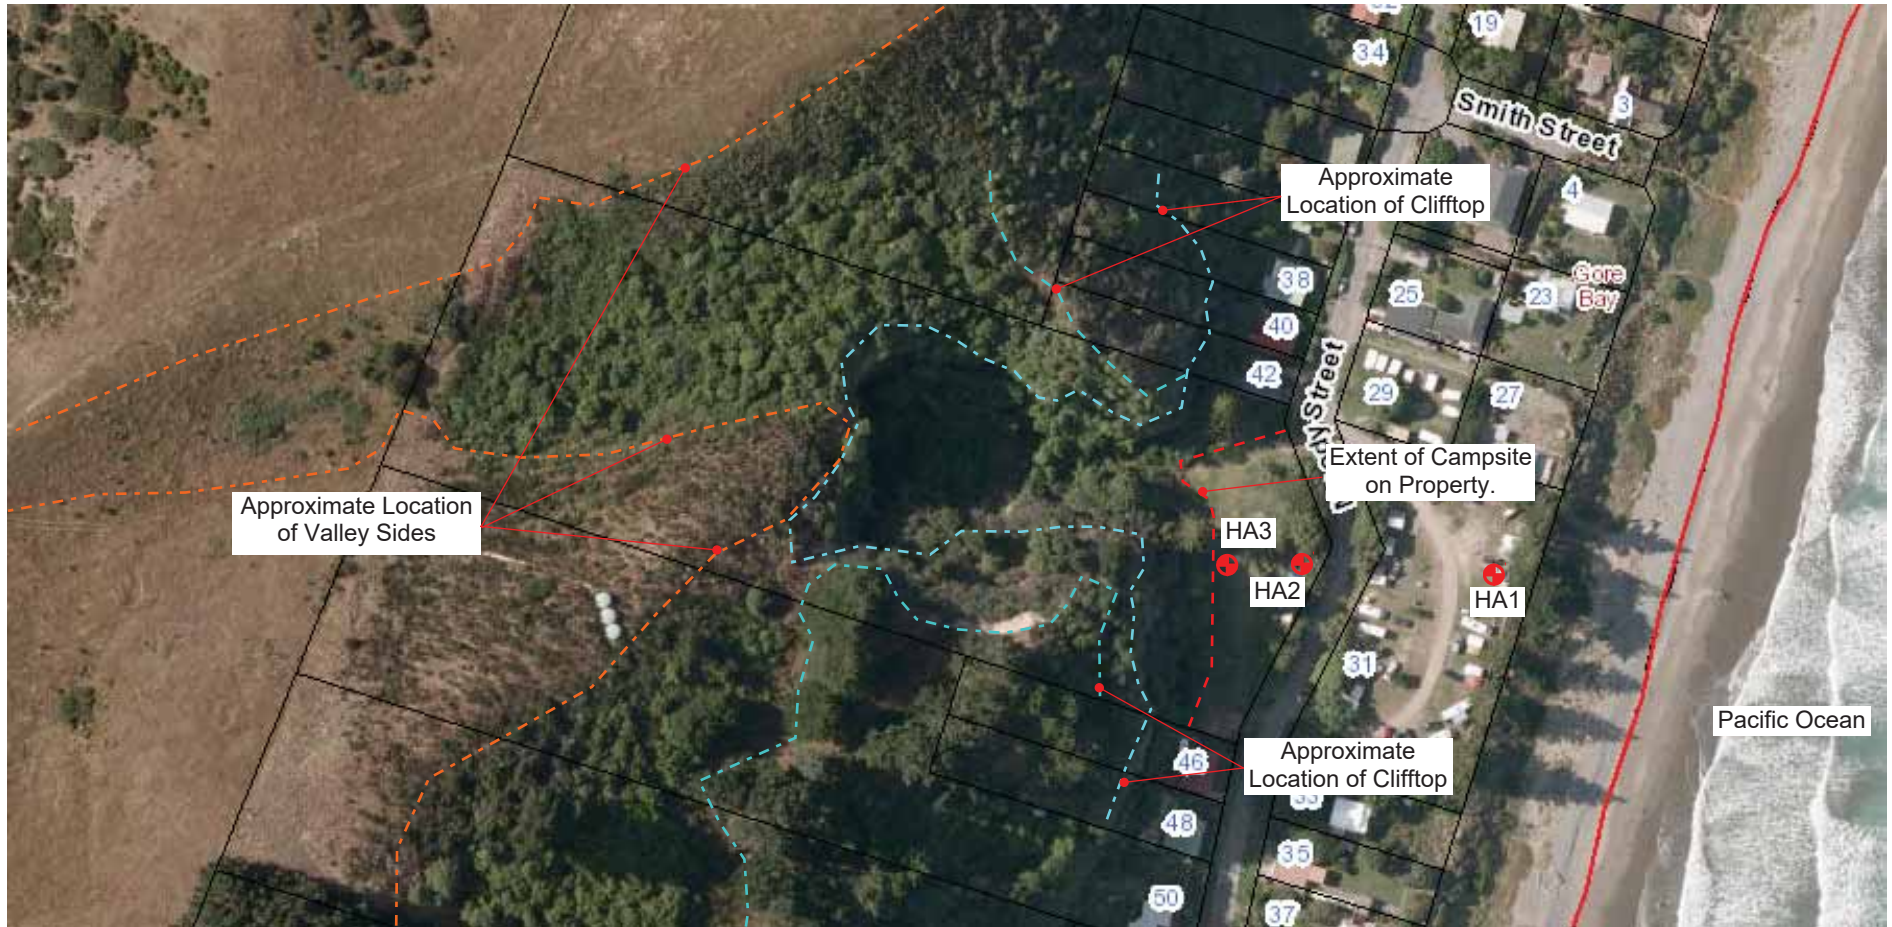
- Site Testing Location Plan – SK-1
- Approximate Cliff Regression and Recommend Extent of Rockfall Protection Barrier – Drawing G1.0

Drawing G1.0 (refer to Appendix A) shows the regression of the cliff top area from 2010 to 2016. We have taken the cliff edge to be where the land starts to noticeably slope downwards, not necessary the edge of a vertical or near vertical face, in order to provide a conservative estimate of cliff regression. We have not used the image from 15th November 2016 due to darkness and lack of clarity. It should also be noted that the ground surface profile across the western half of the subject property includes a series of near vertical faces, as well as moderately to steeply sloping topography. This varied landform, in conjunction with heavy vegetation coverage has meant there is a margin of error (± 5.0 m) in the identification of a suitable reference line across the cliff face.

Potential runout of landslip material has been assessed based on a cliff height of 20 m, a conservative 0.5-1.0 m thickness of near surface colluvium, and an angle of repose of 18 degrees (1V to 3H). By considering these parameters, we estimate that runout resulting from a typical shallow slip failure could extend to a distance of 6-8 m from the base of the cliff. By applying a factor of safety of 1.25 (or 25%) we consider a safe set-back from the toe of the cliff to be 10 m. This restriction zone may be reduced subject to the installation of new, suitably designed and constructed retaining structures and/or rockfall protection barriers. The retaining structures/rockfall barriers would be subject to specific design but preliminary assessment suggests they would be 2.0-2.5 m high and installed a minimum of 3 m from the toe of the cliff, along the length of the camp ground at risk as presented in Drawing G1.0, Appendix A. Appropriate maintenance of the structure is required to prevent reduced functionality, including the regular removal of accumulated debris.
