Mt Lyford Village

Geological Assessment for Slope Hazards

1895571_7407-003-R-Rev0

December 2018

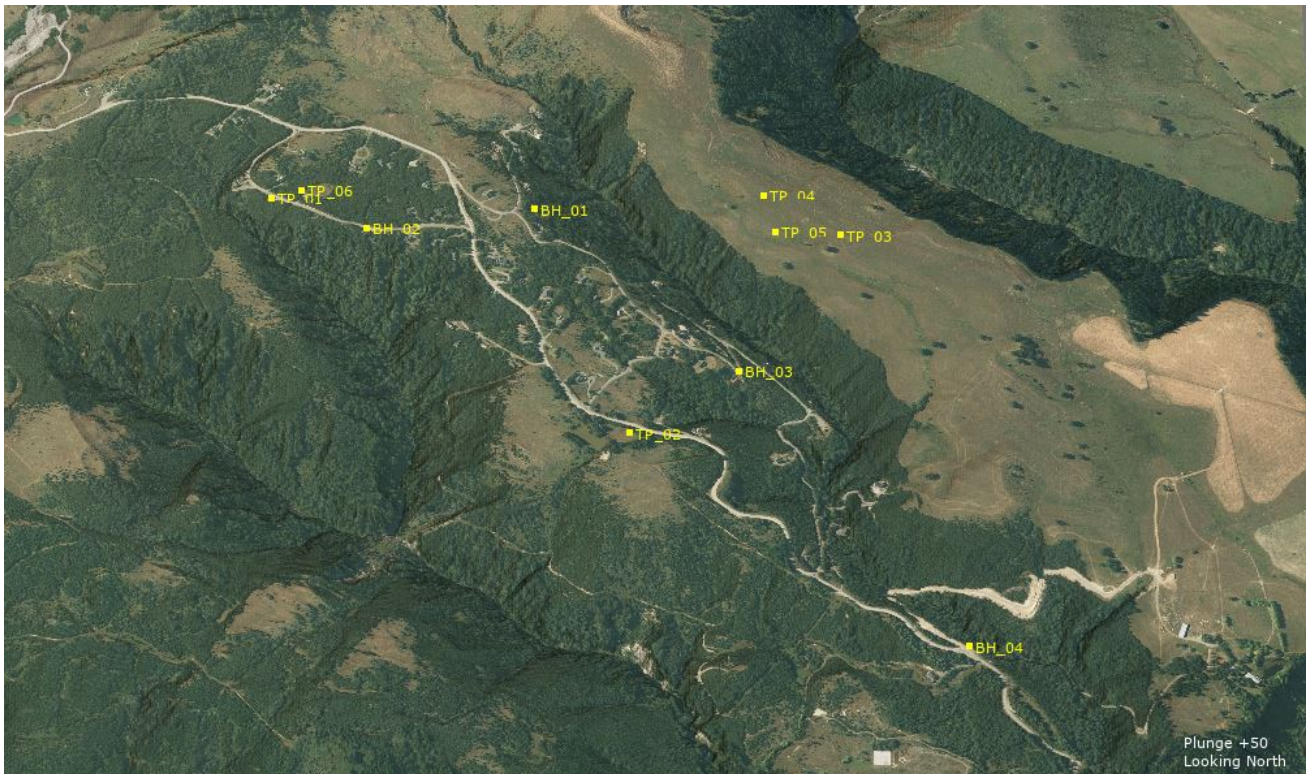
A field programme comprising test pitting and drilling investigations was undertaken between 23 November 2018 and 7 December 2018. The investigation locations are shown in Figure 2 and in the site plans included in Appendix B.

Figure 2: Oblique aerial photo looking North of Mt Lyford area showing investigation locations.
