**Land damage and natural hazards in the Mt Lyford  
Village area following the 2016 Kaikōura earthquake**

**GNS Science Consultancy Report 2017/227  
April 2018**

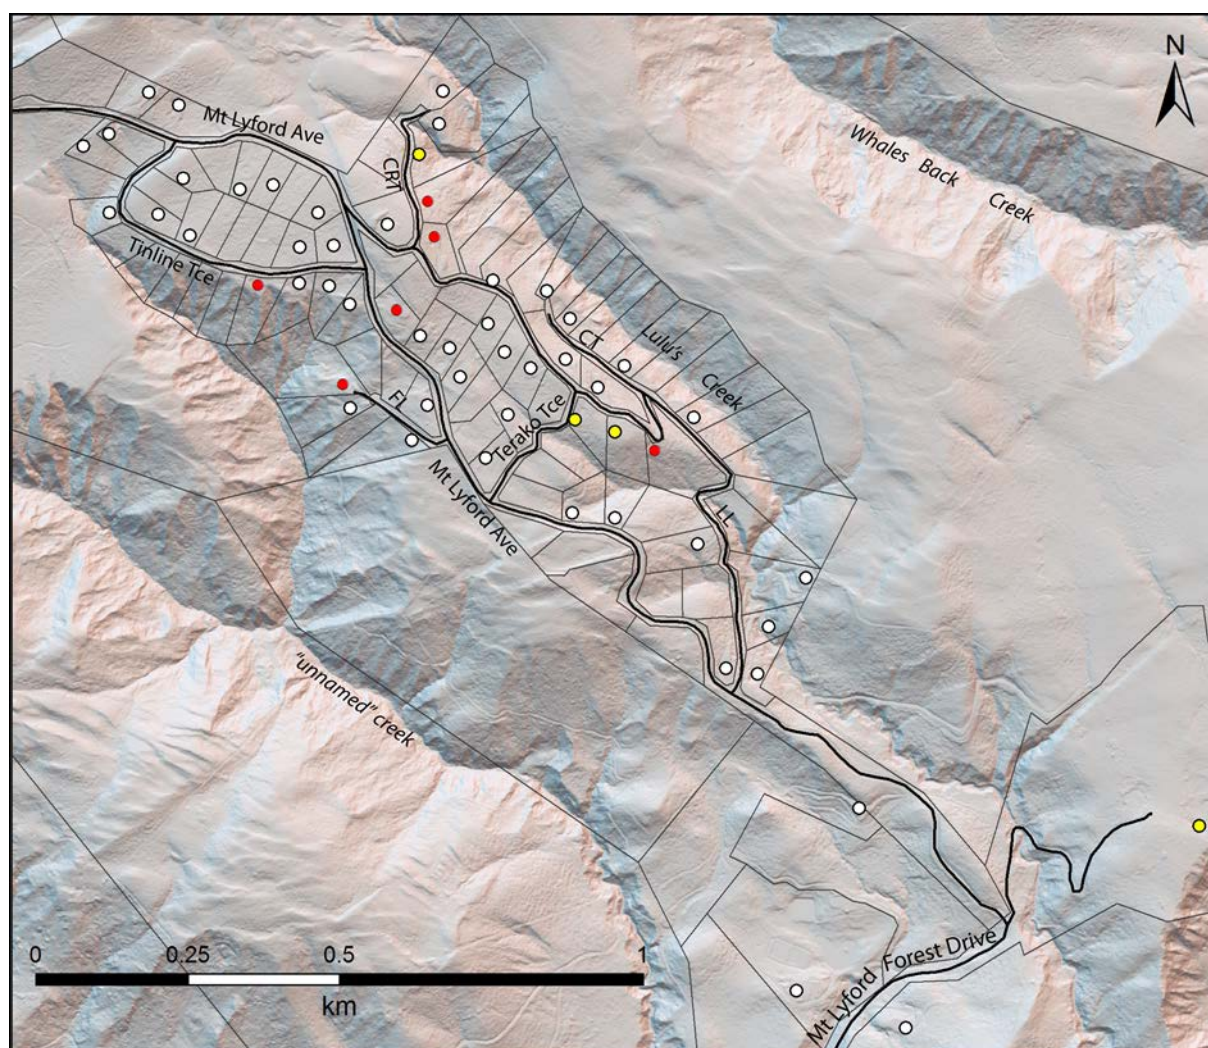
**Figure 1.3** Airborne LiDAR-derived hillshade model of the Mt Lyford Village area highlighting street names, property boundaries, and post-earthquake rapid assessment placarding on houses. Dots are house sites, and the colours correspond to red, yellow and white 'placarding'. Abbreviations for street names are: FL, Foggy Lookout; LL, Lulus Lane; CT, Charwell Terrace; CRT, Cloudy Range Terrace.

Rapid Building Assessment data was collected for 68 houses in the wider Mt Lyford Village area (Figure 1.3). Fifty-one of these assessments were on houses within the village above the junction between Lulus Lane and Mt Lyford Avenue, while a further eight properties were assessed between Lulus Lane and the Inland Road, along the Mt Lyford Forest Drive. Nine further properties were assessed along the Inland Road corridor southwest and northeast of the Mt Lyford Lodge. This project does not deal with the latter set of nine properties along the Inland Road corridor southwest and northeast of the Mt Lyford Lodge.

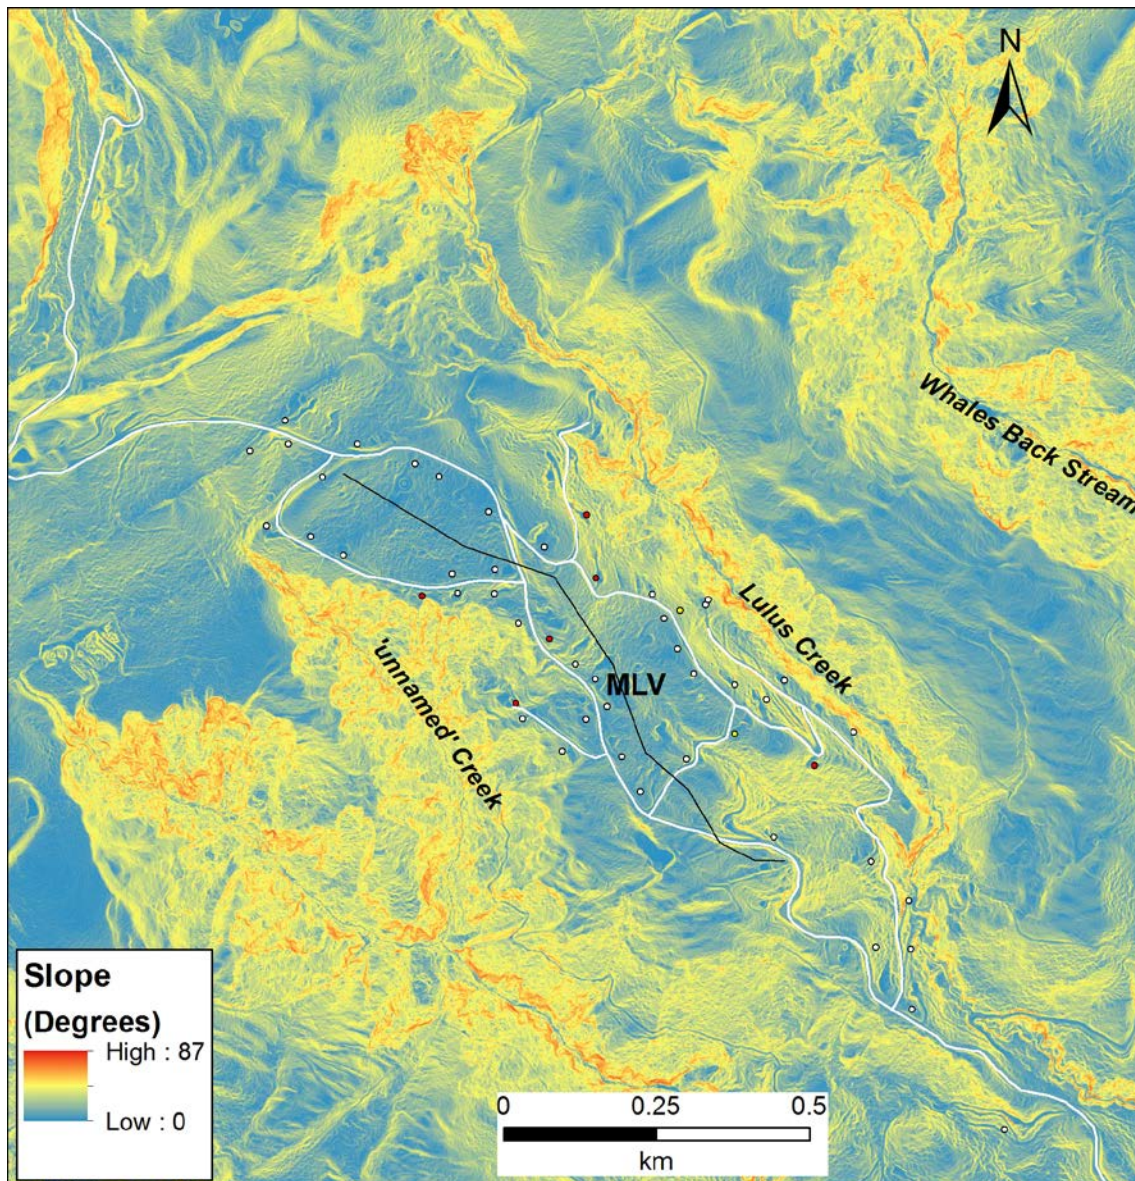
From Figure 3.2 we define three types of area with very steep slopes: (i) areas of very steep slopes consistently greater than 25°, limited to the steeply eroded gullies and streams (Whales Back Stream, Lulus and unnamed creeks); (ii) very steep slopes defined by alluvial

**Figure 3.2** A digital Slope map of the wider Mt Lyford village (MLV) area. Slopes in bluish colours are between c. 0-20°, while slopes in yellow and orange are c. >25°. Village road network is shown in white and post-earthquake response placards are shown as dots. The black line is the profile shown on **Figure 3.3**

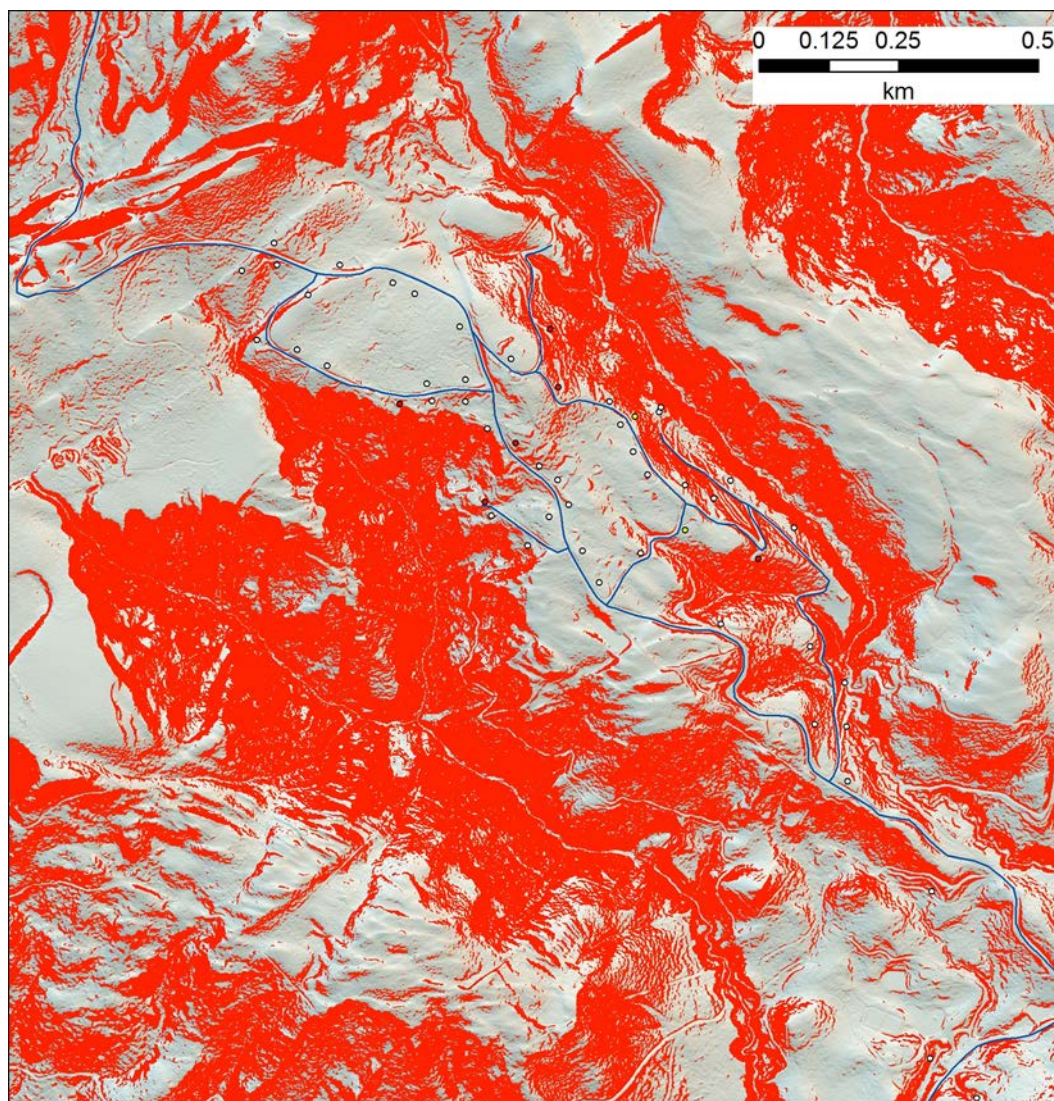
and fault scarp risers; and (iii) terraced, patchy or 'marbled' areas of moderate to very steep slopes with a mixture of slope angles greater than and less than 25°, but often with up to 50% of the area greater than 25° slope. Figure 3.4 highlights the important slope cut-off value of very steep slopes greater than 25°.

**Figure 3.4** Digital Slope Map of Mt Lyford Village. Slopes  $\geq 25^\circ$  are coloured red and are termed 'very steep slopes'. Areas with slope  $< 25^\circ$  are transparent, revealing the underlying hill-shaded DTM.

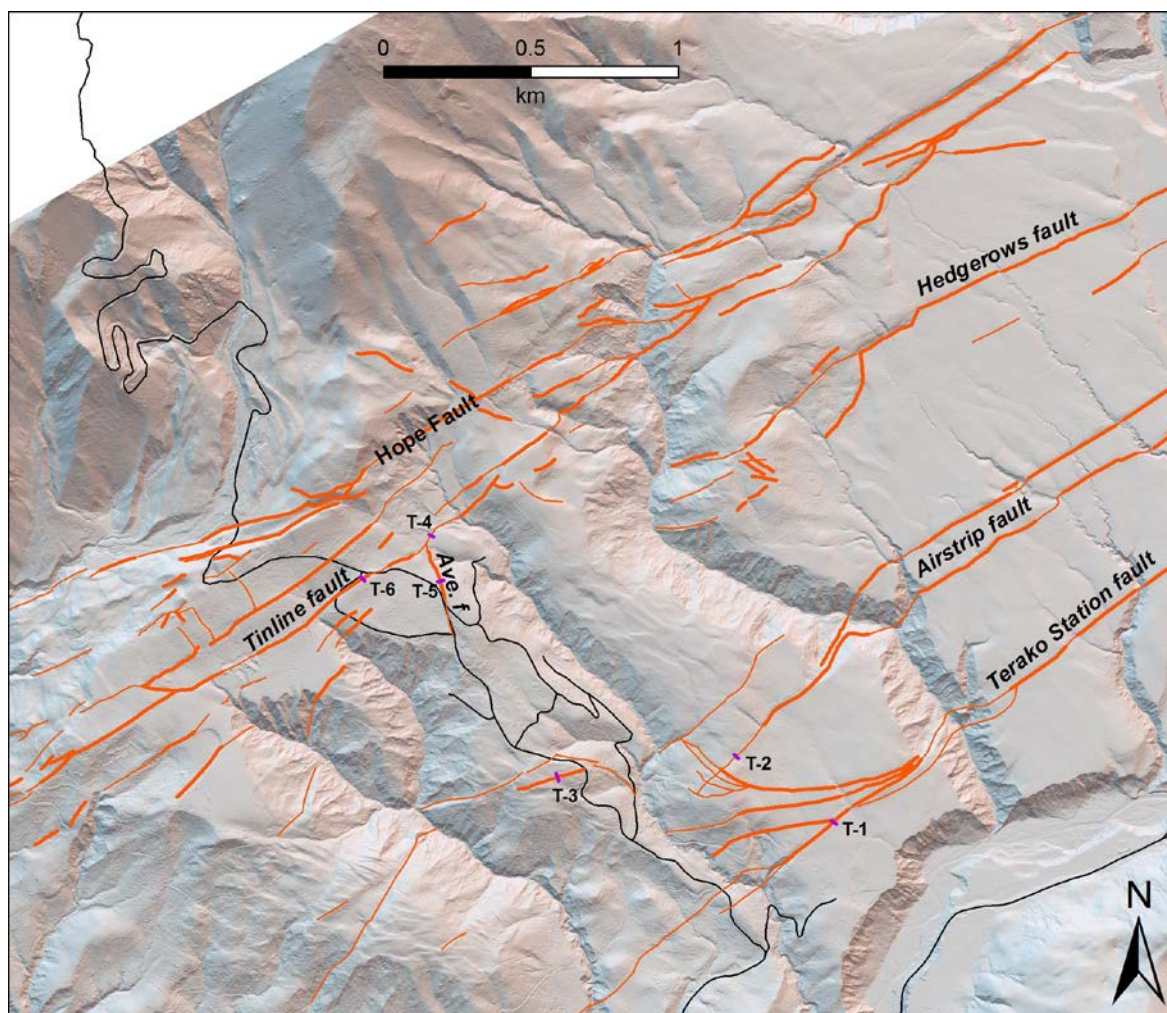
In addition to faults striking NE, other fault strike populations exist. For example, northwest of the Tinline Terrace loop we observe a pattern of faulting where there are short NNW- to NW-striking traces set in between the main NE-striking fault traces of the Hope Fault (Figure 3.5), e.g. the Avenue fault. While these features could be interpreted as alluvial or gravitational in origin, we prefer to consider them as active faults at this time (though we know little about their activity). In other cases, we observe fault traces that bend away from NE-strikes toward having NW-strikes. For example, there is an area of faulting between T-1 and T-2 (Figure 3.5) that takes this form, with curved fault traces bending from the Terako Station fault toward the northwest.

**Figure 3.5** Updated active fault map for the Mt Lyford Village area. The Hope fault is a distributed fault zone of up to 0.5 km width, and could include informally named faults (those in italics) such as the Tinline Fault. The accuracy of fault location is shown by the thickness of lines (accurate = thickest). The trenches excavated in 2006 are shown by purple dashes across faults and labels T-1, T-2 etc.

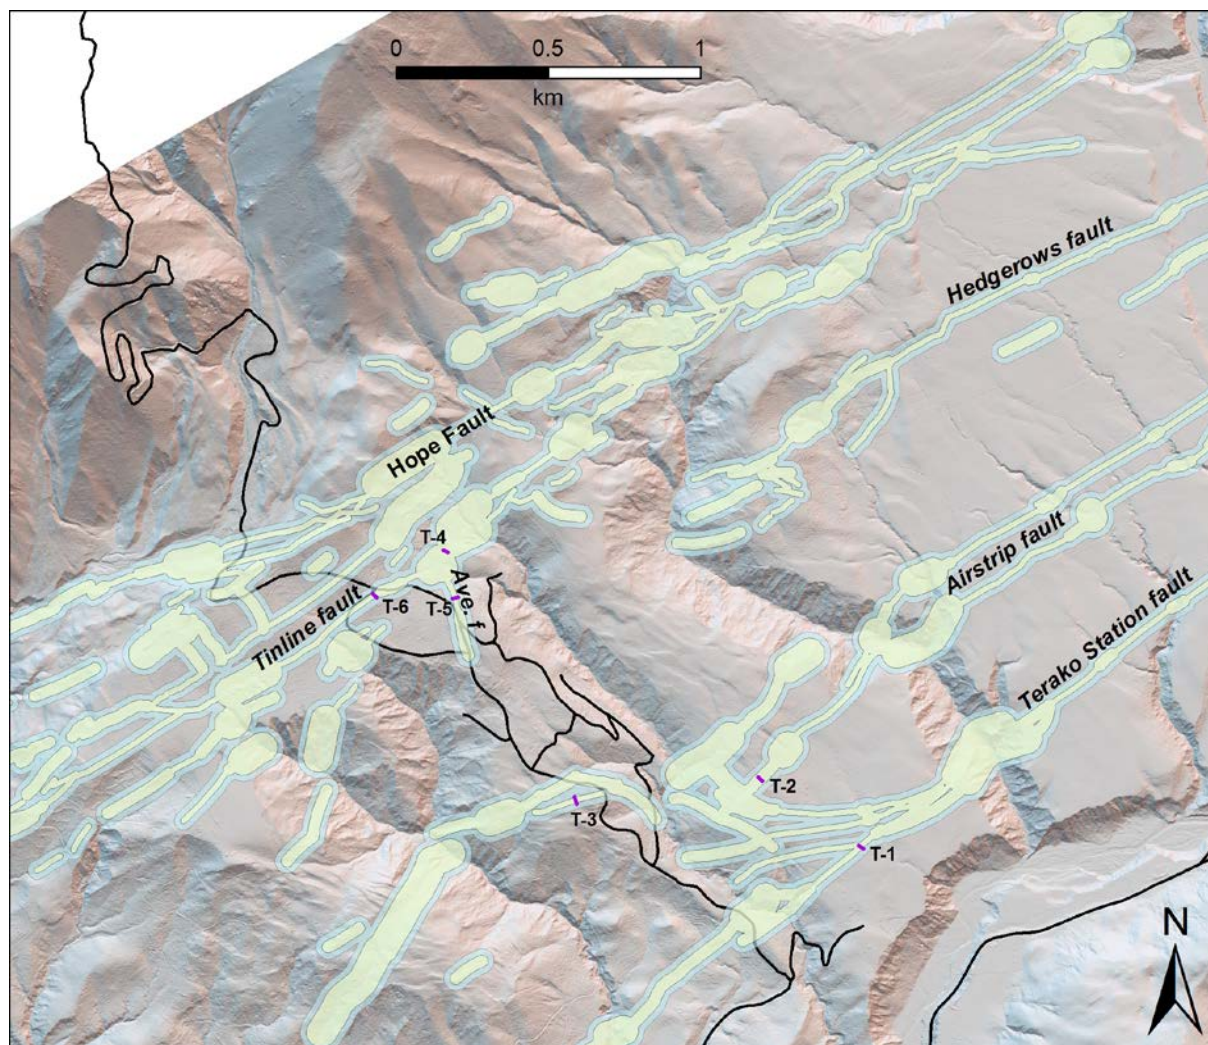
The MfE Guidelines recommend that a 'Margin of Safety' buffer of an additional 20 m be applied to either side of the fault trace (Kerr et al., 2003). Thus, an 'accurately' mapped trace will have a Fault Avoidance Zone of 60 m FAZ centred on the mapped fault location. Similarly, the FAZ widths for faults attributed 'approximate' and 'uncertain', are 80 and 140 m, respectively (Table 3.1).

**Figure 3.7** Fault Avoidance Zone (FAZ) map of the Mt Lyford Village area. The light green regions represent the width of the Fault Location certainty (expressed as ‘accurate, approximate, or uncertain’). The light blue edges are a 20-m wide margin of safety buffer. The FAZ is the sum of both coloured areas. Purple lines represent the locations of paleoseismic trenches excavated for Hancox et al. (2006).

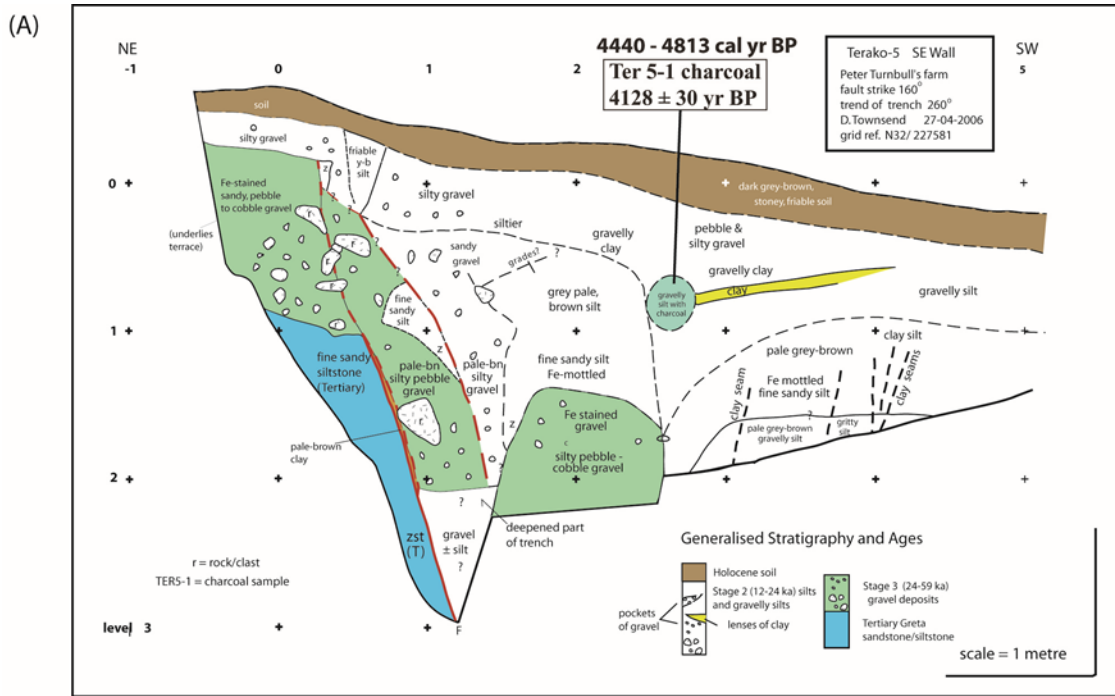
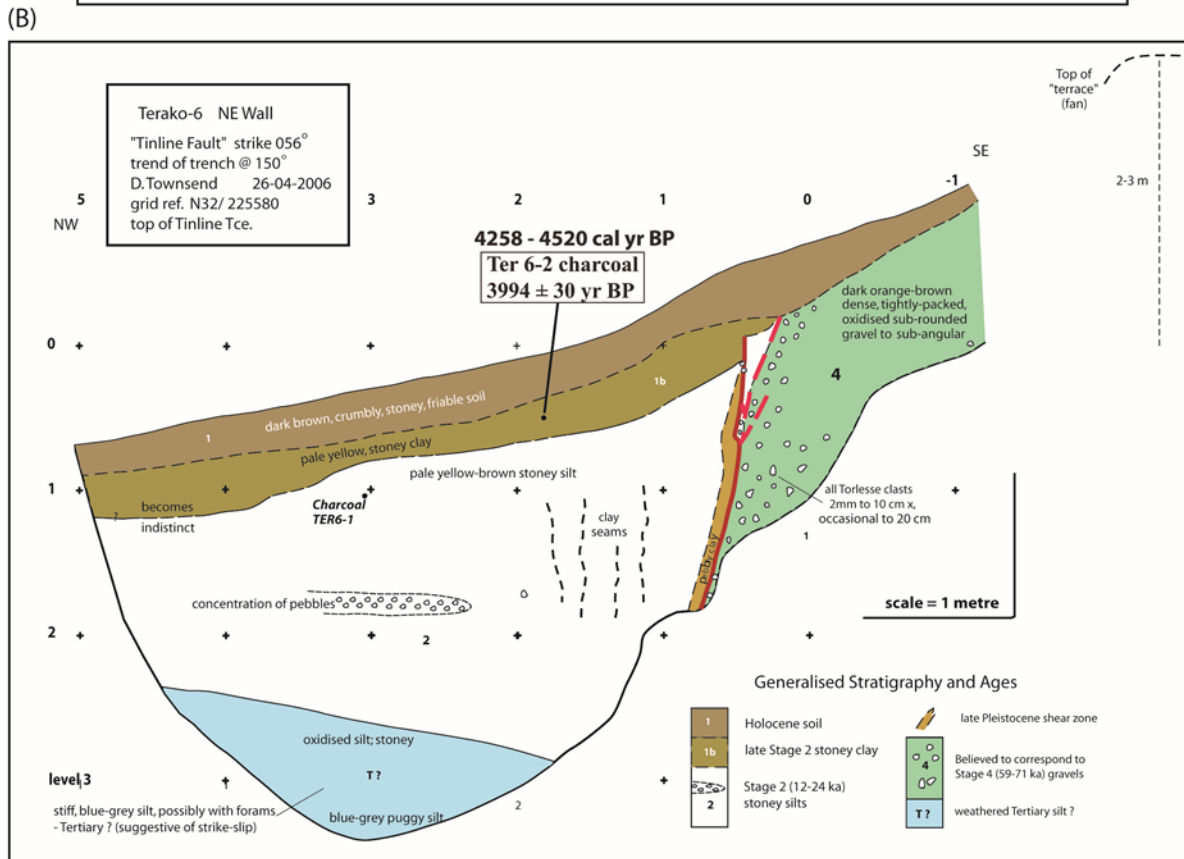
Terako trench-5 (Figure 3.8a) was excavated into a NNW-trending scarp (Figure 3.7) of a fault we informally call the Avenue fault due to its proximity to Mt Lyford Avenue (Table 3.2). The trench shows evidence for a complex zone of steeply-dipping (to the west) faulting associated with the scarp. Siltstone bedrock was observed in the footwall of the fault, interpreted as belonging to either the Waima or Greta formations. The calibrated radiocarbon date Ter 5-1 (4440-4813 cal. years BP) comes from a pod of gravelly silt that is arguably overlain by a scarp-derived colluvial wedge (upper white unit on Figure 3.8a), i.e. a silty gravel deposit that reflects a surface faulting event. This deposit itself is faulted at its base and the lateral continuity of the white (silty gravel) unit is broken by a triangular zone of friable yellow-brown silt, which may be filling a small wedge derived by faulting. From this description, we argue for two (or more) surface faulting events since the deposition of charcoal sample Ter 5-1, i.e., since 4440-4813 cal. years B.P. (Table 3.2).

As described above, we visited the site of trench-5 along the Avenue fault to look for evidence of recent surface faulting, noting a series of *en echelon* cracks with several cm of opening along the lower edge of the scarp, immediately north of the location of trench T-5. While this cracking was over a length of only a few metres along this fault, we infer that it provides evidence of possible surface faulting related to the 2016 Kaikōura earthquake. In terms of the recurrence of faulting along the Avenue fault, the events in the trench and, arguably in 2016, suggest at least 3 occasions of surface faulting or deformation during the last c. 4800 years. Even if we discount the evidence for recent faulting, there has been at least 2 events during the last 4440-4813 years. Given also that there has been no other known surface faulting during the New Zealand historical period at this site, we conclude that the Recurrence Interval for the Avenue fault is <2000 years and it should therefore be assigned to RI Class I.

Terako trench-6 was excavated into a NE-trending scarp related to a fault informally named as the Tinline fault (Hancox et al., 2006). This trench (Fig. 3.8b) shows evidence for a zone of steeply NW-dipping faulting. Tertiary siltstone (Waima or Greta formations) was mapped in the hanging wall of the fault, which was used as evidence to suggest that there was a strike-slip (horizontal) component of motion on this fault, in addition to the vertical component of motion as indicated by local geomorphology. The calibrated radiocarbon date Ter 6-2 (4258-4520 cal. years BP) comes from a pale yellow stony clay. We interpret this deposit (olive coloured unit in Figure 3.8b) as a scarp-derived colluvial wedge, i.e. a silty gravel deposit that reflects a surface faulting event. The base of this colluvial unit is faulted, which provides some evidence that there has been more than one faulting event recorded in the upper part of this trench. If this is the case, then there are two (or more) faulting episodes that have occurred since the deposition of charcoal sample Ter 6-2, which has a calendar calibrated age range of 4258-4520 cal. years BP (Table 3.2). We did not see any evidence for recent surface faulting along the Tinline fault. Despite this, and considering the lack of faulting events since AD 1840, it is again reasonable to concur that the Tinline fault has a Recurrence Interval which is very close to 2000 years. Based on its proximity to the Hope Fault (and Avenue fault) it is reasonable to also place the Tinline fault in RI Class I (Table 3.2).

**Figure 3.8** Logs for paleoseismic trenches Terako-5 (A) and Terako-6 (B) after Hancox et al. (2006), with radiocarbon dates and calibrated ages added. Stratigraphic columns and interpretations have not been changed from the 2006 report.

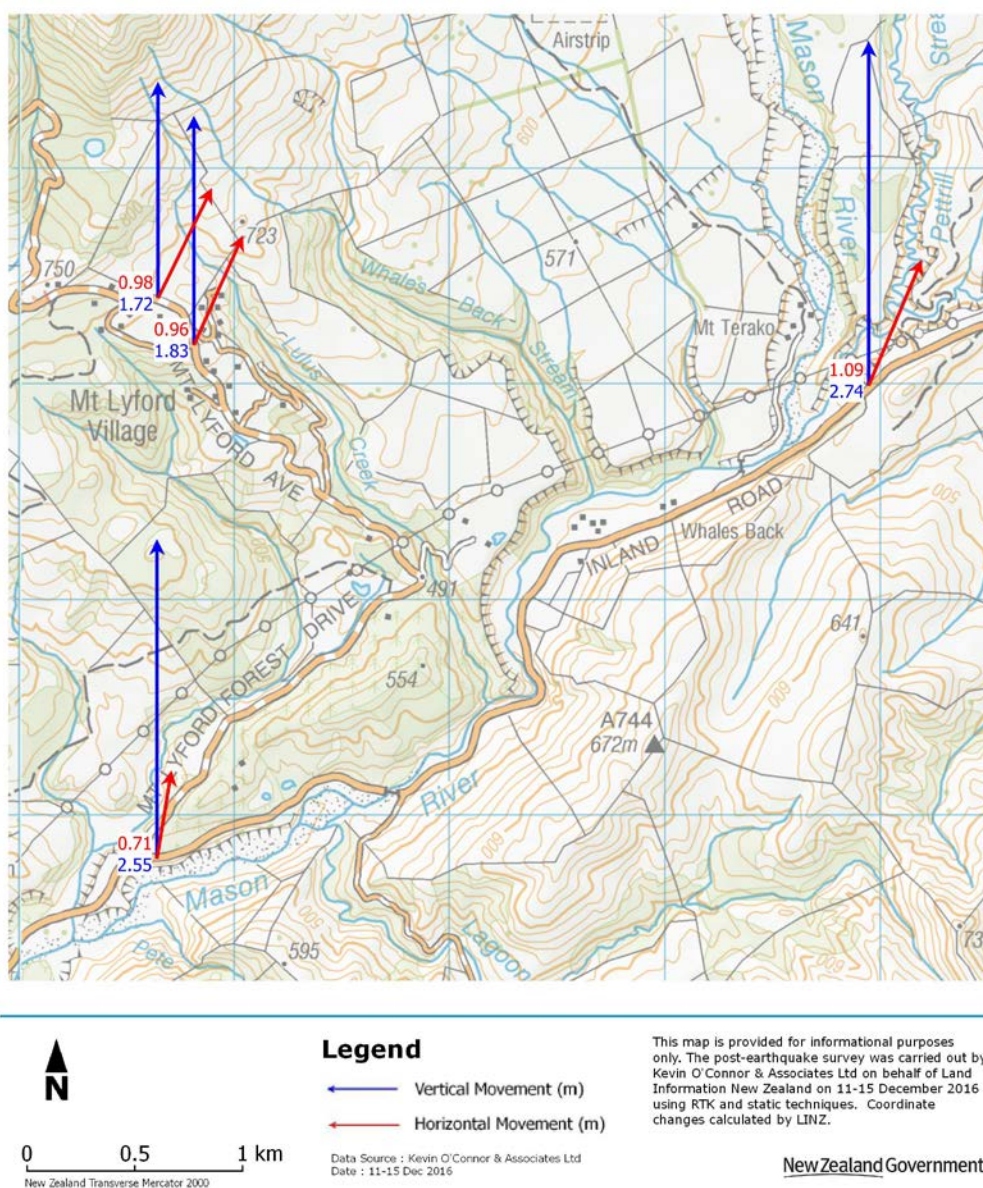
LiDAR acquisition and trig station surveying undertaken by Land Information NZ (LINZ) after the 2016 Kaikōura earthquake has enabled us to consider the relative co-seismic vertical and horizontal deformation that occurred in the Mt Lyford Village area. As part of a regional post-seismic survey of trig monuments, LINZ have reoccupied several of the trigs in the area (Figure 3.9). The surveying shows that there has been a measurable co-seismic vertical and horizontal movement of the Earth's surface, i.e. a crustal movement, relative to before the Kaikōura earthquake. In the village, the land has moved on the order of c. 1.7-1.8 m vertically, and about one metre horizontally, with motion directed upwards and toward the NNE, respectively. Two other trig monuments (one near Mt Lyford Lodge, the other near Mt Terako Station; Figure 3.9) suggest even larger vertical motions (2.5-2.7 m upwards) and

about the same horizontally 0.7-1.1 m). These larger movements can perhaps be explained by their closer proximity to The Humps Fault, and Conway-Charwell Fault, respectively (Figure 1.1; Nicol et al., 2018).

**Figure 3.9** Co-seismic movement of the land during the 2016 Kaikōura earthquake, measured at the available LINZ trig monuments (data supplied by LINZ). Movement has vertical (upwards/blue) and horizontal (to the NNE/red) components.

The amount and styles of deformation are consistent with the observations shown by the 4 LINZ trig monuments (Figure 3.9). For example, the two trig monuments along the Inland Road suggest uplift of >2.5 m, which is borne out from the wider D-LiDAR coverage.

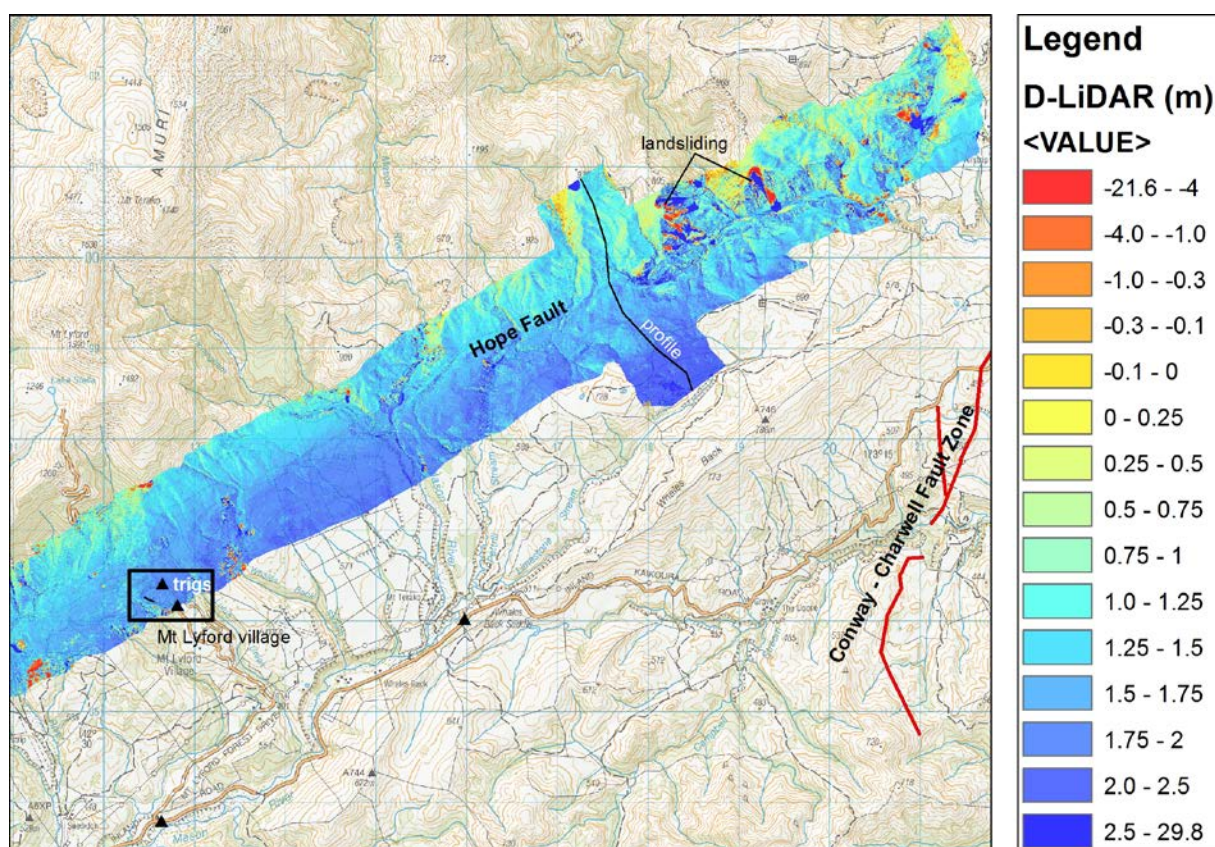
**Figure 3.10** Available D-LiDAR coverage includes a strip along the Hope Fault between the Wandle River and Cloudy Range Station. Colour gradient reflects vertical change pre- versus post-Kaikōura earthquake. Black triangles are positions of LINZ re-survey monuments (Figure 3.9) and black line indicates the location of a topographic profile shown in Figure 3.11. Box shows area of detail shown in Figure 3.12.

The main signals observed from D-LiDAR analysis (Figure 3.10) are:

- (a) Region-wide uplift of the whole area, both northwest and southeast of the Hope Fault (which is spanned by the D-LiDAR strip);
- (b) Higher uplift southeast of the Hope Fault;
- (c) Higher uplift across the strip toward the southeast, i.e. toward the Conway-Charwell Fault Zone, observed along a profile perpendicular to the strike of the Hope Fault (Figure 3.11), and progressively higher uplift along the strip to the northeast compared with the southwest;
- (d) Landsliding, indicated by coupled areas of intense red and blue colours in Figure 3.10, indicates significant elevation losses (red; landslide source areas) and gains (bright blue; in landslide accumulation areas).

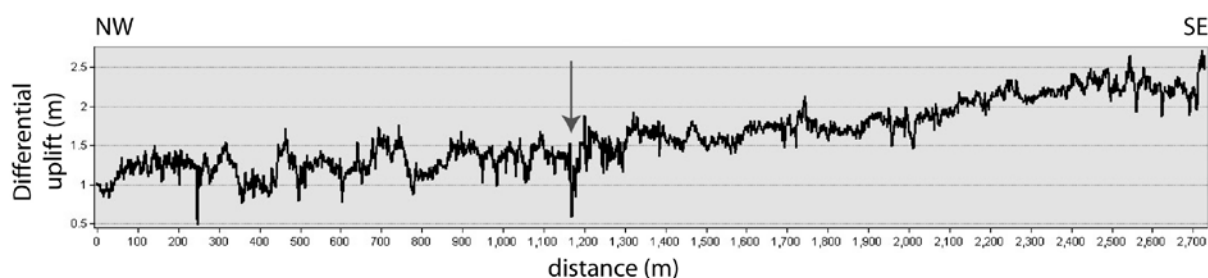
A profile across the widest part of the D-LiDAR strip in the Towy River area gives a good indication of the vertical deformation from NW to SE (Figure 3.11). Uplift of the Amuri Range to the north of the Hope Fault is c. 1-1.5 m. Uplift on the south side of the Hope Fault is c. 1.5-2 m and increases to 2-2.5 m towards the Conway–Charwell Fault Zone, which ruptured during the 2016 Kaikōura earthquake.

**Figure 3.11** D-LiDAR profile showing differential uplift (in m) from the Towy River headwaters north of the Hope Fault (marked by arrow) to Limestone Creek in the southeast. Arrow marks the location of the Hope Fault. Uplift to the NW of the Hope Fault is lower than to the SE of it. The profile location is shown in Figure 3.10.

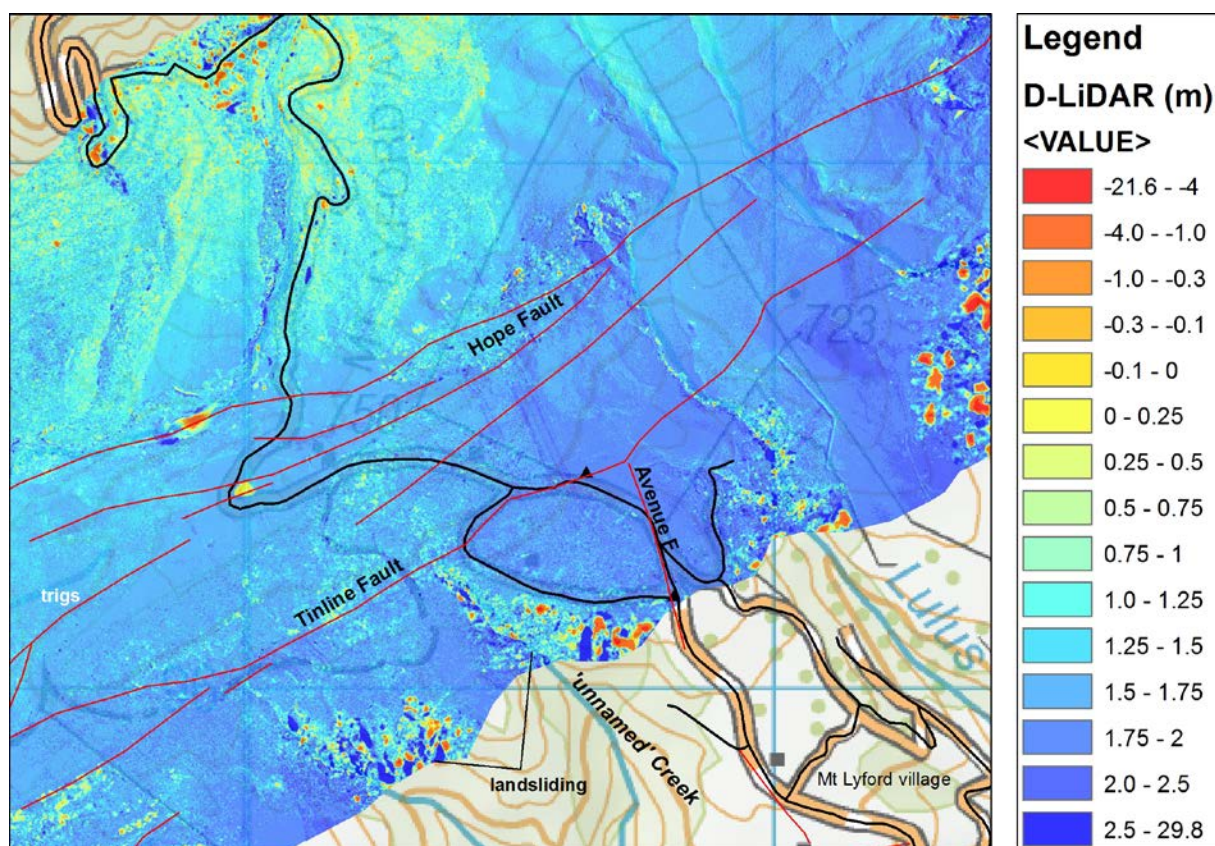
Figure 3.12 displays the D-LiDAR coverage within Mt Lyford Village in detail. Some of the most intense differences (bright red to bright blue) relate to landslides indicating a consistent red-at-top (headscarp/elevation loss) to blue-at-bottom (deposit/elevation gain) signal. A good example of this is a fresh and active landslip on the face northeast of Lulus Creek (visited during the field reconnaissance) (Figure A1.3). This provides some control between field observation and the digital model. However, at this scale there are effects in the D-LiDAR image that are artificial and not related to real land movement or deformation, e.g. the finely speckled bright red/blue pattern observed in the steep gullies of Whales Back Stream, Wandle River, and Lulus, 'unnamed' and other creeks. This may be an artefact of significant differences in the 2012 vs. 2016 LiDAR acquisitions (or processing) that are exacerbated in the gullies and streams, particularly where penetration through the vegetation cover. Above all, Figure 3.12 highlights that the upper part of the village has been consistently uplifted by c. 2 m, and the hazard potential posed by slope movements in the steep gully walls of the drainages around Mt Lyford Village.

**Figure 3.12** D-LiDAR coverage centred on the upper part of Mt Lyford Village. Caveats related to the interpretation of this data are discussed in the text.

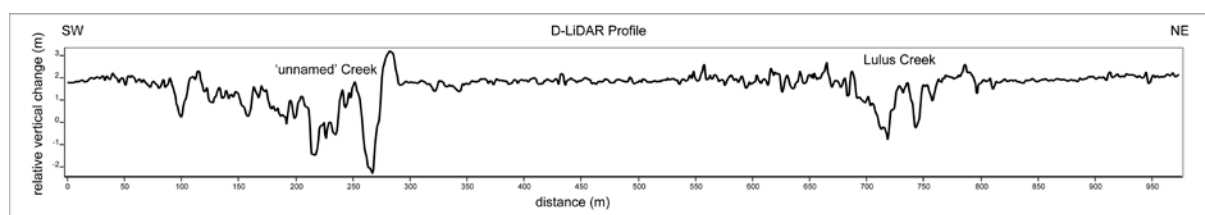
This rate is partly climatically driven (rainstorm events) and partly tectonically driven (regional uplift and stream base level changes). The Kaikōura earthquake uplifted the landscape in the area of the village by c. 1.7-1.8 m (Figure 4.1). The local streams will begin to respond to this tectonic change in level by incising further. This incision will have the effect of steepening and destabilising the valley side walls as the streams erode, which will likely have a detrimental impact on the stability of the land above.

**Figure 4.1** Profile along the SE edge of the D-LiDAR dataset in Mt Lyford Village. The profile indicates that there was broadly 2.0 m of co-seismic uplift in the central part of the village.

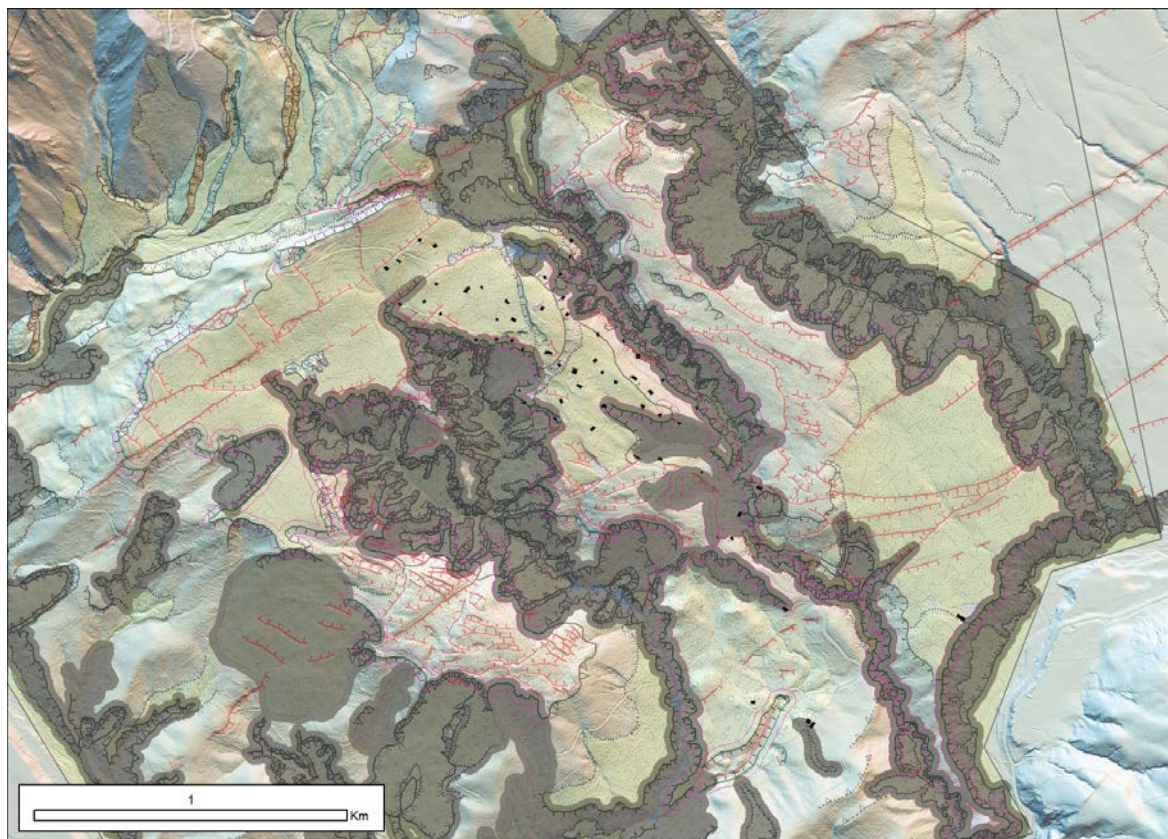
Cracking and land damage was also observed along the southwestern loop of Tinline Terrace. An oral account suggests that, following the Kaikōura earthquake, there were tensional cracks in this packed dirt road. Part of the road would be included in our 20-m setback exclusion zone (Figure 4.2). In addition, there was significant land damage (cracking and downslope movement) around the telecommunications repeater on Tinline Road (Figure A1.7).

**Figure 4.2** A geomorphic map of Mt Lyford Village with a 20m wide buffer added above the slope break between very steep slopes and less steep slopes. Current house footprints are shown as black polygons. Slopes of less than 25° are depicted as light green and light orange areas, (there is some variation in colour due to the underlying grey hill shade model). Slopes of 25° or steeper (including a 20m set-back buffer) are shown in grey. Thus, the grey areas represent very steep and/or vulnerable slopes. The darker brown-grey areas represent areas the highest slope stability hazard in the Mt Lyford area.

In this area, the land slumped away by at least 0.5-1.0 m downslope across a zone of land extension toward the head of 'unnamed' Creek.

In this study, we have considered the upper limit of what are defined as 'steep slopes' (i.e. 15-25°) by Hancox et al. (2006) as an important slope angle break. Thus, we define slope angles of  $\geq 25^\circ$  as being 'very steep slopes' (Figure 3.3). We consider that building in such areas of very steep slope should be managed and avoided if possible. Based on our observation and analysis, we also suggest that a setback distance of 20 m from the upper edges of areas of very steep slopes is warranted. Figure 4.2 shows an example of the suggested set-back zoning for the upper part of Mt Lyford Village. Set-back limits skirt around the upper catchment of 'unnamed' Creek and other creeks with very steep slope edges. Landslide run-out has not been considered in this study and so building below very steep slopes is not considered in this analysis.

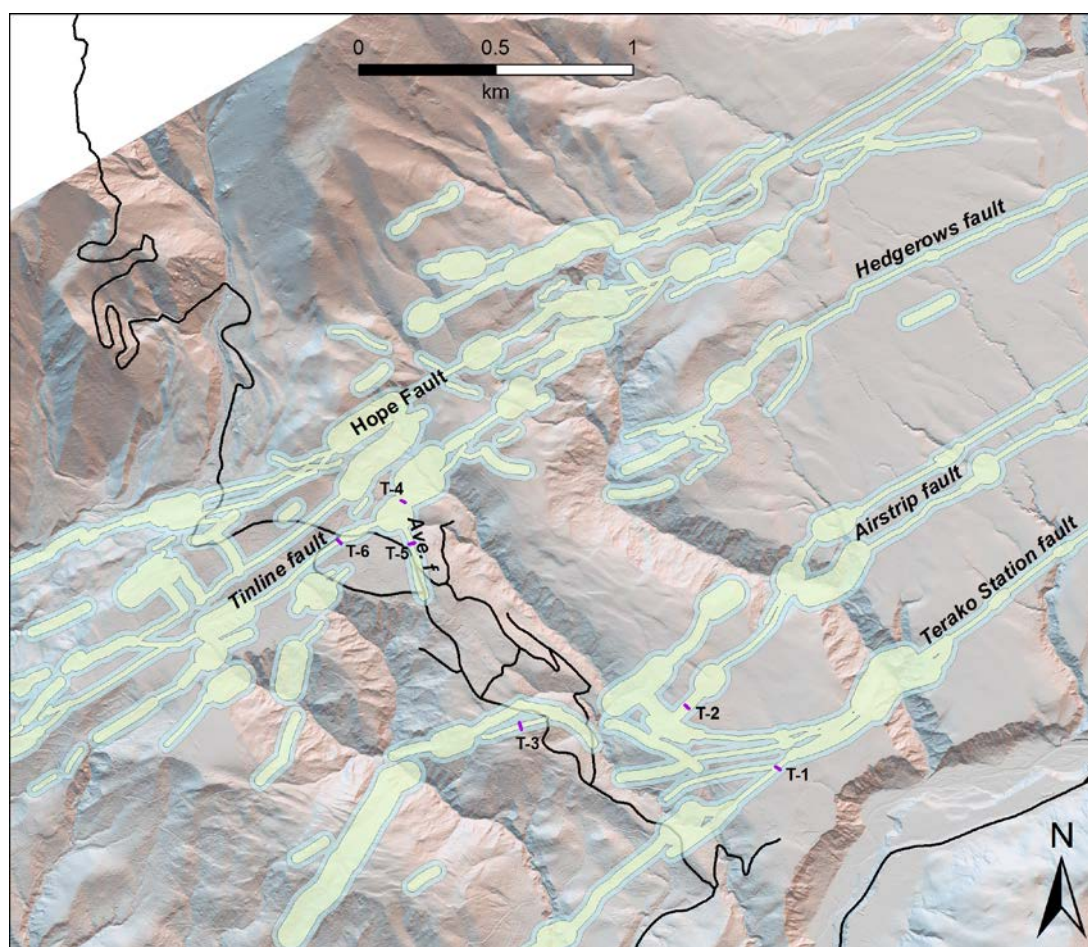
Figure 3.7 and Figure 4.3 show fault avoidance zone maps for the Mt Lyford Village area. These show the areas where restrictions on building activity might apply in relation to active faults. The width of fault avoidance zones is defined by how accurately the fault can be located, termed the fault complexity in the MfE Guidelines (Kerr et al., 2003). The structure of planning decisions developed in the MfE Guidelines use fault recurrence interval, fault complexity, building importance class, and current land use type to determine the appropriate resource consent category for a building type/use at a site.

In this study, we have defined the active faults that cut across the land in the Mt Lyford Village as having a recurrence interval (RI) class of I or II. The Hope, Tinline and Avenue faults are defined as RI Class I (RI <2000 years), while the Airstrip1, Airstrip2, and Terako Station faults are defined as RI Class II ( $\geq 2000$ -<3500 years). Based on estimates of vertical slip rate from offset terraces on Terako Station and its proximity to other RI Class I faults, the Hedgerows fault has been placed in Recurrence Interval Class I.

**Figure 4.3** Fault Avoidance Zone (FAZ) map for Mt Lyford Village. FAZ 'sausages' are shown with their associated active faults as labelled. See text and **Figure 3.7** for details of how this is constructed. Fault line data is intentionally left off this map to focus on the avoidance zones.

For Greenfield sites, the recommended resource consent activity status ranges (because of variations in fault complexity) between Non-Complying and Discretionary for BIC 2a/2b structures in RI Class I and II fault avoidance zones.

For developed or already subdivided sites the recommended resource consent activity status ranges (because of variations in fault complexity) between Non-Complying and Discretionary for BIC 2a/2b structures in RI Class I fault avoidance zones, and ranges between Discretionary and Permitted for BIC 2a/2b structures in RI Class II fault avoidance zones.
