LIQUEFACTION HAZARD IN HURUNUI DISTRICT

**Environment Canterbury
&
Hurunui District Council**

Report prepared by GEOTECH CONSULTING LTD

Environment Canterbury report number R11/61
ISBN: 978-1-927146-31-6

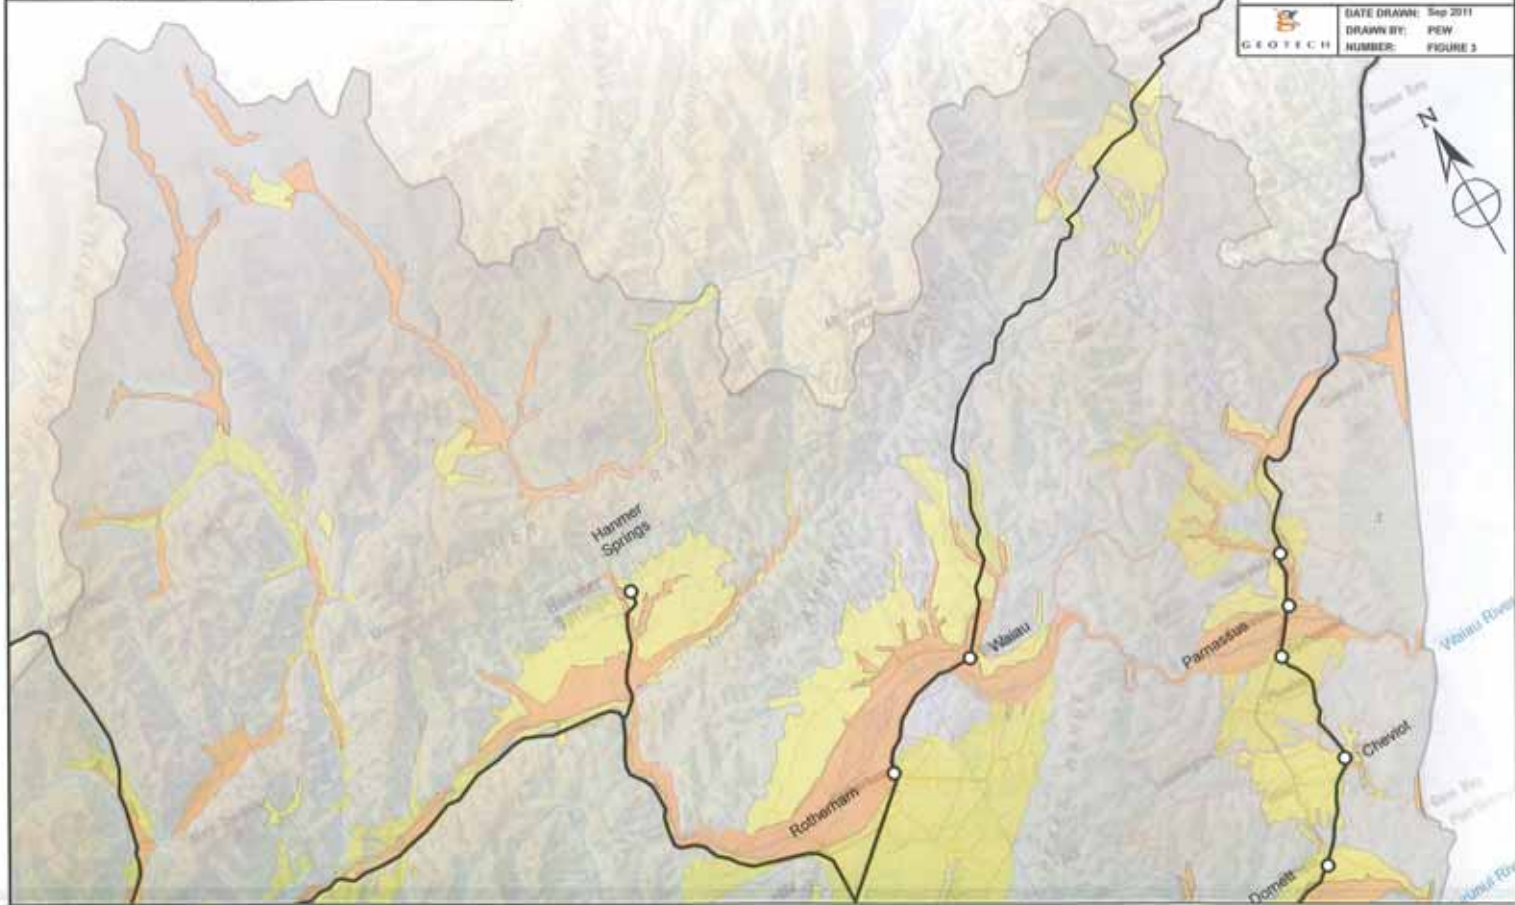
DATE DRAWN: Sep 2011
DRAWN BY: PEW
NUMBER: FIGURE 3

Zone boundaries have been determined principally from geological maps of the district, with some additional limited borehole information. The zone boundaries are approximate only. Some areas within one zone may behave more like an area in another zone. For any critical structure, a specific site study is needed to determine the actual degree of hazard.
