## **LIQUEFACTION HAZARD IN HURUNUI DISTRICT**

**Environment Canterbury  
&  
Hurunui District Council**

Report prepared by GEOTECH CONSULTING LTD

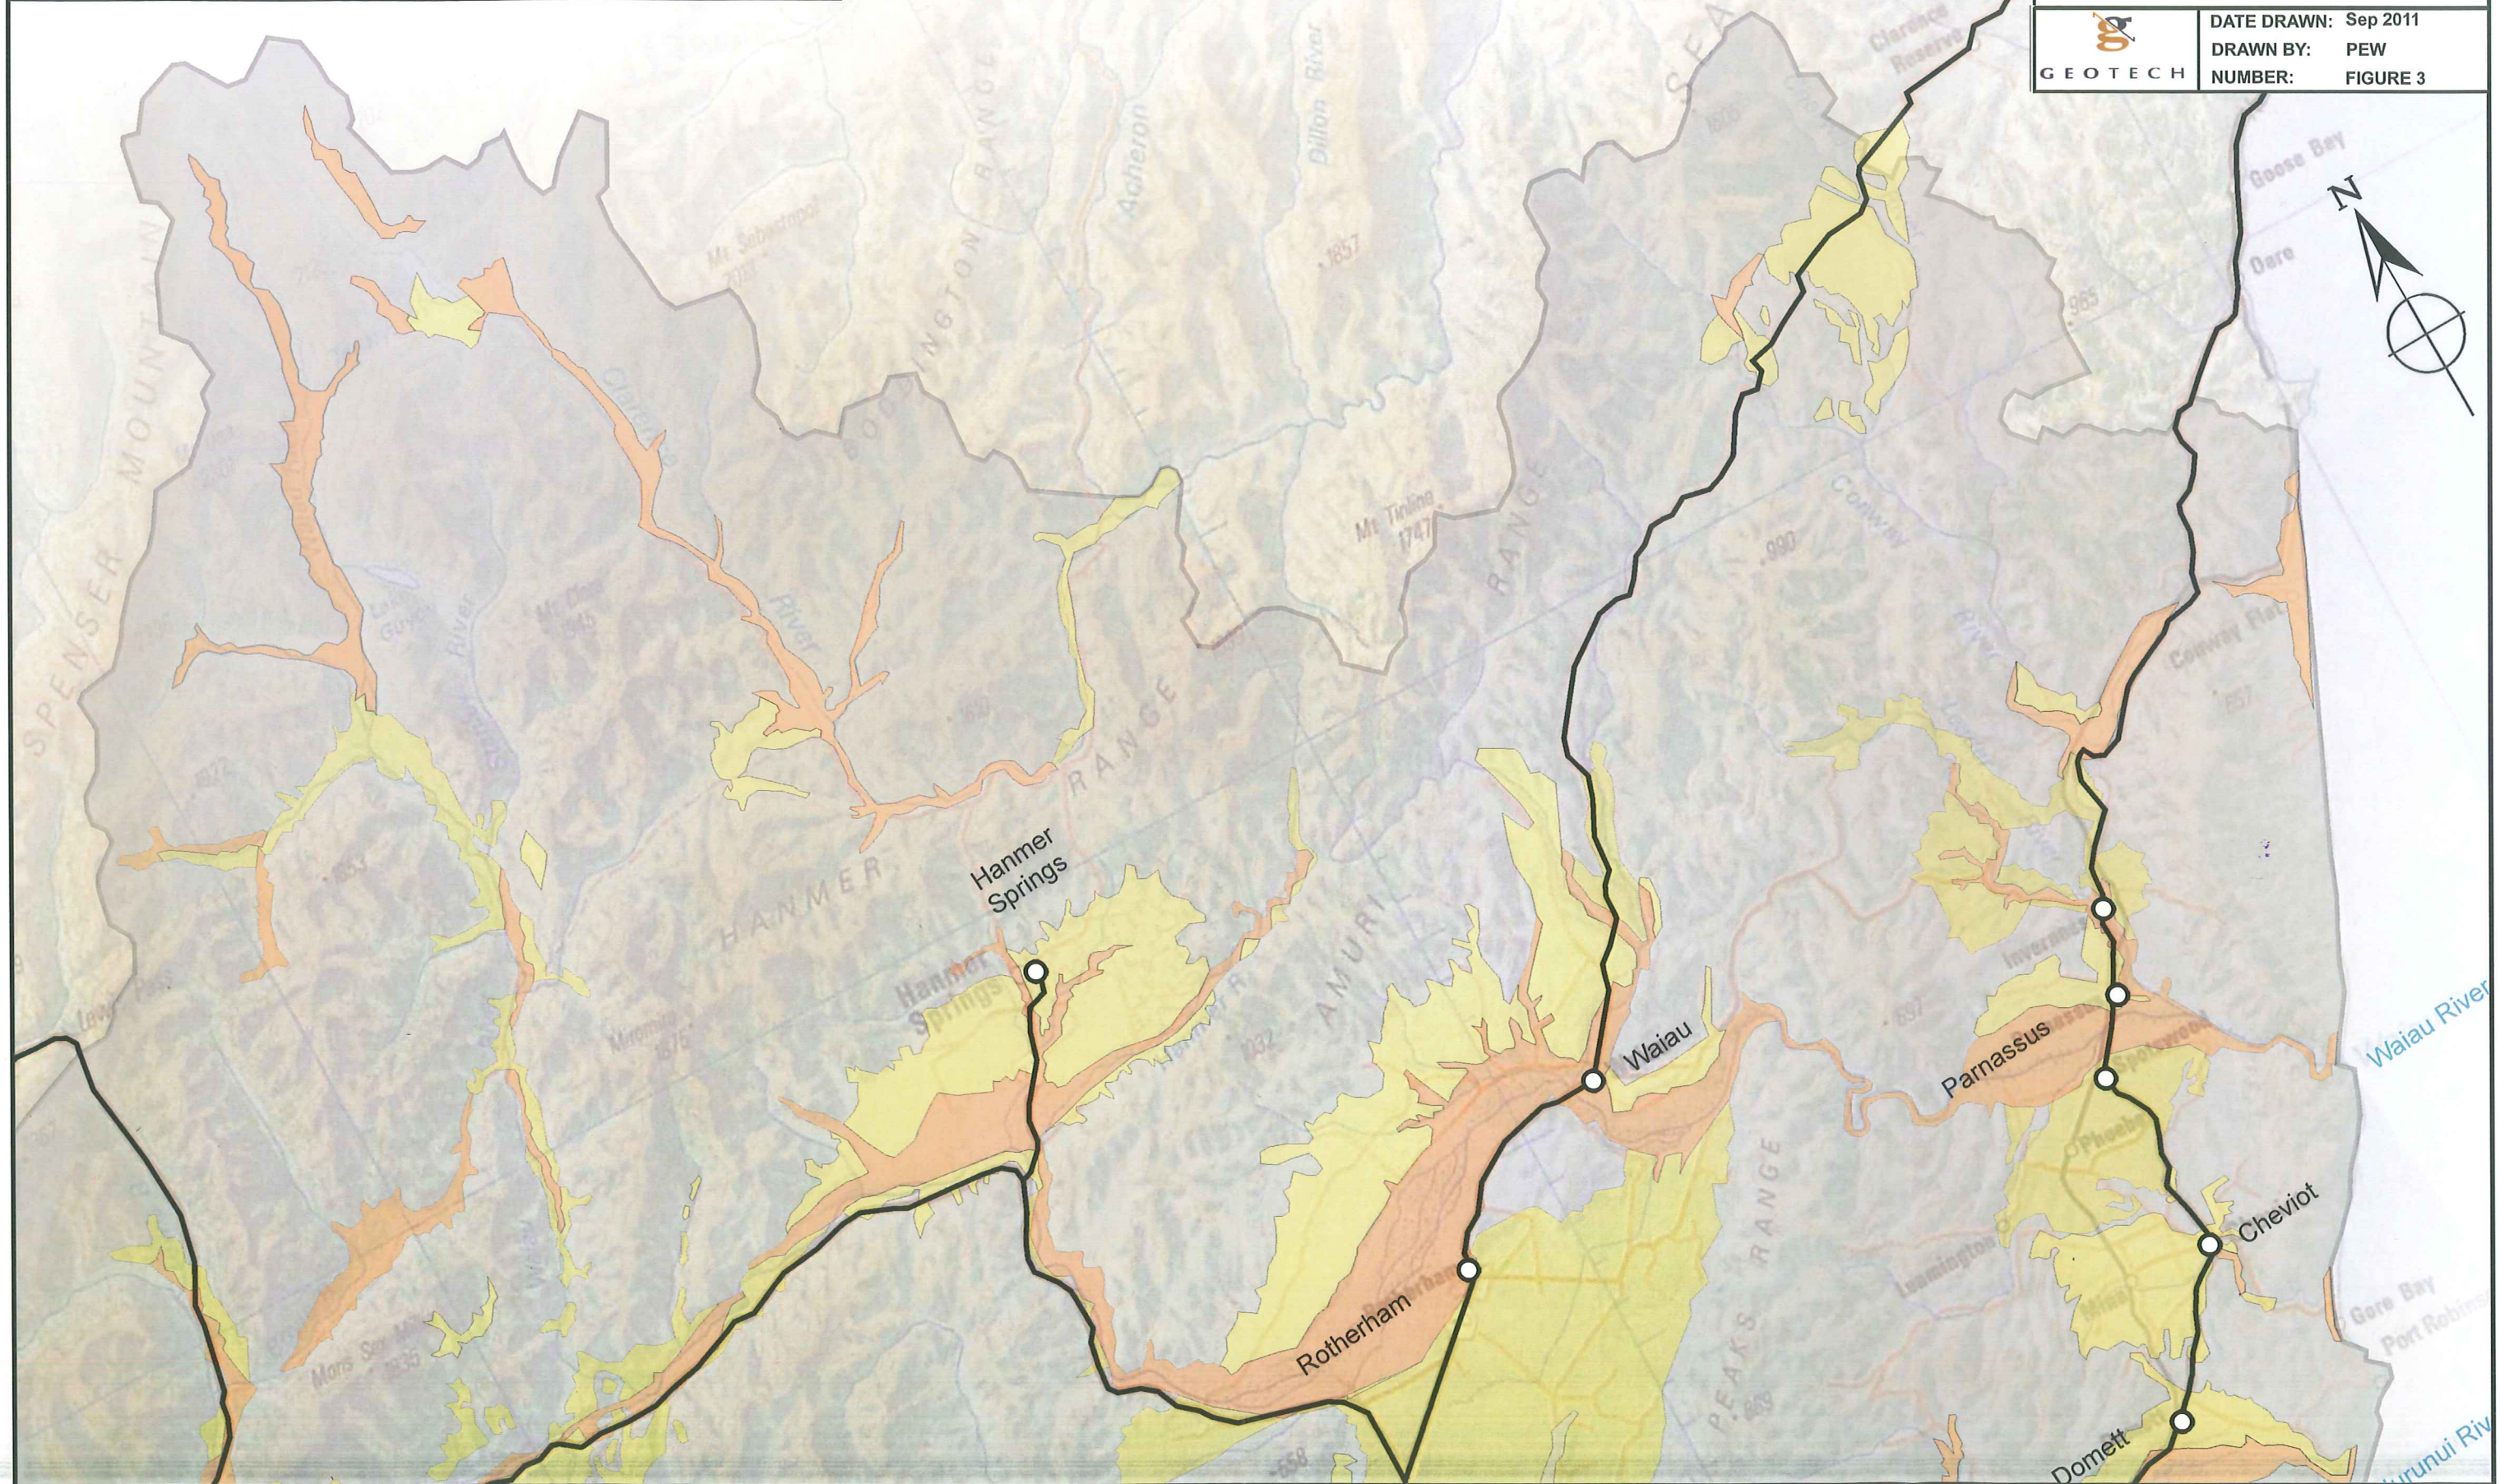
DATE DRAWN: Sep 2011  
 DRAWN BY: PEW  
 NUMBER: FIGURE 3

Zone boundaries have been determined principally from geological maps of the district, with some additional limited borehole information. The zone boundaries are approximate only. Some areas within one zone may behave more like an area in another zone. For any critical structure, a specific site study is needed to determine the actual degree of hazard.

- Figure 1 Liquefaction Potential in Hurunui District  
(1:500,000 scale)
- Figure 2 Liquefaction Potential in northern part of Hurunui District  
(1:250,000 scale)
- Figure 3 Liquefaction Potential in southern part of Hurunui District  
(1:250,000 scale)
