## Appendix 3

Mt Cass Access Road Restoration

Batterslope Mitigation

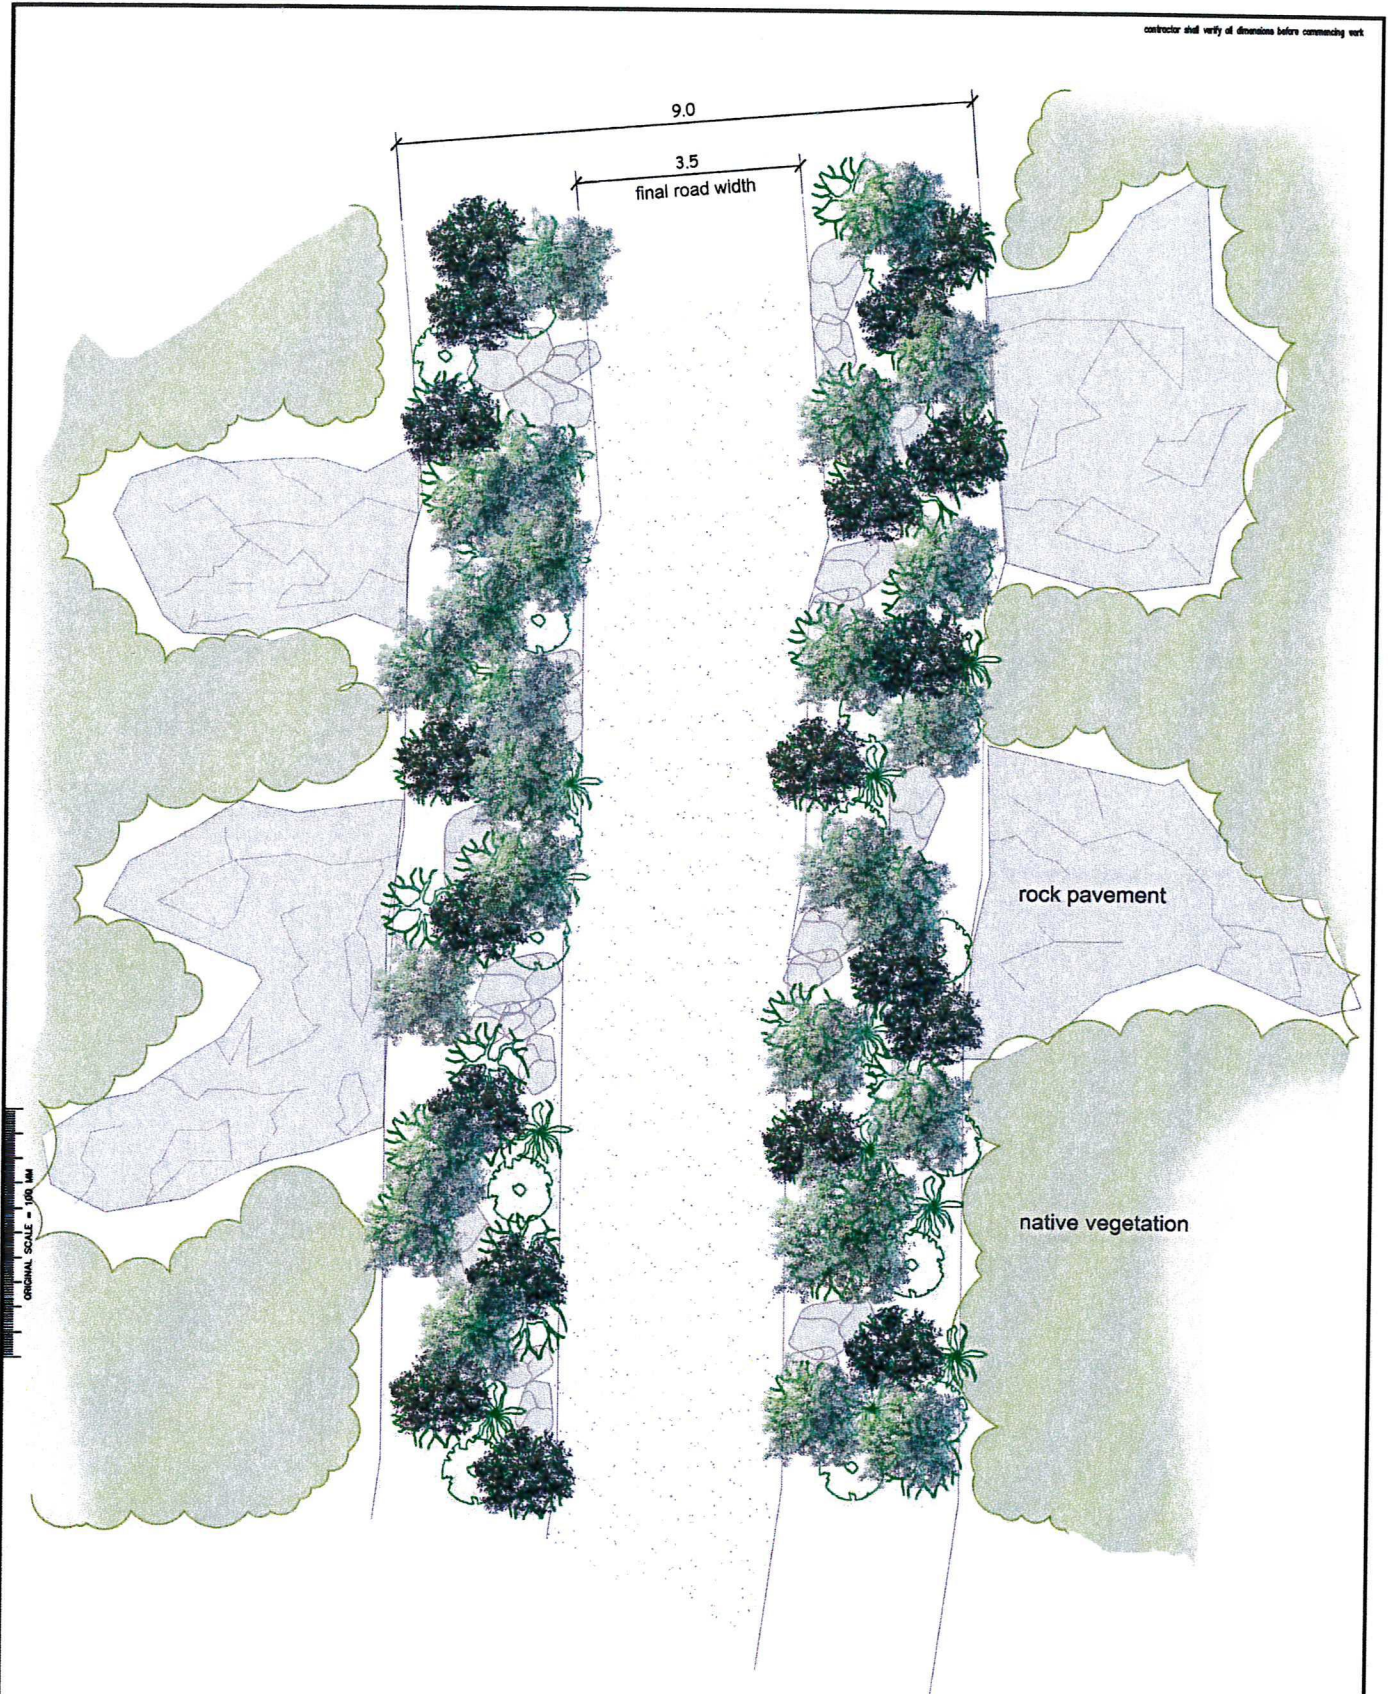
1. Chris Glasson Plan, 15 November 2010
2. Cross section of completed road formation with mitigation 24 July 2010

3. Plan view of completed road formation

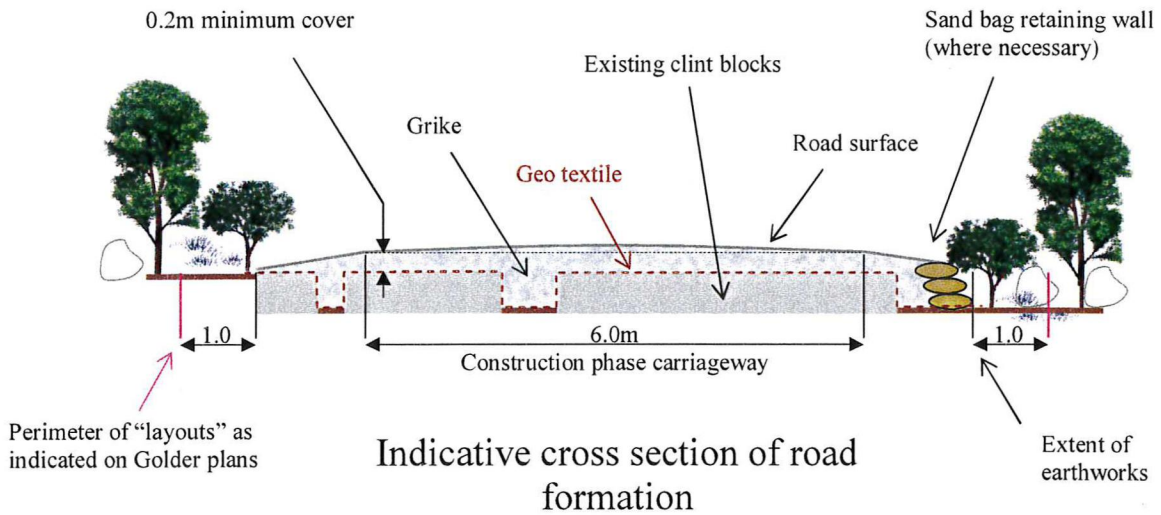
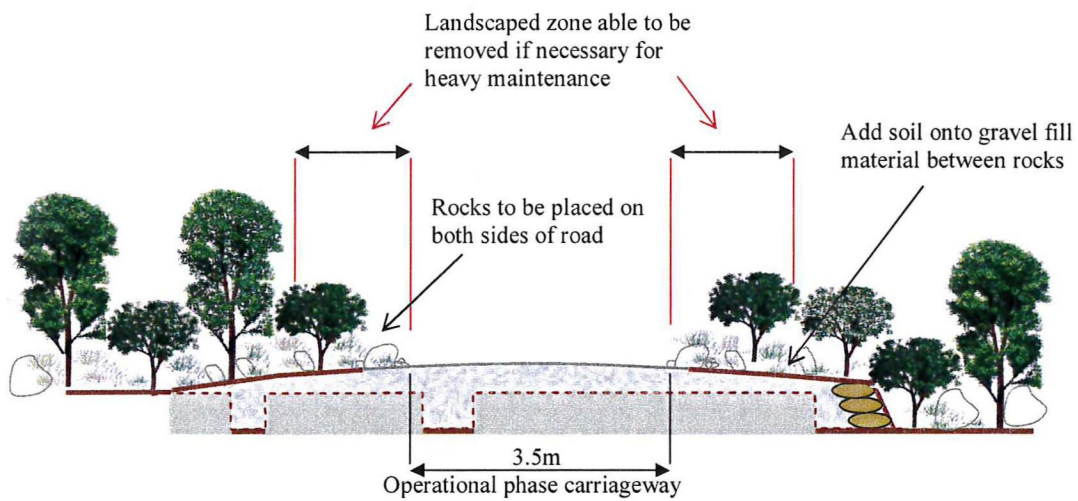
**Road crossing over limestone pavement between location 800 to 950**
